**Project:** 22\_VTA\_05\_01  
**Site:** 105 Bartholomew Road, London, NW5 2AR  
**Client:** Debbie Sirkett

Document Title:	Tree Safety Survey - 3 year time cycle.
Document Author:	Peter Haine
Project Manager:	Matt Harmsworth
Project Title:	105 Bartholomew Road, London, NW5 2AR

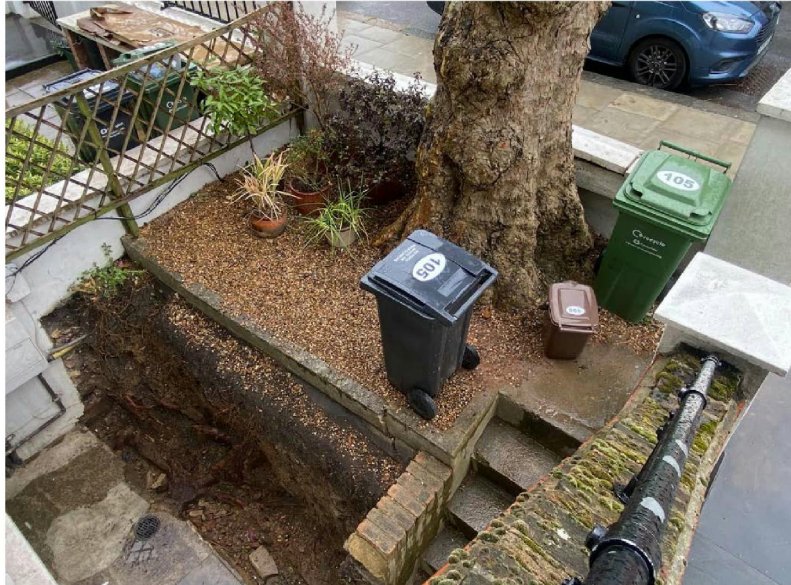
*Photographic plate showing the tree stem in the context of the front garden.*

- 3.1 Tree cover at the site is limited to a single large mature London Plane in the small front garden. The tree appeared to be in fair condition, however as it had recently been pollarded a full assessment of its physiological condition was not possible.

- 4.1 It is recommended that the tree be removed, due to the damage caused to both the retaining wall and the garden wall, in order to facilitate repair to both walls.

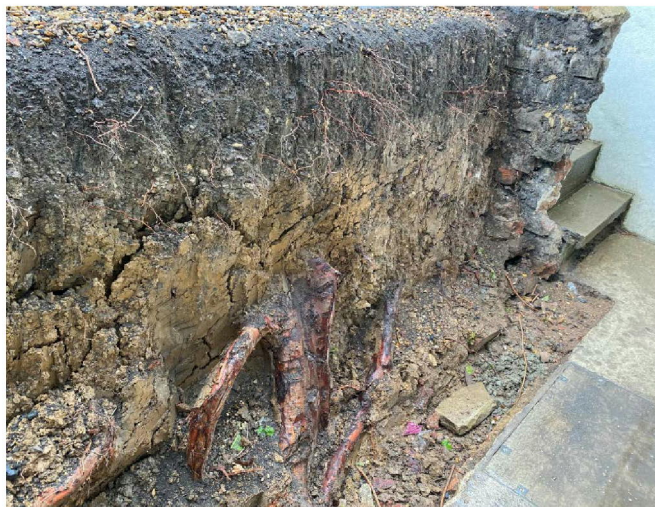
*Photographic plate showing the soil bank behind the failed retaining wall.*

- 3.5 The retaining wall between the front elevation of the building and the tree partially collapsed and has been removed. In its absence the extensive tree roots below and behind the wall are evident. A retaining wall is required to prevent collapse of the bank into the house, however construction of a new retaining wall and associated foundations would require removal of structural tree roots to install. Small diameter pile foundations have been considered, however due to the dense nature of the root network it is difficult to envisage how they could be installed.

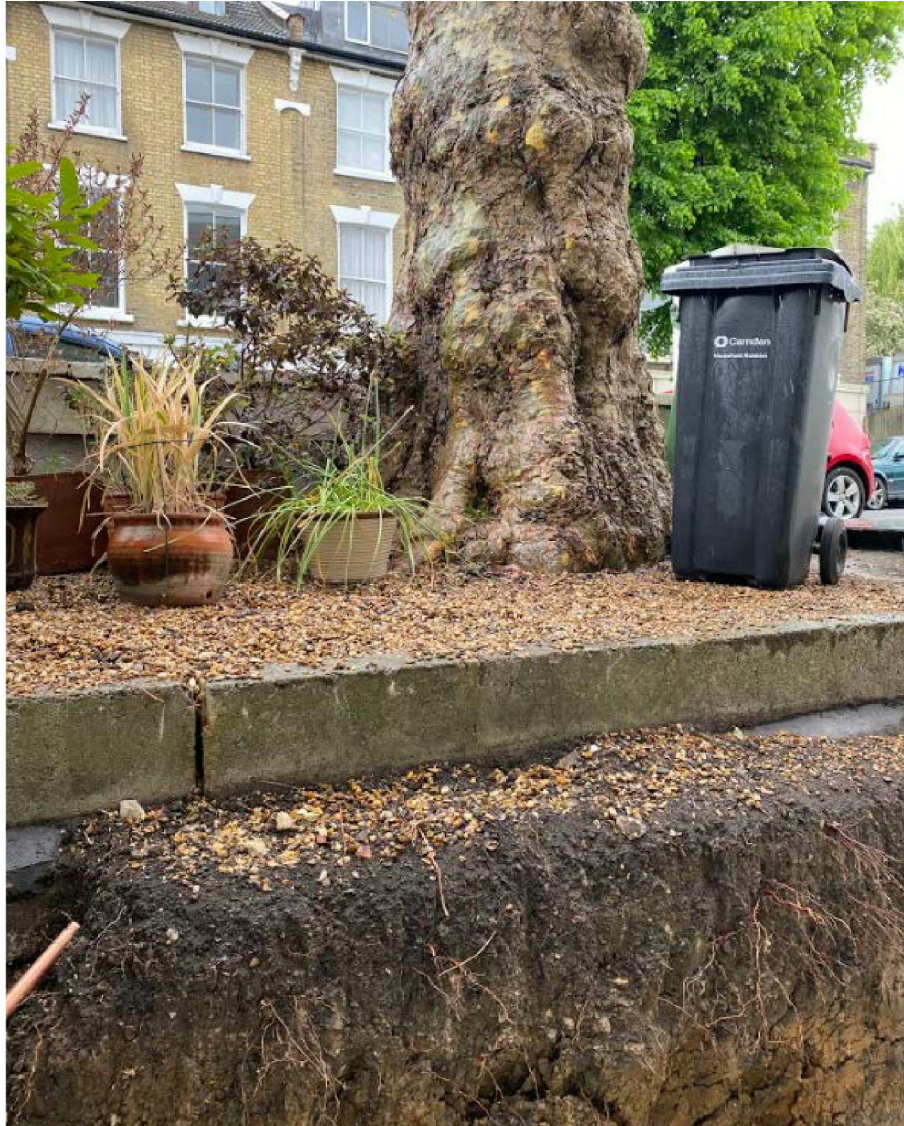
*Photographic plate showing the tree's stem and proximity to the failed retaining wall*

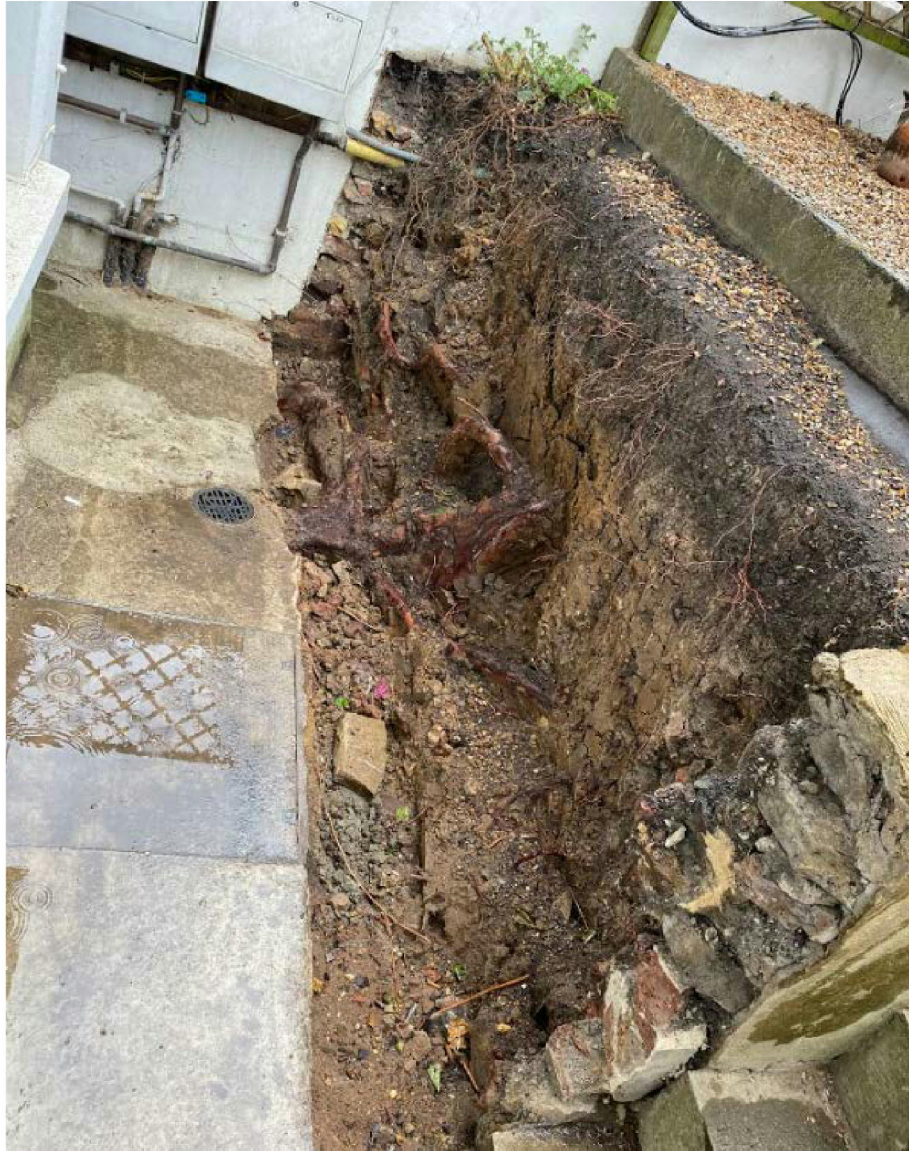
*Photographic plate showing the extensive root system immediately behind and below the failed retaining wall.*

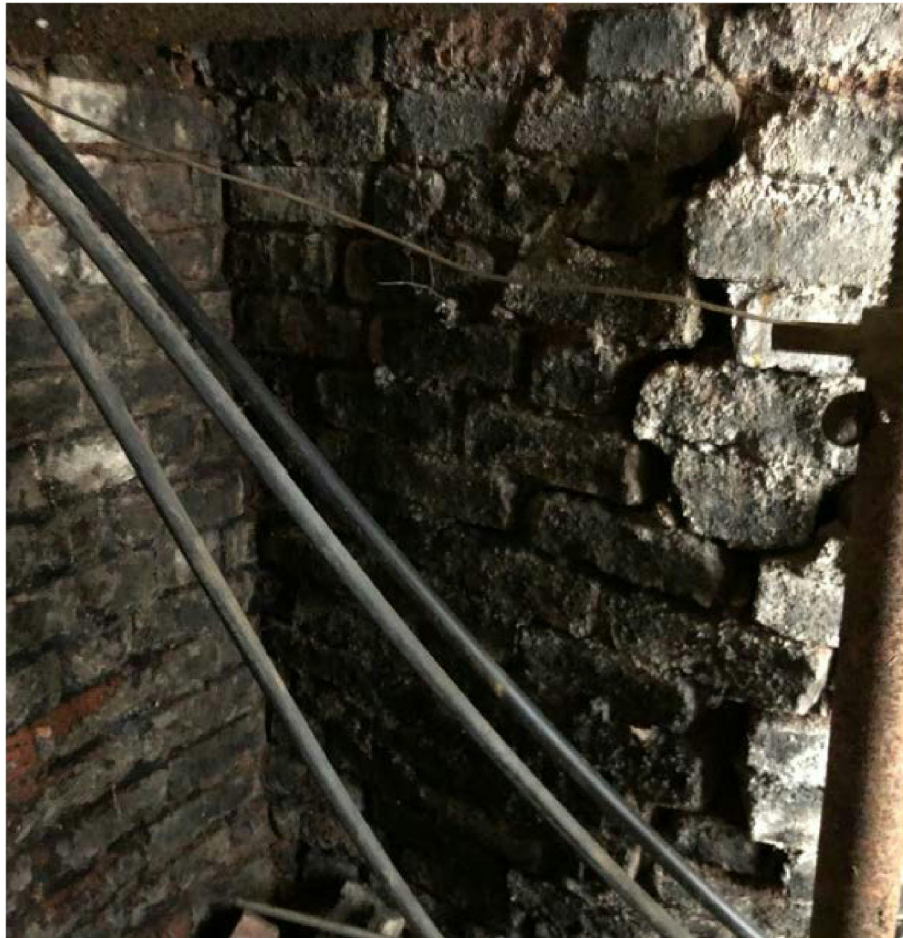
*Photographic plate showing the damaged walls under the entrance steps.*

- 3.4 A resident reported that damage to the wall below the front steps had suffered extensive damage requiring emergency repairs. This work has now been carried out, however there are still concerns around tree roots damaging the fabric of the building.

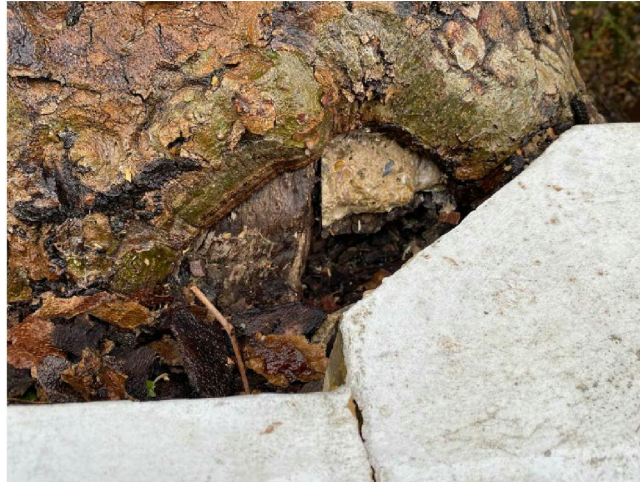
*Photographic plate showing coping stones on front garden wall, damage to tree stem and embedded concrete from coping stones.*

- 3.3 Repairs to the front garden wall have allowed retention of the tree by bridging the rooting area with a steel beam, and infilling below to create a facade to match the neighbouring properties. This arrangement is now becoming damaged by the incremental stem growth, the coping stones have been reduced several times to accommodate the stem, however the steel beam is now being pushed out of place by the tree stem.

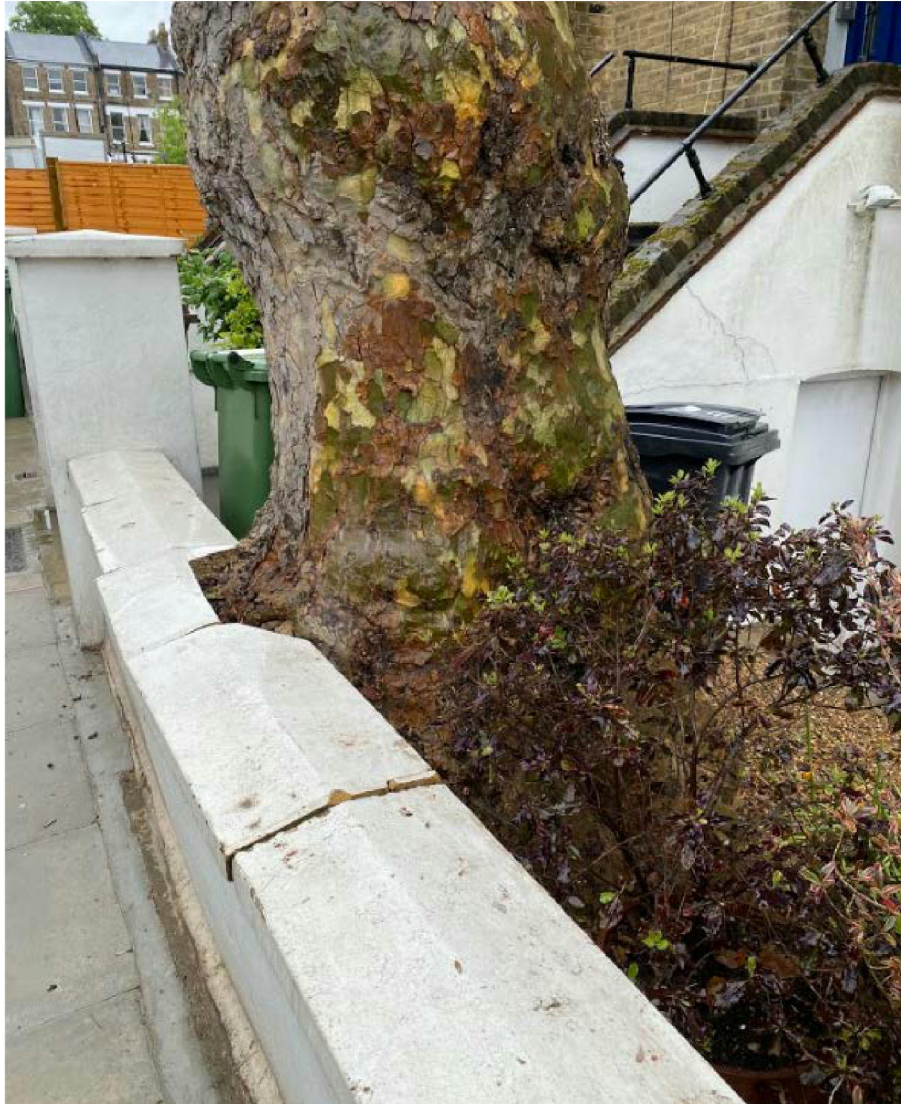
*Photographic plate showing front garden wall, coping stones displaced by tree stem, and bowing in wall from pressure from tree stem.*
