LEC1/9E Canal Bridge Masonry Repairs

164941-MMD-00-XX-DR-C-1005

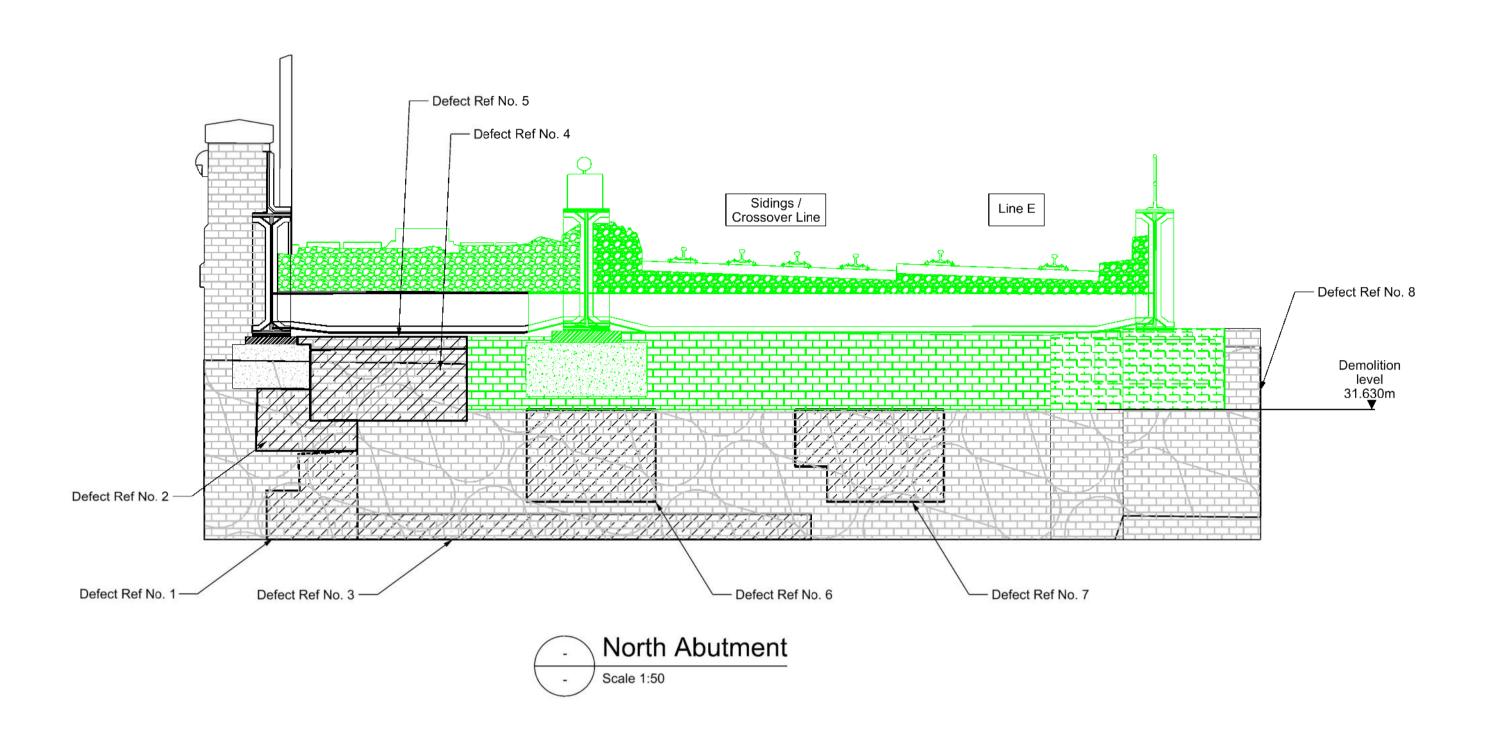
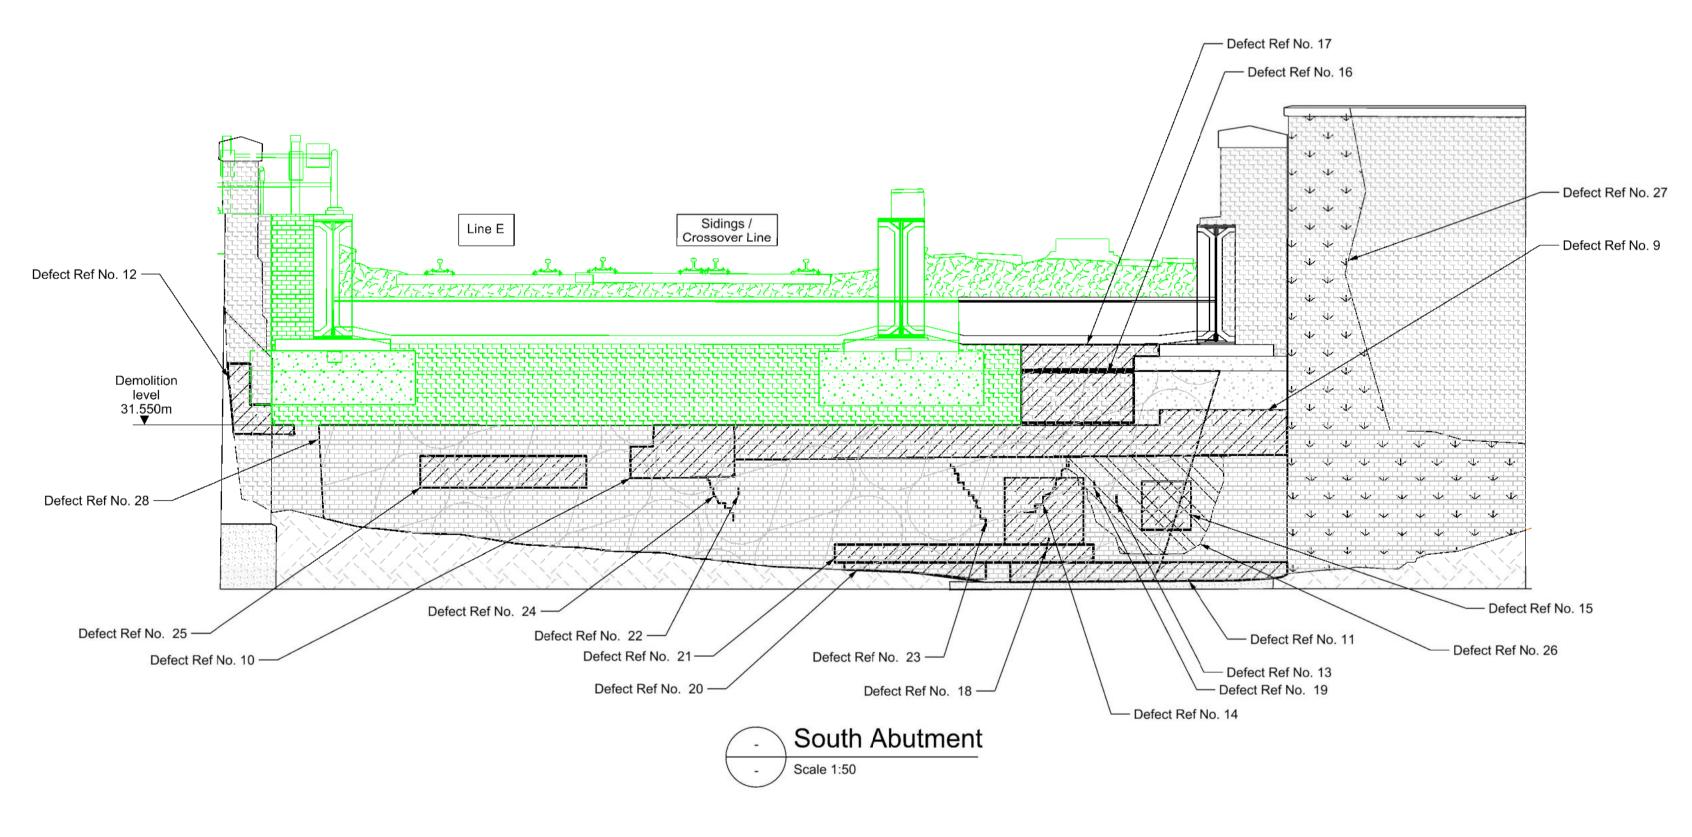
Ref.	Location	Defect	Dimensions	Proposed Repair	
1	High mileage	Open joints at 25mm	1.5m <sup>2</sup>	Rake out and repoint in accordance with drawing	
1	abutment	depth	1.5111	NR/CIV/SD/101.	
2	High mileage abutment	Open joints at 10mm depth	1m²	Rake out and repoint in accordance with drawing NR/CIV/SD/101.	
3	High mileage abutment	Open joints at 5-10mm depth	2m <sup>2</sup>	Rake out and repoint in accordance with drawin NR/CIV/SD/101.	
4	High mileage abutment	Open joints at 40mm depth	2m²	Rake out and repoint in accordance with drawing NR/CIV/SD/101.	
5	High mileage abutment	Open joints at 30mm depth	1.5m <sup>2</sup>	Rake out and repoint in accordance with drawing NR/CIV/SD/101.	
6	High mileage abutment	Open joints at 10mm depth	2m²	Rake out and repoint in accordance with drawing NR/CIV/SD/101.	
7	High mileage abutment	Open joints at 10- 15mm depth	2m²	Rake out and repoint in accordance with drawing NR/CIV/SD/101.

8	High mileage abutment	Non- offensive graffitti	30m <sup>2</sup>	Jet wash abutment (see Note 10.)	
9	Low mileage abutment	Open joints at 10mm depth	3.5m <sup>2</sup>	Rake out and repoint in accordance with drawing NR/CIV/SD/101.	
10	Low mileage abutment	Open joints at 5-10mm depth	1m²	Rake out and repoint in accordance with draw NR/CIV/SD/101.	
11	Low mileage abutment	Open joints at 10mm depth	1.5m <sup>2</sup>	Rake out and repoint in accordance with drawing NR/CIV/SD/101.	
12	Low mileage abutment	Open joints at 10mm depth	0.5m <sup>2</sup>	Rake out and repoint in accordance with drawing NR/CIV/SD/101.	
13	Low mileage abutment	Hairline fracture	Through 1No. brick	No action. Monitor as part of ongoing maintenance regime.	
14	Low mileage abutment	Hairline fracture through mortar and brickwork	10No. brick courses	Stitch fractures in accordance with Drawing NR/CIV/SD/110.	
15	Low mileage abutment	Open joints at 10mm depth	0.5m <sup>2</sup>	Rake out and repoint in accordance with drawing NR/CIV/SD/101.

16	Low mileage abutment	Open joints at 5-10mm depth	1m²	Rake out and repoint in accordance with drawing NR/CIV/SD/101.	
17	Low mileage abutment	Open joints at 20mm depth	1m²	Rake out and repoint in accordance with drawin NR/CIV/SD/101.	
18	Low mileage abutment	Hairline fracture	Through 1No. brick	No action. Monitor as part of ongoing maintenance regime.	
19	Low mileage abutment	Hairline fracture	Through 1No. brick	No action. Monitor as part of ongoing maintenance regime.	
20	Low mileage abutment	Open joints at 10mm depth	0.5m <sup>2</sup>	Rake out and repoint in accordance with drawing NR/CIV/SD/101.	
21	Low mileage abutment	Open joints at 10mm depth	1m <sup>2</sup>	Rake out and repoint in accordance with drawing NR/CIV/SD/101.	
22	Low mileage abutment	Hairline fracture	Through 1No. brick	No action. Monitor as part of ongoing maintenance regime.	
23	Low mileage abutment	Hairline fracture	Through 13No. brick	Stitch fractures in accordance with Drawing NR/CIV/SD/110.

24	Low mileage abutment	Hairline fracture through mortar and brickwork	Through 10No. bricks	Stitch fractures in accordance with Drawing NR/CIV/SD/110.	
25	Low mileage abutment	Open joints at 5mm depth	0.5m <sup>2</sup>	Rake out and repoint in accordance with drawing NR/CIV/SD/101.	
26	Low mileage abutment	Leachate staining.	2.5m <sup>2</sup>	Leachate staining to be removed (see Note 10).	
27	Low mileage wingwall	Vegetation growth covering wall.	3m <sup>2</sup>	See Note 9.	
28	Low mileage abutment	Non- offensive graffitti	25m²	Jet wash abutment (see Note 10.)
