SJ Stephens Associates

Re: Report on Trees at 44 Denning Road, NW3 1SU

Tree Schedule

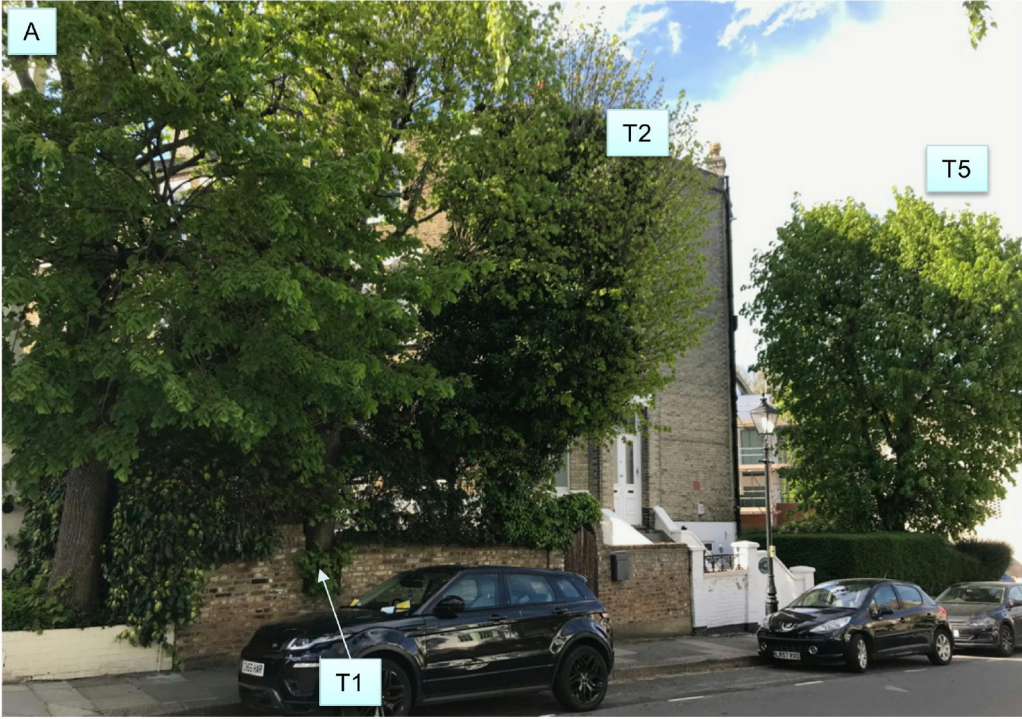
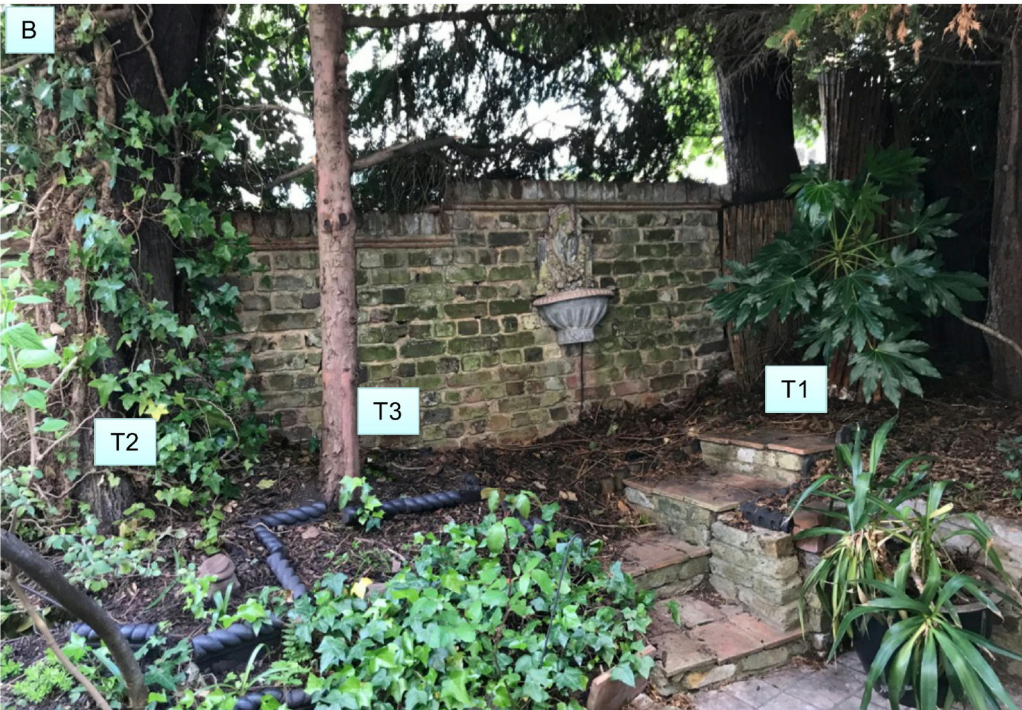
There are three early mature lime trees, T1, T2 and T5, growing close to boundary walls bordering onto Pilgrims Lane. T1 and T2 are growing approximately 0.7m above pavement level and T5 is growing approximately 0.3m above pavement level. All three are causing damage to the wall.

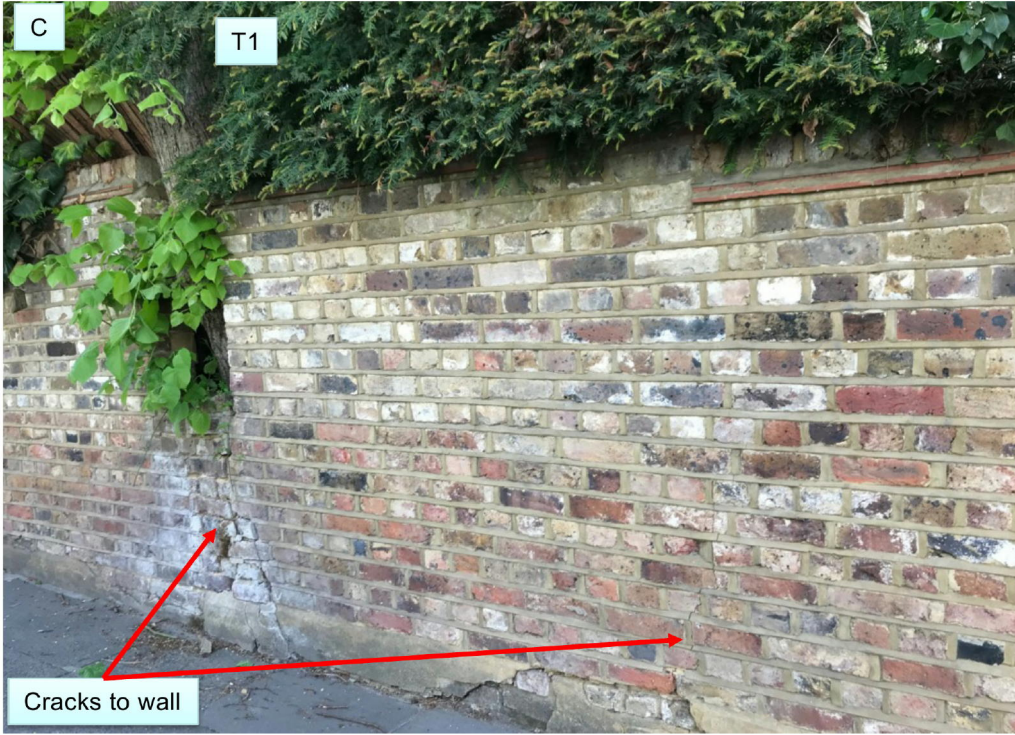
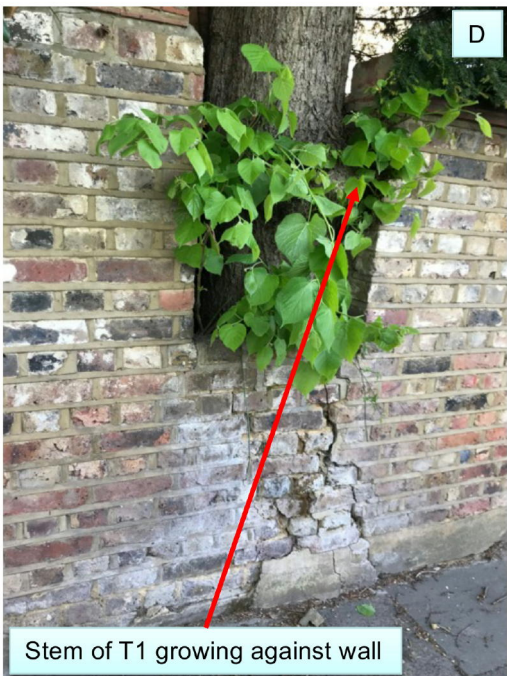
The wall has been built around T1, as can be seen in photos C and D, however the stem base is now growing against the base of the wall and higher up, the stem is growing against a point approximately 0.3m from the top of the wall. The base of T2 is further from the wall, however the tree has a slight lean over the pavement and the stem, combined with dense ivy growth, is growing against the top of the wall. As seen in photo E, there are cracks in the wall between T1 and T2 and it is leaning over the pavement as a consequence of the increasing pressure exerted by both trees. This will get more extreme as the trees grow.

Modification of the wall, increasing the width of the "window" around T1 and creating a similar "window" in the brickwork around T2 would reduce stresses on the wall. However, advice from a structural engineer should be sought to advise whether this action, together with repointing, would be adequate to make the wall safe and limit further deterioration. Ivy should be removed from around the base of T2 and regular pollarding of the trees will help to limit future growth.

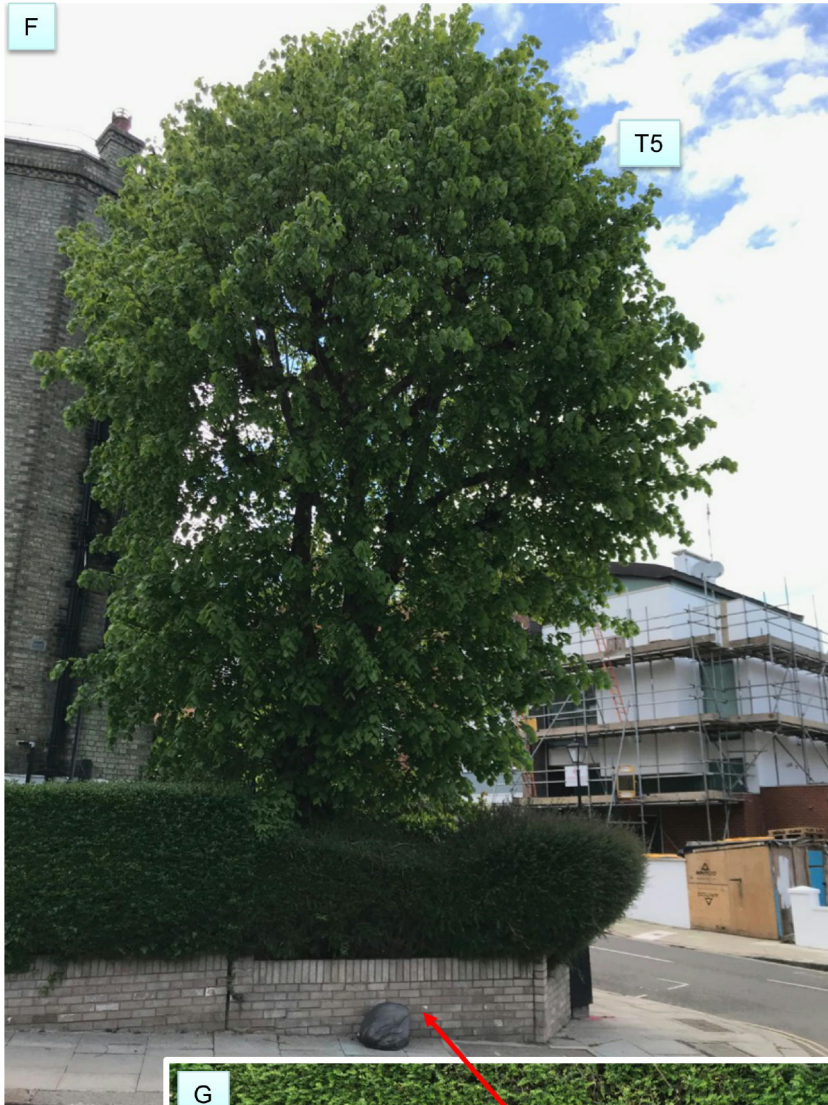
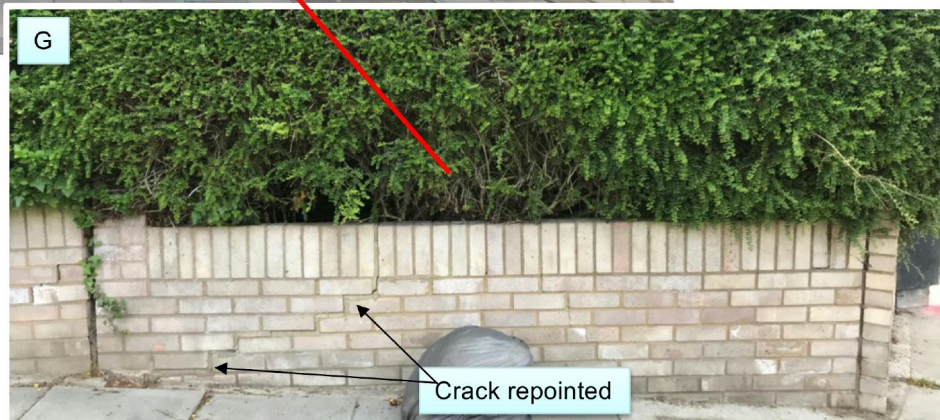
T5 is of particularly high amenity value and the crack in the boundary wall appears to be of less significance. However, this should be checked by a structural engineer.
