# 1-10 Cambridge Gate

## Condition Report

**Condition survey of  
Gate piers, 1-10  
Cambridge Gate,  
Regents Park.**

Report prepared for:  
**Crown Estate Paving  
Commission**

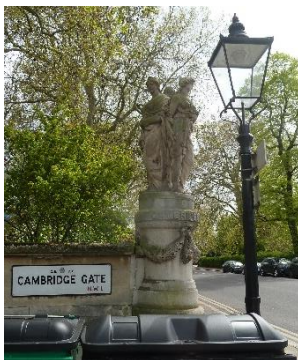
Monument 1 (M1), the southernmost pier, which adjoins the property of the Royal College of physicians, shows significant historic movement away from the wall and visibly leans toward the south-west. The cause of the shift is the growth of a large London Plane tree within the grounds of the Royal College of Physicians directly next to the wall. The condition of the wall shows a clear heft upwards at the base of the tree which has disrupted the stonework and the wall slopes towards the road. Large sections of previous repairs at the join between the wall and the plinth, show that this has been a long-term issue as the tree has grown. Cracks of 5-7mm along the edge of the fill on the north side of the plinth suggest that this issue is ongoing. The displacement of the M1 statues and plinth is not thought to be problematic, but the rate of movement could be monitored.

*Figure 21*  
Pier 1 leaning westwards  
towards the road

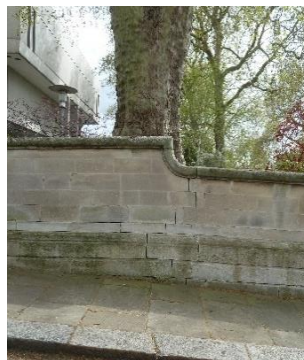
*Figure 22*  
Southern boundary wall  
cracked and distorted by the  
growth of the tree and the  
displacement of the wall  
westwards towards gate pier 1.

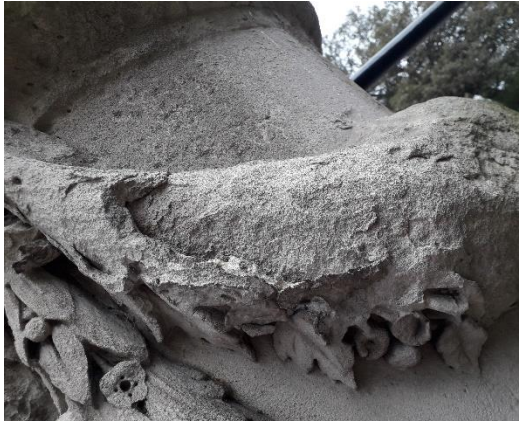
The limestone of the plinths is eroding dramatically and fast, causing great losses of detail as well as reduction to the flat areas and edges of moulded surfaces. There are many areas of carved detail on the point of falling at any moment Figure . The limestone of which the plinths and also the wall is made erodes easily, grain by grain as well as being lost in larger spalling areas (Figure 25 & Figure 26). Many repairs have been effected over the years which are harder than the stone surface and are often causing damage, leaving seriously eroded areas around them (Figure 29 & Figure 30).

*Figure 25*  
*Sudden loss of large areas of detail from deep cracks within the stone*

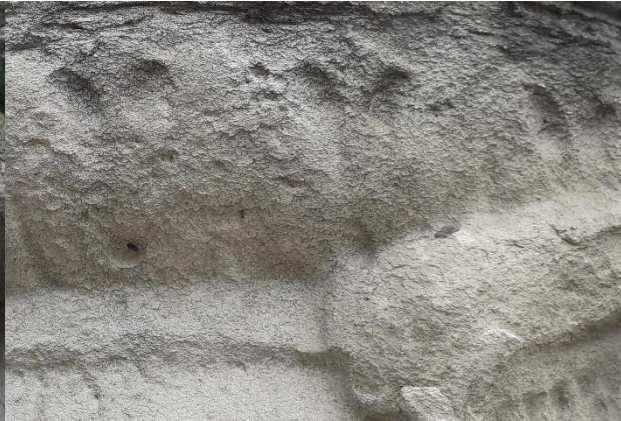
*Figure 26*  
*Surface erosion with gradual but almost total loss of detail and softening of carved edges. These areas are clean where the water has washed the polluted surface away*

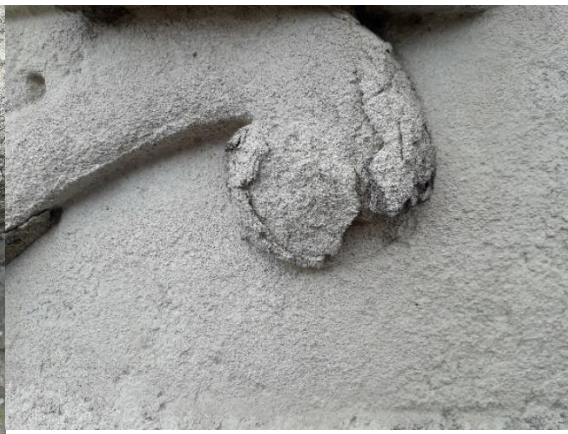
*Figure 28*  
*Smaller scale losses due to flaking/ delamination*

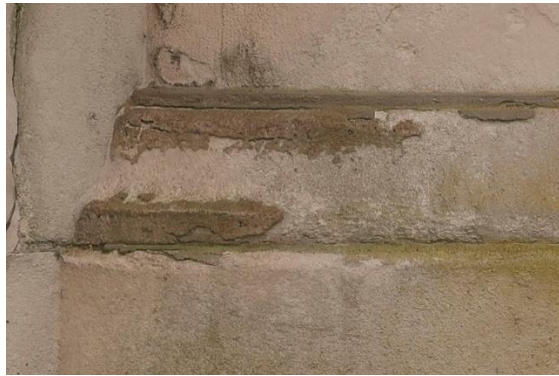
*Figure 29*

*MP1 Repair to edges of moulding where the stone is eroding beneath. Both images show different campaigns of repair.*

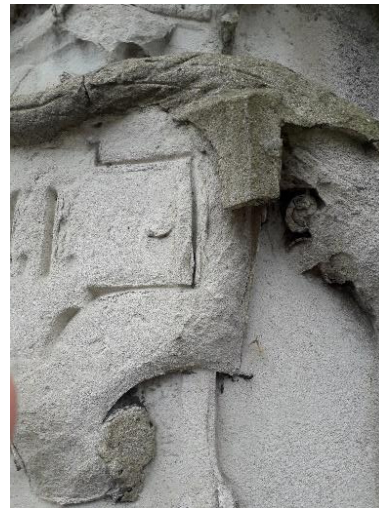
*Figure 30*

*MP2 Large hollow area behind and below the hard repair*

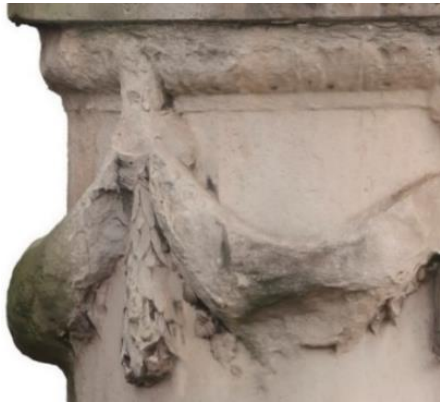
Below are images showing a comparison of the extent of erosion in the 4 plinths, the worst condition being MP2. MP2 is particularly badly affected overall having lost almost all detail on all swags as well as large chunks of the shape which have spalled off Figure 31.

*Figure 1*  
MP2 Almost complete erosion of detail on the swags and the central knot. Small areas survive where protected from the water run-off.

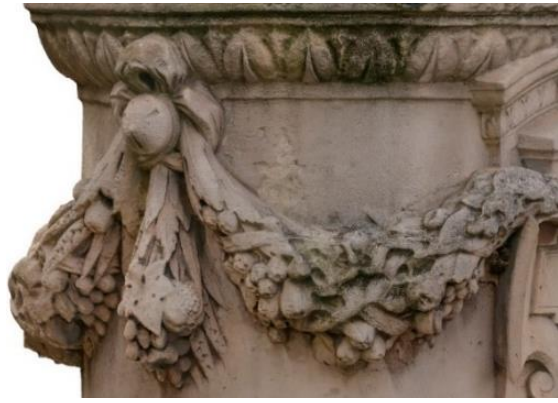
*Figure 32*  
MP3 almost complete although still deteriorating

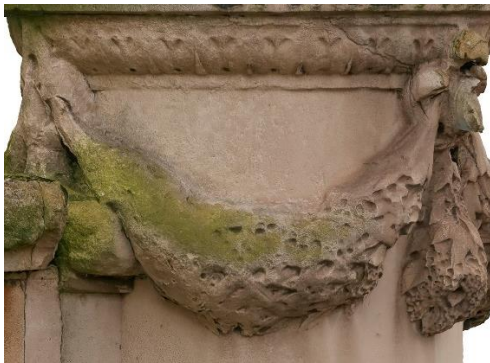
*Figure 33*  
MP1 moderate to bad erosion. Swags eroded badly on two sides of the plinth. Cyma pattern is almost discernable but worn.

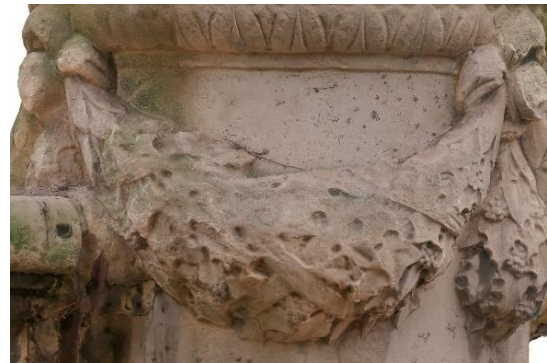
*Figure 34*  
MP4 moderate erosion to detail, cyma detail can be read

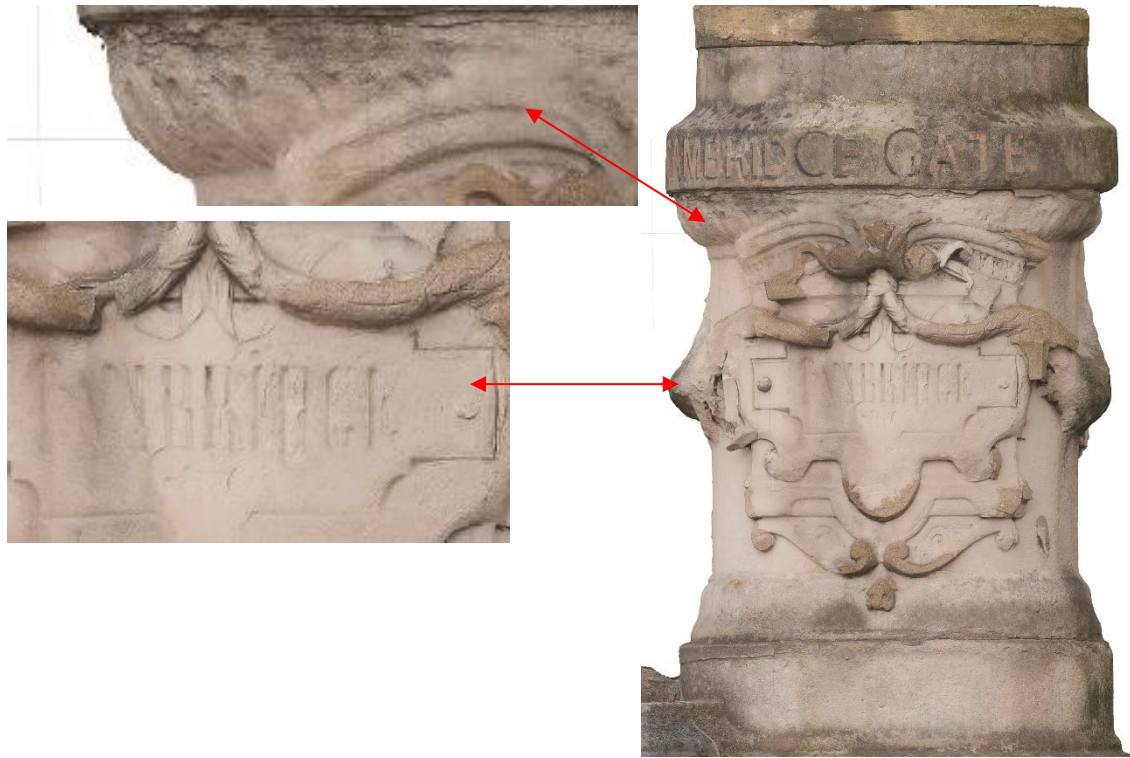
*Figure 35*

The cartouche of MP2 too has eroded badly losing large parts of the design. Considerable key areas have been rebuilt in the past with a hard mortar and the limestone has eroded substantially behind these repairs leaving them hollow and proud of the monument. The inscribed writing of the cartouche has become almost illegible along with the carving of the cyma (Figure 31). The legibility of the whole cartouche is only saved by the shape of the hard repairs which are causing it to deteriorate at a faster rate in places.

*MP2 showing extent of loss / previous repair*

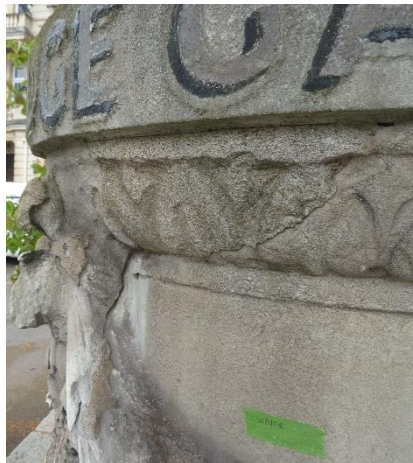
*Figure 38*  
MP1, cyma still readable. Large repair to one area approximately 20cm

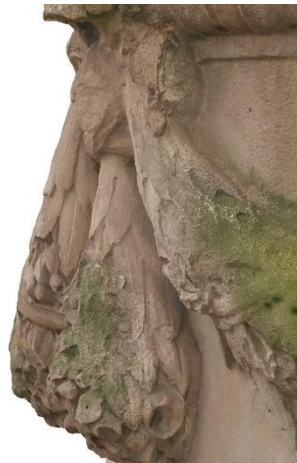
*Figure 39*  
MP1 areas of spalling and loss

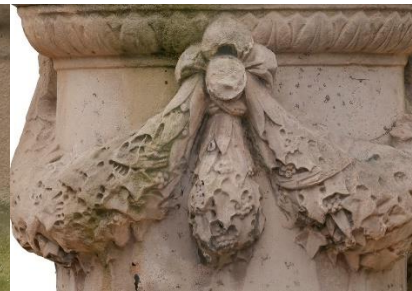
*Figure 40*  
MP4. The carving is in similar but better condition than MP1

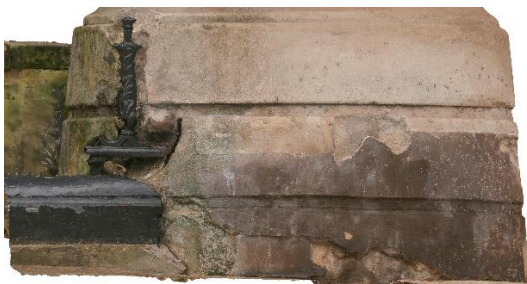
*Figure 41*

There have been major repairs to the lower areas of the base of all 4 plinth bases, where render has been applied in large swathes. These have been made with harder, less permeable materials, in several campaigns of repair. In some places these patches adhere well to the stone, however, where water has been able to penetrate behind, the stone has eroded badly. This is particularly evident in Monuments MP2 and MP4 (Figure 41 and Figure 42). MP1 and MP3 show smaller areas of similar render repair (See markup of repairs all elevations). In places the render is still firmly attached to the monument and may do more damage to remove it than in leaving it, however it is difficult to determine how much moisture is trapped behind these areas. Due to the failure of pointing at around all joints, in particular that between the pavement and the base, water ingress will be contributing to this issue. Although not obviously associated with damaging repairs, MP2 has one large masonry block in the centre of the trio of mouldings running around half of the plinth's circumference which is particularly prone to erosion, with a network of fissures running horizontally with associated loss of stone surface along the fissures (Figure 43). This may be what lies beneath the remainder of the render.

*M4. A large area of render repair about 7mm thick all around the bottom two tiers of moulding with significant delamination behind. Edges of the render is adhering well elsewhere. Pointing between the bases and the pavement will be allowing liquid water to penetrate beneath.*

*M4 Crudely cut stone to fit railings*

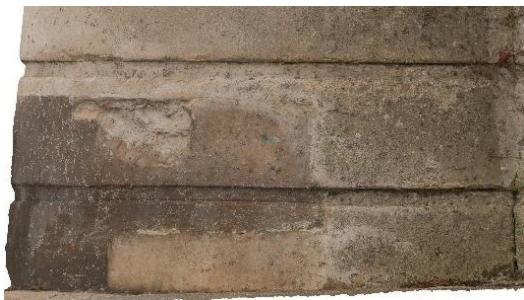
*Figure 42*

*MP4. Elevation 1 south facing: as above*

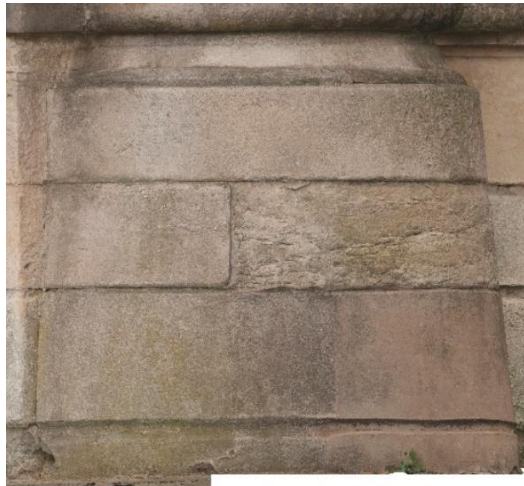
*Figure 43*

*MP2. Two schemes of render repair on the base sections, adhering strongly, one grey (left side of repair) and rough in texture one reddish and smooth (right side of repair). It is perhaps an indication of why the blocks below were rendered. This render repair runs all the way around the base at this height.*

*Above the render is the block with fissures and cracks which continues around half the circumference of the base.*

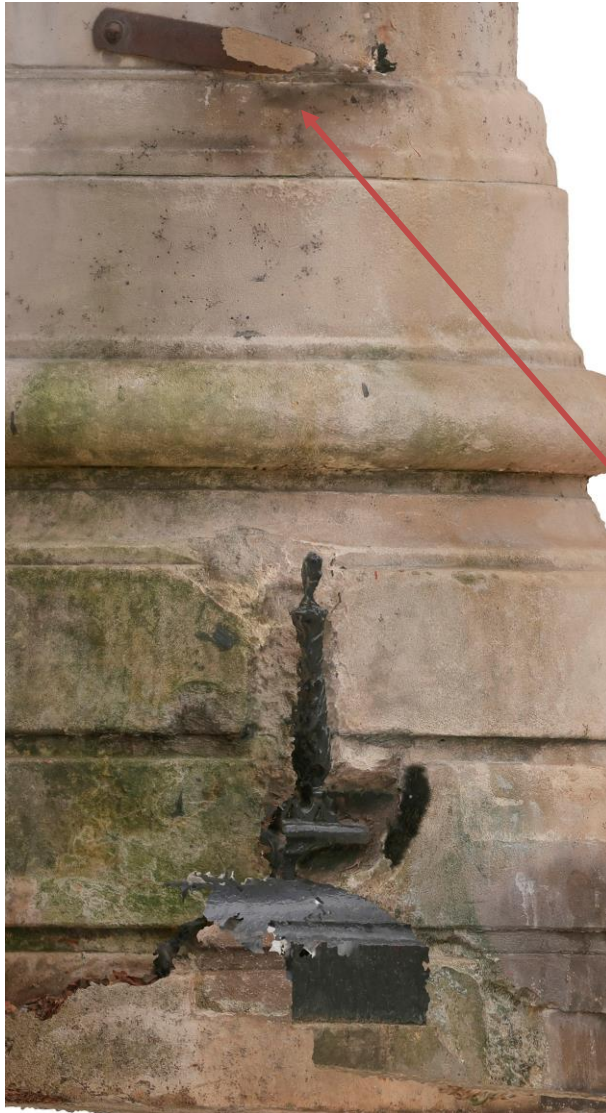
*Figure 44*  
MP4

Displacement of this monument is described above (Figures 22-24). Wall displacement has caused large cracks with more than one iteration of infill with mortar fills to crack. Large mortar fills and loss to stone outlined above (Figure 44).

- Large stone loss: crudely removed to accommodate the installation of railings (Figure 44).
- Metal strap which supports the railing is attached with a bolt to the plinth. It is un-painted and rusting. There is a small rust stain but no sign of damaging expansion as yet.

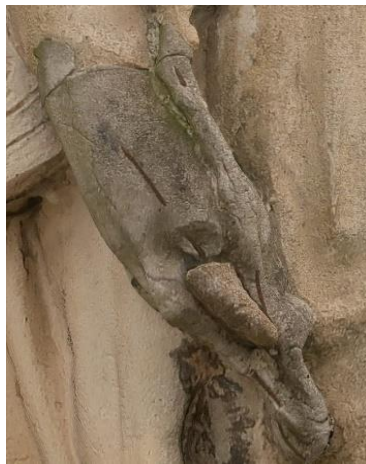
*Figure 49  
MS3.1. Ferrous  
armature for the  
hand associated  
with repairs*

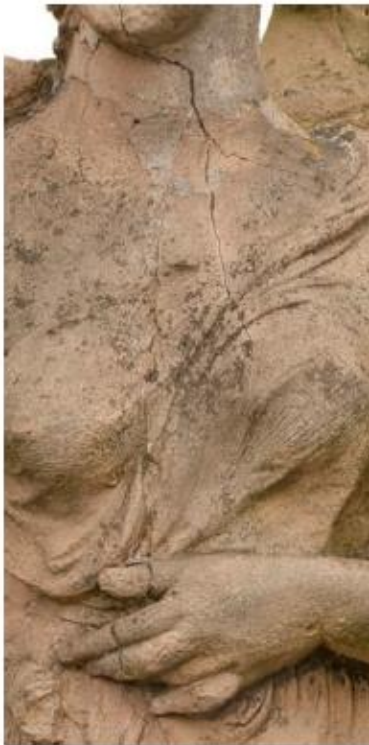
There is major through-cracking to MS3.1 A large line of cracks run from top to the bottom of the statue, with multiple cracks to the face, head and torso as well as the full length of the left leg. The head appears at first to have been pieced together from fractured elements. One might associate this with the presence of corroding and expanding ferrous armatures within. The central iron bar of MS3.1 shows some cracking to the top mortar cap of all four statues, outwardly it appears fairly uncorroded at the top where it is visible. There are cracks which can be seen in the area between the heads, which show there may have been some expansion, of the iron. MS3 shows the most disruption in this area but it does not seem significant enough to have caused the cracking seen. All the cracks appear stable. Since there is no armature detected in the leg and it sounds hollow when tapped as one would expect, this is highly unlikely to have been caused by expansion of an armature. It is interesting to note that MS4.2 also has a crack, albeit hairline, in the same place on the forward leg. This may be a weakness in the cast either caused by a joint between cast sections,

The cracks on MS3.1 may have started by thermal expansion and contraction of the terracotta in fluctuating weather conditions, cracking the sections of the cast at its weakest points, mainly the joints between the cast sections. The cracks would then have been exacerbated by freeze and thaw cycles affecting the water being trapped in biological growth and debris caught in the cracks.

*Figure 50*  
**MS3.1** crack running from head through torso ad fingers

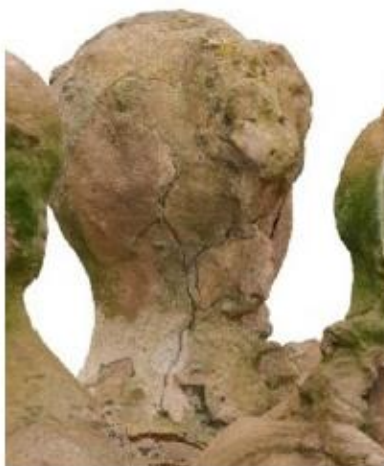
The cracks on the face of MS3 are very regular - this may possibly show a pattern of separate cast shapes which would have been joined with clay slip during manufacturing. This could since have been preferentially eroded, although this would mean the head was cast in more sections than usually needed. The crack pattern could alternatively indicate stress fractures created in the kiln from differing thicknesses and shapes of the clay. The cracks at the back of her head are less ordered. This could be representative of areas where separate pieces of clay were been pressed into the moulds, creating less well bound lines. Whatever the reason, any cracks will have been exacerbated over time by repeated thermal expansion and contraction and freeze thaw cycles.

*Figure 51*  
**MS3 figure 1.** Detail of face cracks and large crack running from top to bottom

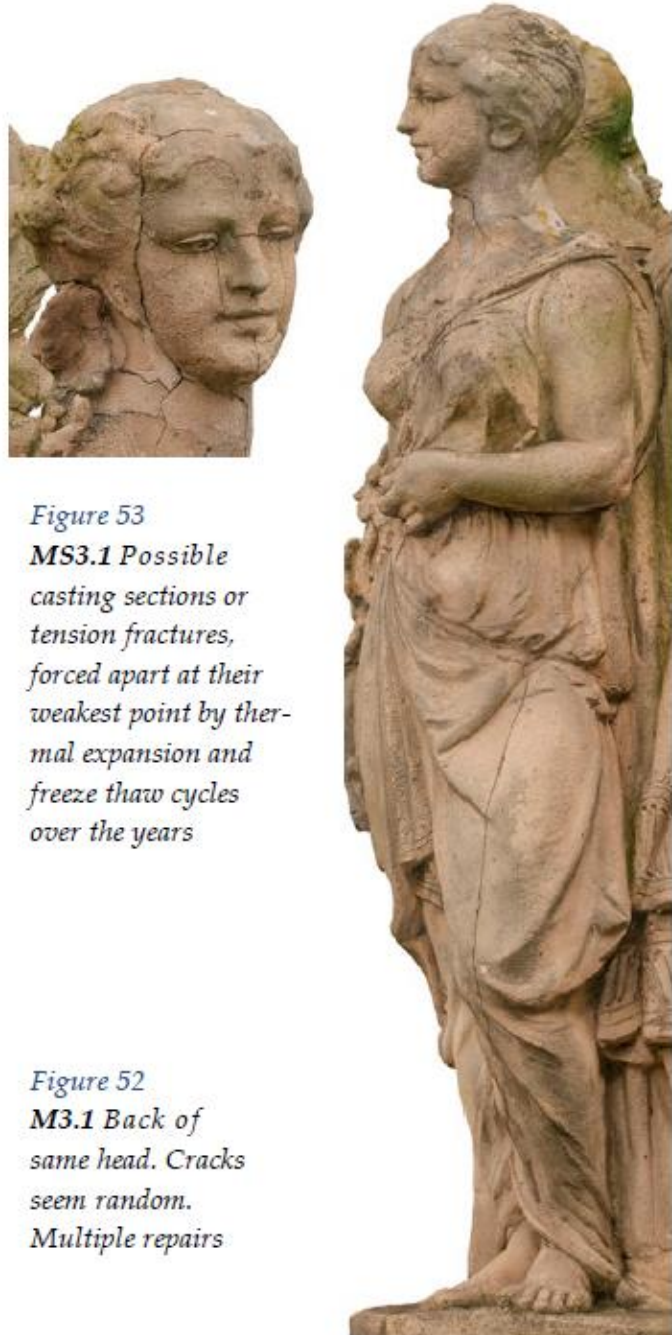
*Figure 53*  
**MS3.1** Possible casting sections or tension fractures, forced apart at their weakest point by thermal expansion and freeze thaw cycles over the years

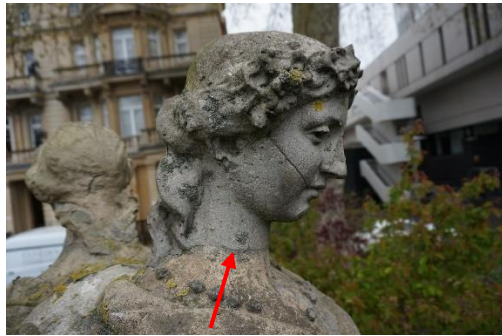
Area of movement MS1.1

*The crack all around the neck is moving. Other deep looking cracks are stable. The softness of the repair is shown clearly in the erosion of the crack edges.*

*The beads around her neck are of the same campaign of repair as the face. It is not known if they replicate originals as there are none present. The gaps may represent subsequent loss of original or loss of repairs.*

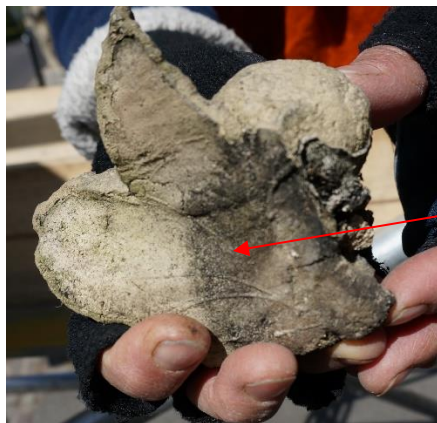
*Figure 54*

*MS4.1 Removed loose section*

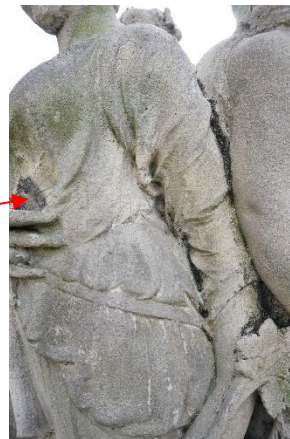
*Figure 55*

*MS4.1 area from which loose section was removed*

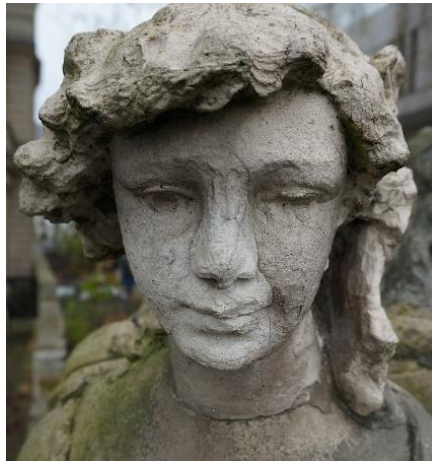
*Figure 2*  
MS1.3 Thought  
to be hard  
terracotta. Pale,  
smooth  
textured.  
Cracking and  
delaminating  
significantly

This head is smaller than the other heads, partly due to erosion and partly it has perhaps shrunk in the kiln if it was a mould taken from an existing head, then fired? This is made more obvious by the larger scale and proximity of the grey, MS1.1 head. If taken from a cast, it is difficult to assess which head it may be cast from.

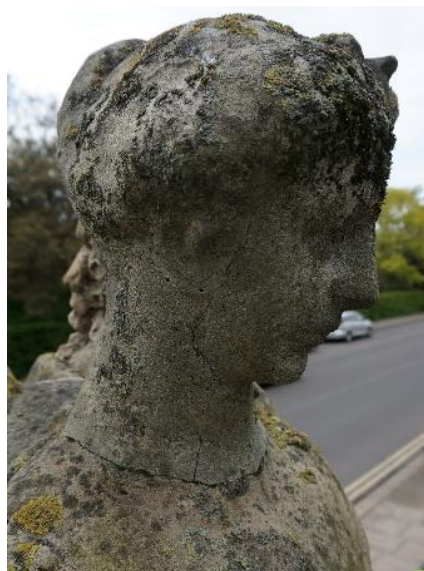
*Figure 58*  
MS2.2 Grey  
sandy material.  
Not thought to  
be harder than  
the surrounding  
terracotta

Significant hard and dry lichen growth which will be contributing to the erosion of this repair.

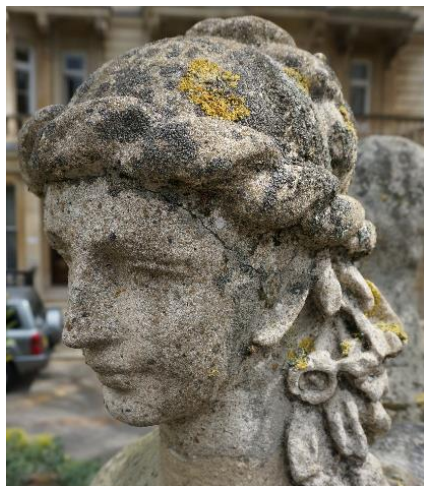
*Figure 59*  
MS2.3  
Distinctively  
large aggregate  
in pale binder

Significant hard and dry lichen growth which will be contributing to the erosion of this repair.

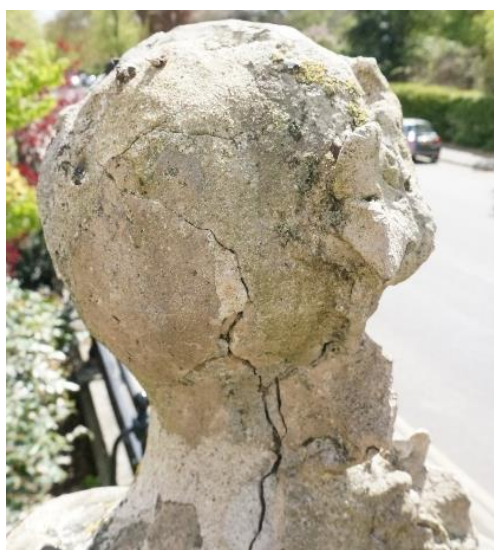
*Figure 60*  
MS3.1

Large area of the back of the head have been repaired with no decorative detail added. Badly cracked. The original front of the head survives but is very cracked.

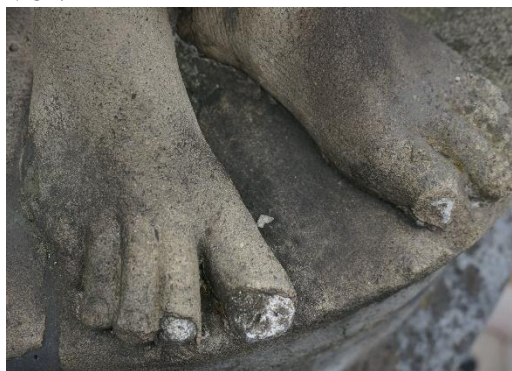
Figure 64  
MS2.3 Toes repairs and loss

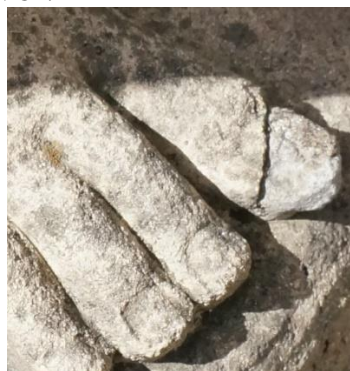
Figure 65  
MS3.2 toe repairs

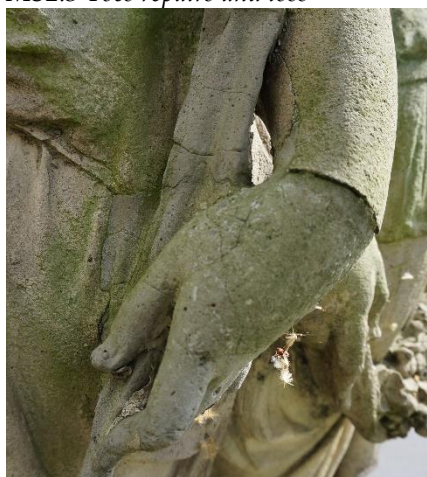
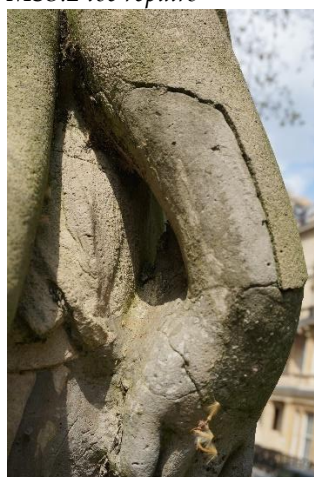
Figure 66 & 67  
MS1.2 damage to hand and foliage stalk, also arm repair. Ill-fitting but stable

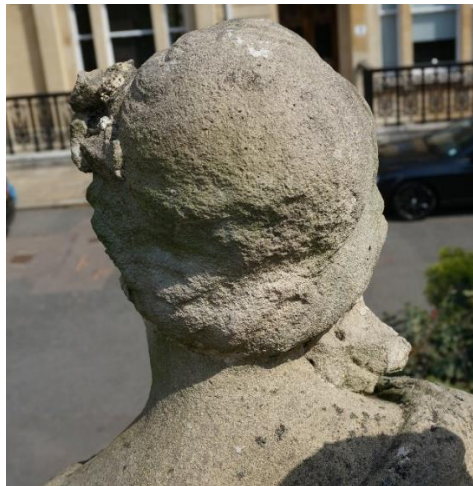
Figure 69

Larger area of cracking with the fracture running around an area which will delaminate

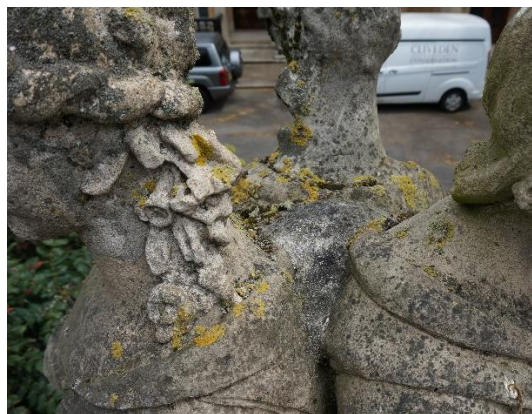
*Figure 75*  
*MS2 Dark areas more likely to stain*

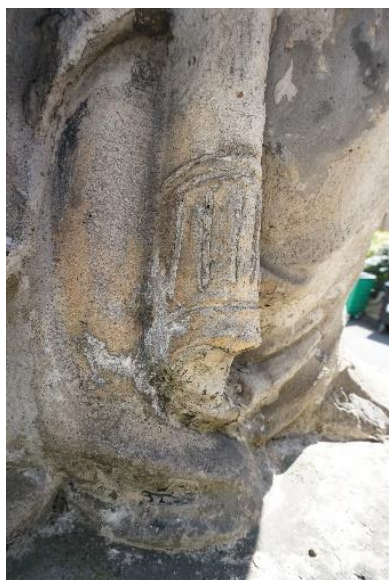
*Figure 76*  
*MS4 Yellow staining of unknown cause*

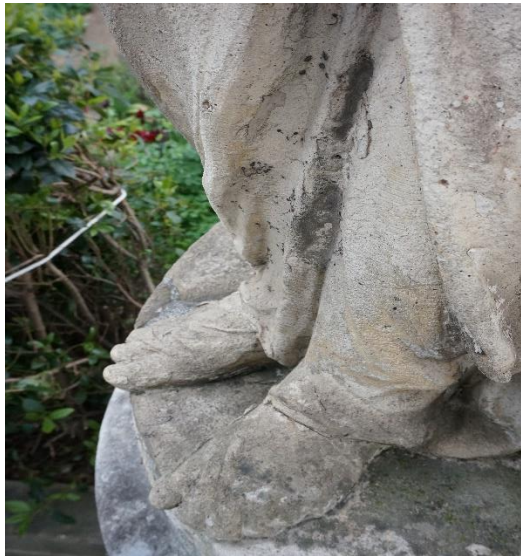
*Figure 77*  
MS4 creeper debris clinging to the surface

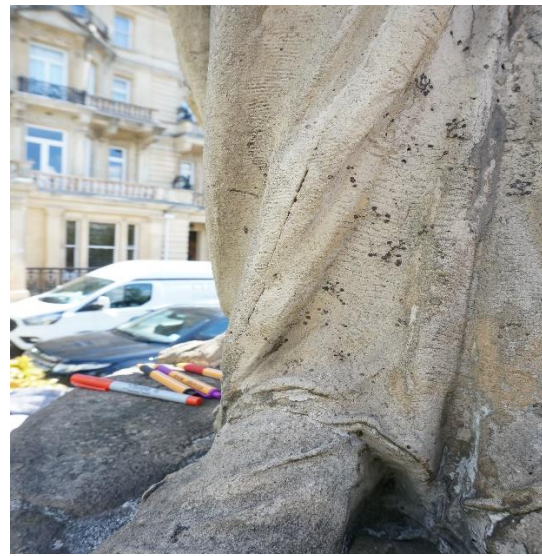
*Figure 78*  
MS4 further creeper debris

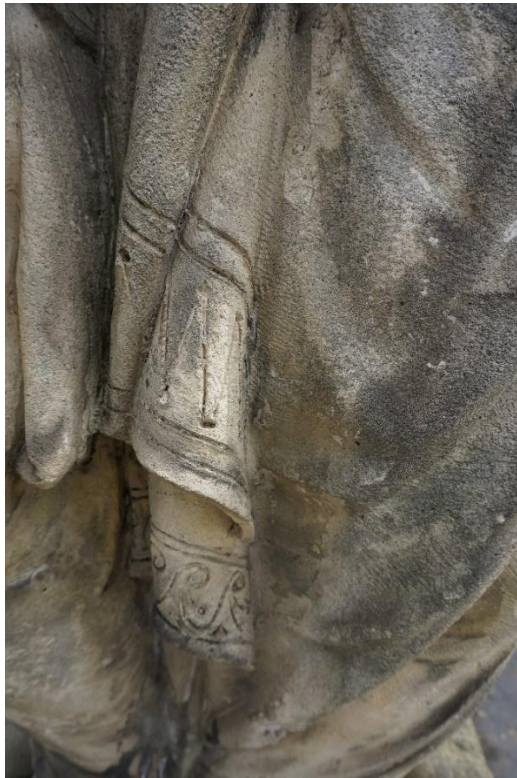
*Figure 79*  
MS2.1 environmental pollution deposit.

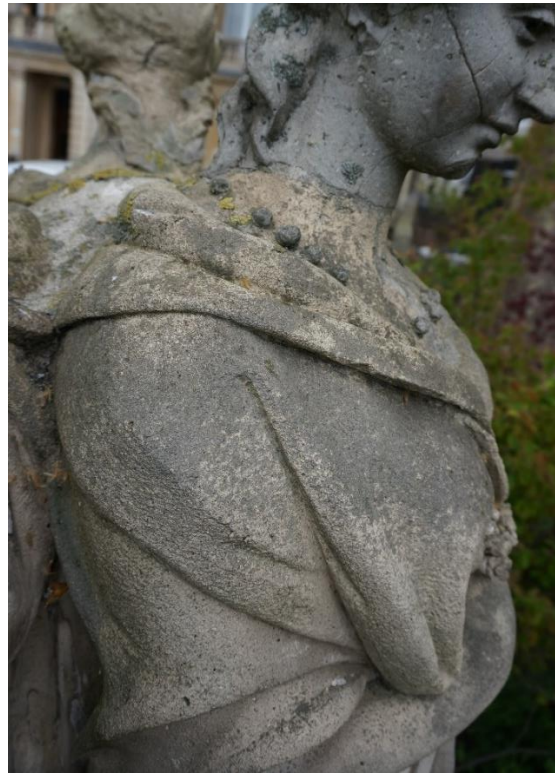
*Figure 80*  
MS1.1 Possibly a mix of dark pollution and biological staining.

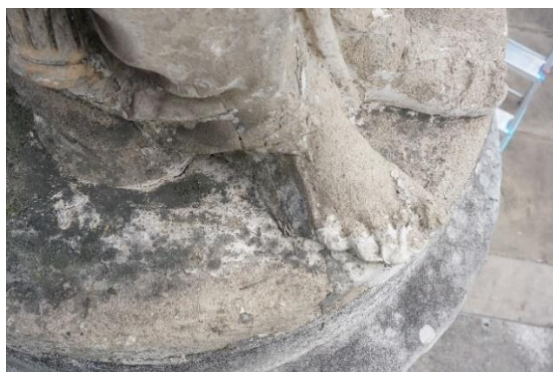
*Figure 83*  
*Paint remains, base of statue MS4*

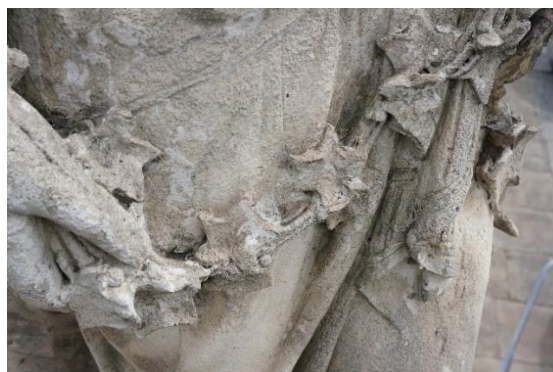
*Figure 84*  
*Paint remains in the cracks of applied detail, MS4*

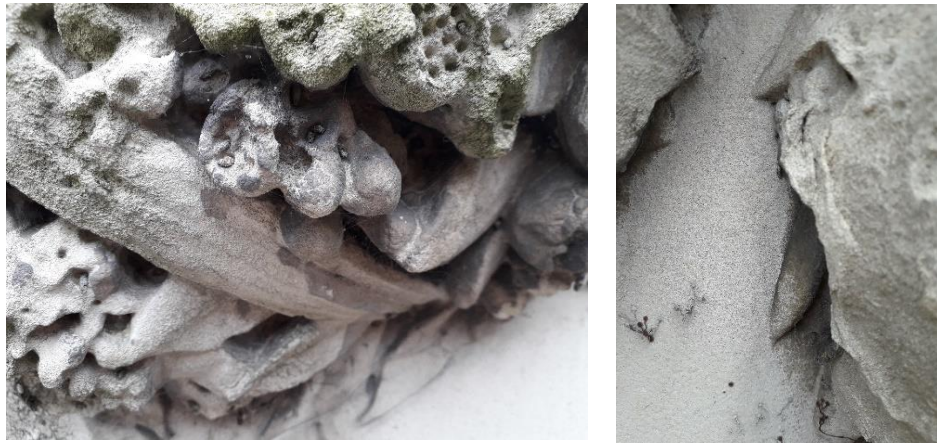
*Figure 88 & 89*

The sulphation is thick on many of the undersides, creating a hard, water resistant layer. The stone behind this can often be delaminating.

*Sulphation crusts on the undersides*
