Subsidence Risk Assessment

Leverton & Sons Ltd
212 Eversholt Street
Camden
London
NW1 1BD

Bartlett Project Reference:

JPL/210310/Ra

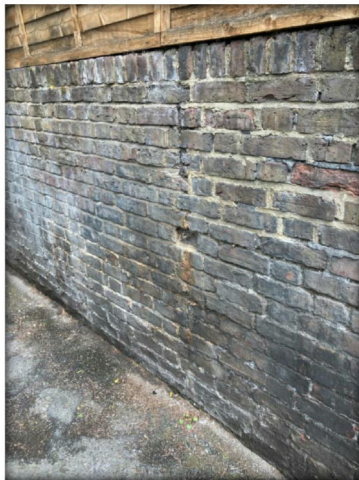
We identified during our site visit, various cracking and deformation to the eastern brick masonry boundary wall adjacent to trees; T01, T02 – Common Lime, T03 – Silver Birch and T05 – Common Lime, please view Figures 4 to 7 below for further information.

Figure 4: Photograph Of Damage Visible To Eastern Flank Wall, Adjacent to T01 – Common Lime.

Due to the damage caused to the eastern brick masonry boundary wall and ongoing issues related to direct damage, we consider that the wall will in time need to be replaced entirely.

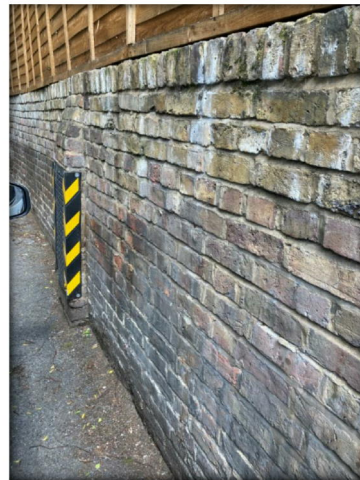
Figure 5: Photograph Of Damage Expressed To Eastern Flank Wall, Adjacent to T02 – Common Lime.

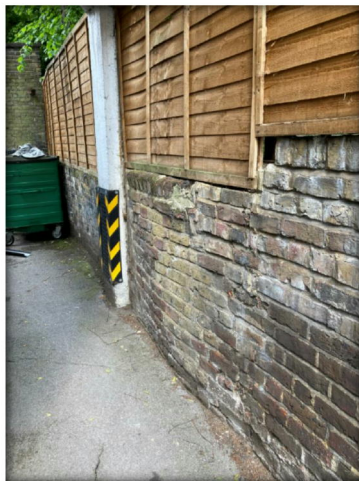
Figure 6: Photograph Of Damage Expressed To Eastern Flank Wall, Adjacent to T03 – Silver Birch.

We consider that T03 – Silver Birch, whilst is categorised as a low water demand tree is the greatest contributing factor associated with the subsidence expressed to 212 Eversholt Street, by virtue of its close proximity to the concrete supporting pillar, measured to be approximately 2.0 metres away. We do not consider a pruning specification compliant with BS: 3998 (2010) *Tree Work – Recommendations* would be effective in reducing the trees Zol, as such we prescribe the trees removal.

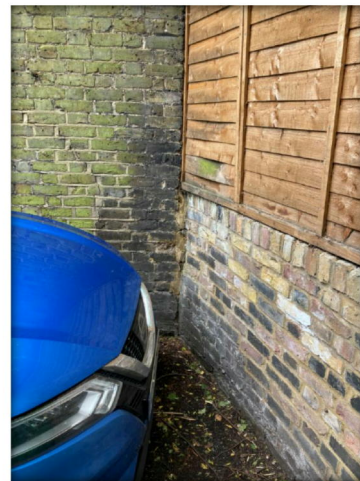
Figure 7: Photograph Of Damage Expressed To Eastern Flank Wall, Adjacent to T05 – Common Lime.

Trees T05 and T06 – Common Lime must now be pollarded, to reduce the trees Zol and thus reduce their potential to cause damage, ideally as soon as practically possible. Please note all these trees are subject to statutory protection, by virtue of them being located within a Conservation Area, as such a Section 211 Notice must be served upon the London Borough of Camden in the first instance.

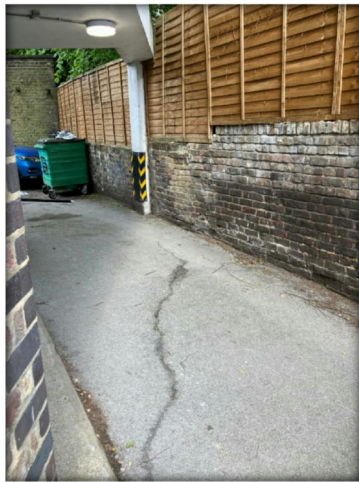
We also identified radiating cracks within the tarmacadam hard surfacing of the vehicular driveway, which is primarily attributed to T03 – Silver Birch, please view Figures 8 and 9 for further information.

Figure 8: Photograph Of Damage Expressed To Tarmacadam, Adjacent to T03 – Silver Birch.

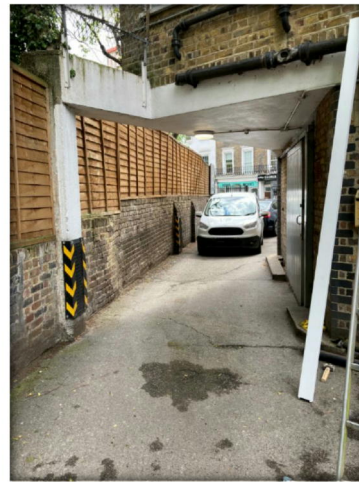
Figure 9: Photograph Of Damage Expressed To Tarmacadam, Adjacent to T03 – Silver Birch.
