# ARBORICULTURAL ASSESSMENT REPORT

37C Westbere Road, London NW2 3SP

Survey Date: 17/11/2021

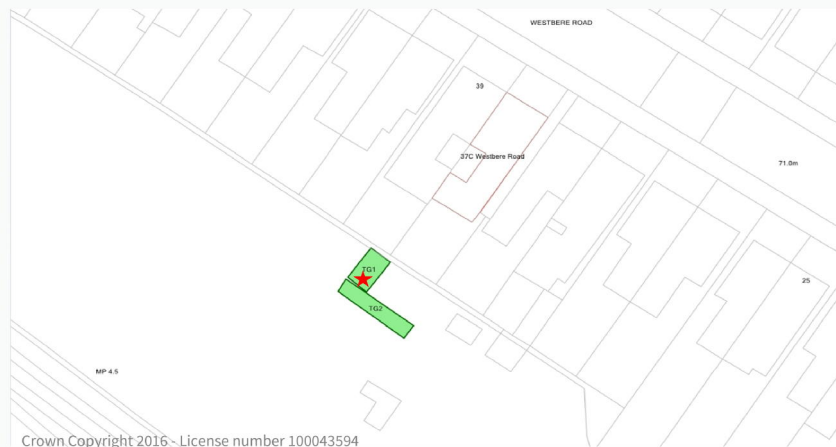
## 7.0 APPENDIX 2: SITE PLAN

Tree No	Common Name	Age Class	Condition	Height (m)	Crown Spread (m)	Stem diam. (mm)	Dist to bldg. (m)	Roots Implicated	Pruning history	Recommendation	Tree work constraints	Notes	Owner address	Owner
TG1	Mixed Broadleaf	Young	Fair	12	5.0	190	13	Y* <i>*Aspen only</i>	No significant past tree works.	Fell and treat stump with eco plugs (deciduous).	Restricted access.	10x Aspen, 5x Sycamore. Clear 6m from boundary	District Land Registry Search Required	UKN
TG2	Mixed Broadleaf	Semi-Mature	Fair	11	5.0	220	19	N	Subject to past management.	No work required.		Mostly self-set Sycamore	District Land Registry Search Required	UKN

Tree No:	Species	Works Required
TG1	Mixed Broadleaf	Fell and treat stumps with eco plugs (deciduous).

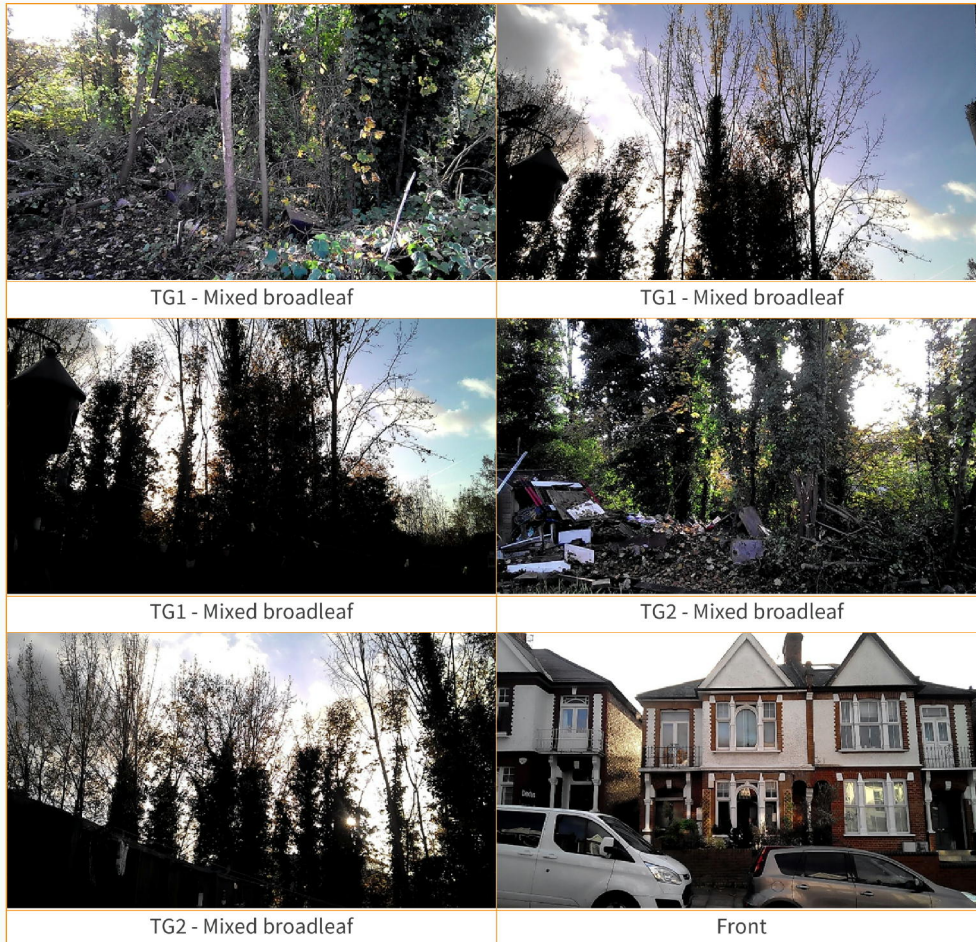
## 8.0 APPENDIX 3: SITE PHOTOGRAPHS

London Borough of Camden Council has confirmed that the implicated vegetation in TG1 is subject to an area Tree Preservation Order
