Michael Hadi Associates Ltd.
Consulting Structural Engineers

Job Title 59 Lambs Conduit Street, WC1N 3NB				Job No. 21015
Drawing Title Photos of Tenons and Joist Failures				Drg. No. SK08
Scale @ A3 NTS	Date Oct. 2021	Drawn MC	Checked RD	Rev.

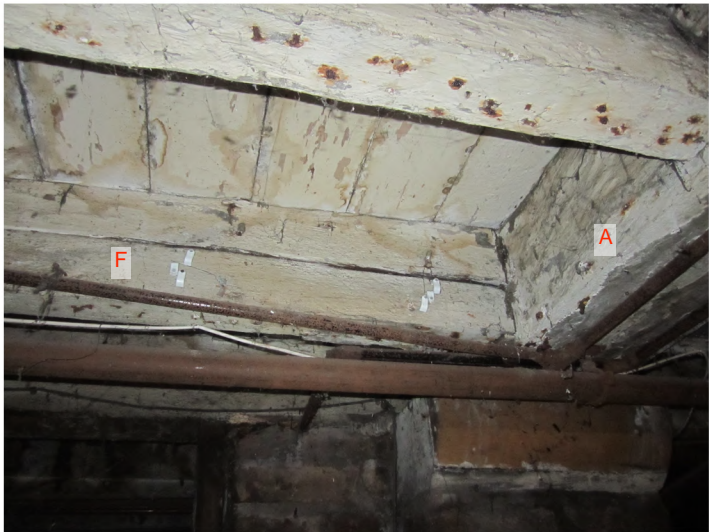
Photo 4390

Joist 'F' Horizontal Failure at Connection to Bressummer 'A' Initiated from Tenon

- Notes
1. This drawing is to be read in conjunction with all relevant surveyors' and engineers' drawings and specifications.
 2. Strategy is for joists without shear splits to be strengthened at the connection to the bressummers by the provision of Simpson Strong-Tie connectors, as shown in the detail on SK05.
 3. Where joists have failed with pronounced shear splits, joists are to be replaced or, if preferred by Camden, then new joists are to be provided immediately adjacent. Connection to the bressummer to be via Simpson Strong-Tie brackets.

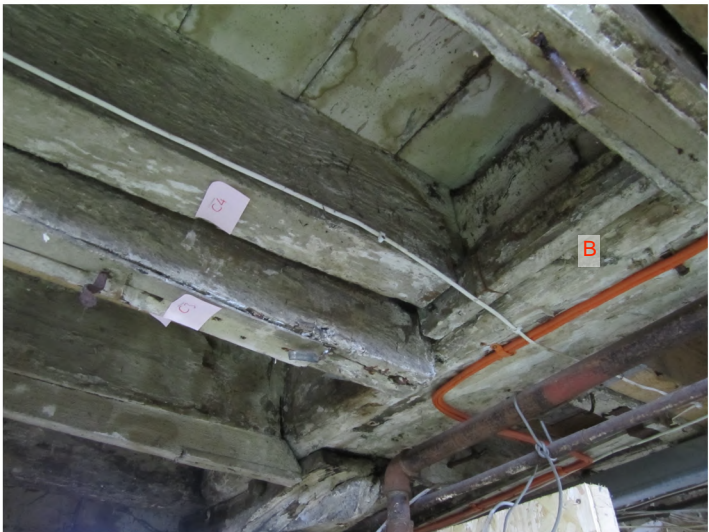
Photo 4872

Joist Zone 'C' 'C3' has Failed Initiated from Tenon

Note, 'C3' has a newer replacement joist behind, 'C2'

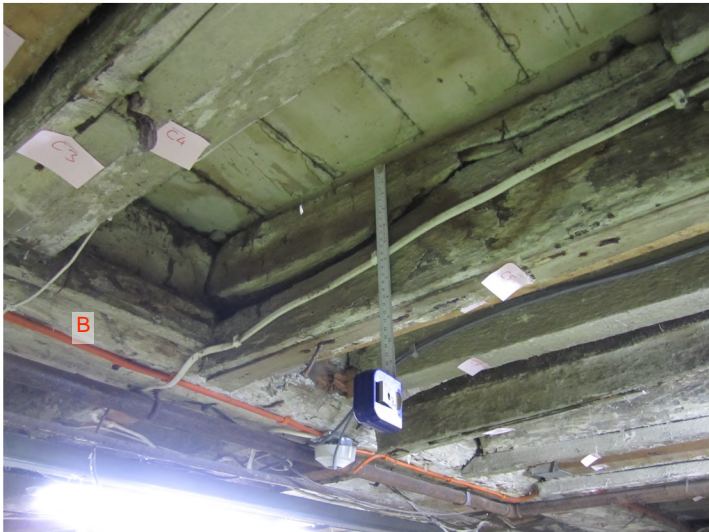
Photo 4873

Joist Zone 'C' 'C5' has Failed Initiated from Tenon

Note, 'C5' has a newer replacement joist behind, 'C6'

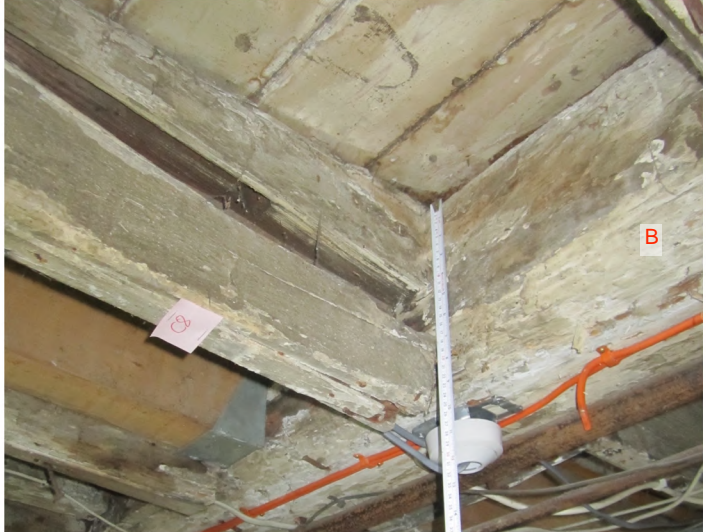
Photo 4875

Joist Zone 'C' 'C8' has Failed Initiated from Tenon

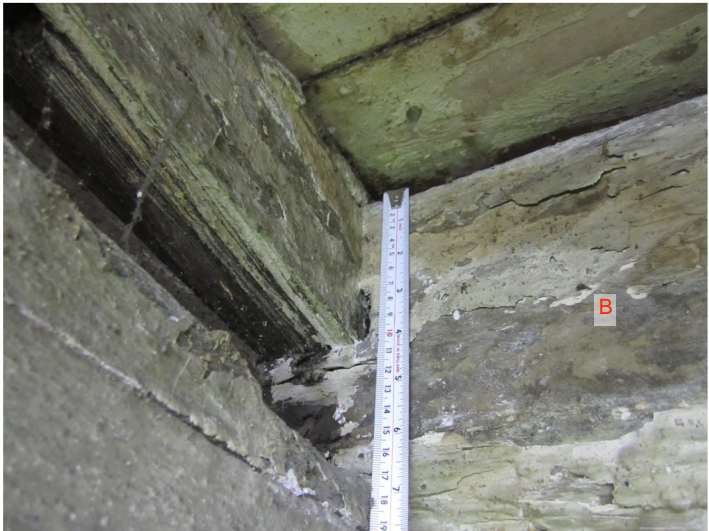
Photo 4877

Joist Zone 'C' 'C8' has Failed Initiated from Tenon

Note the shallow depth of the tenon

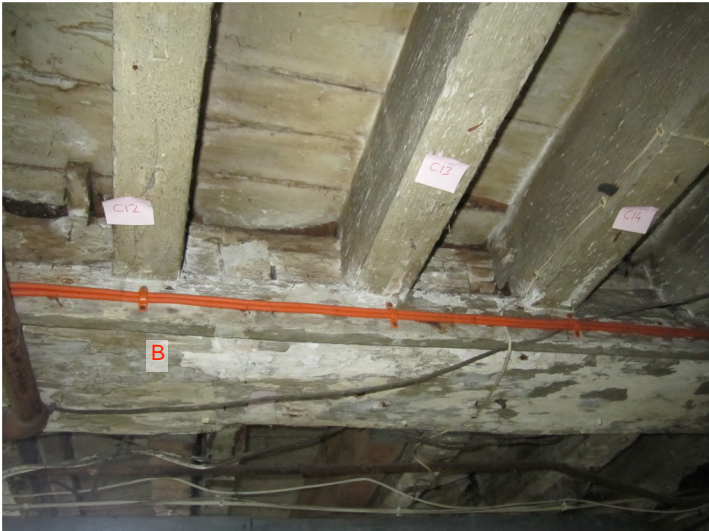
Photo 4879

Joist Zone 'C' Newer Replaced Joists

Note the small vertical depth of the mortice holes into Bressummer 'B'

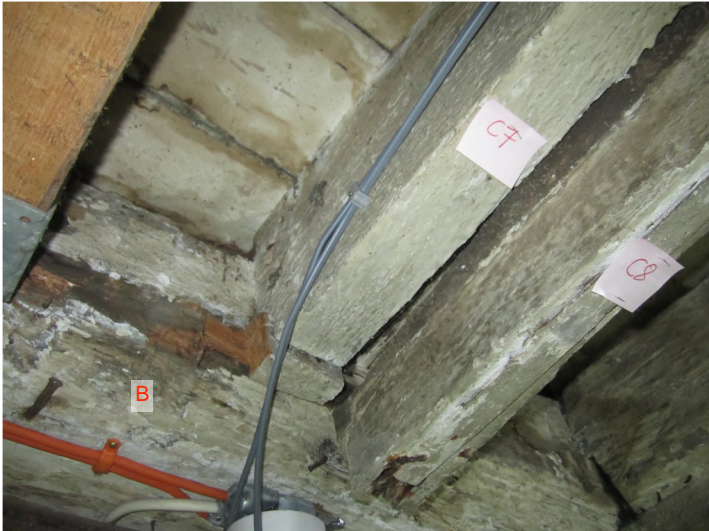
Photo 4886

Joist Zone 'C' 'C8' has Failed Initiated from Tenon

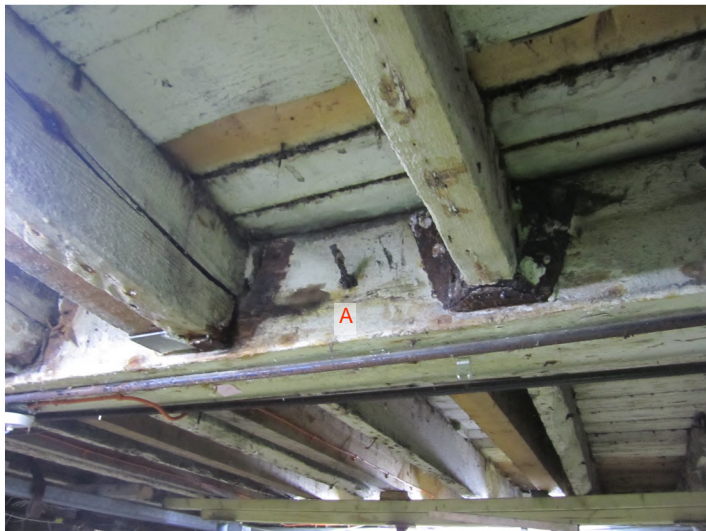
Photo 4893

Joist Zone 'N' Failed Joist Initiated from Tenon

Note the newer replacement joist behind
