59 Lambs Conduit Street, WC1

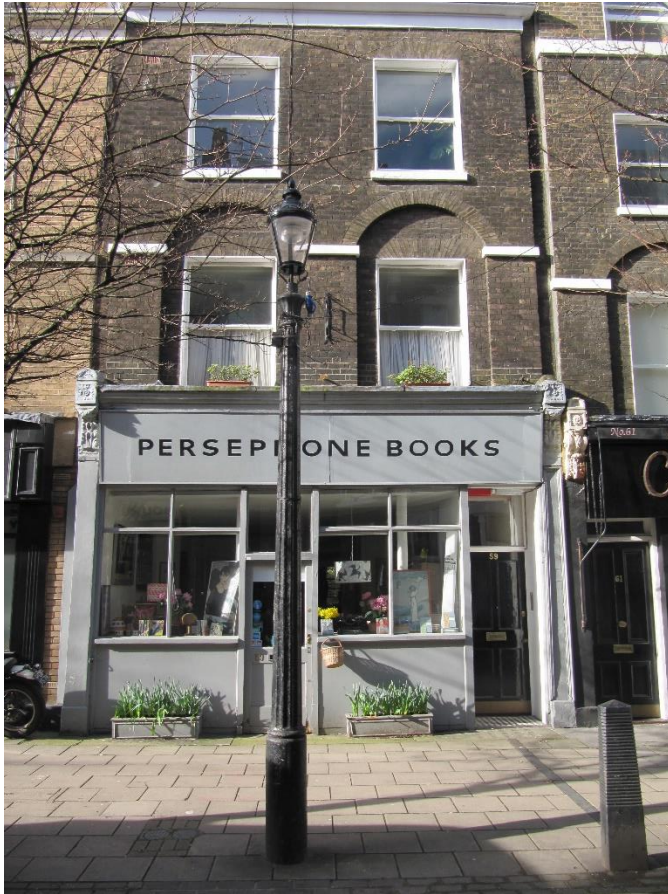
1. Front elevation (no works intended)

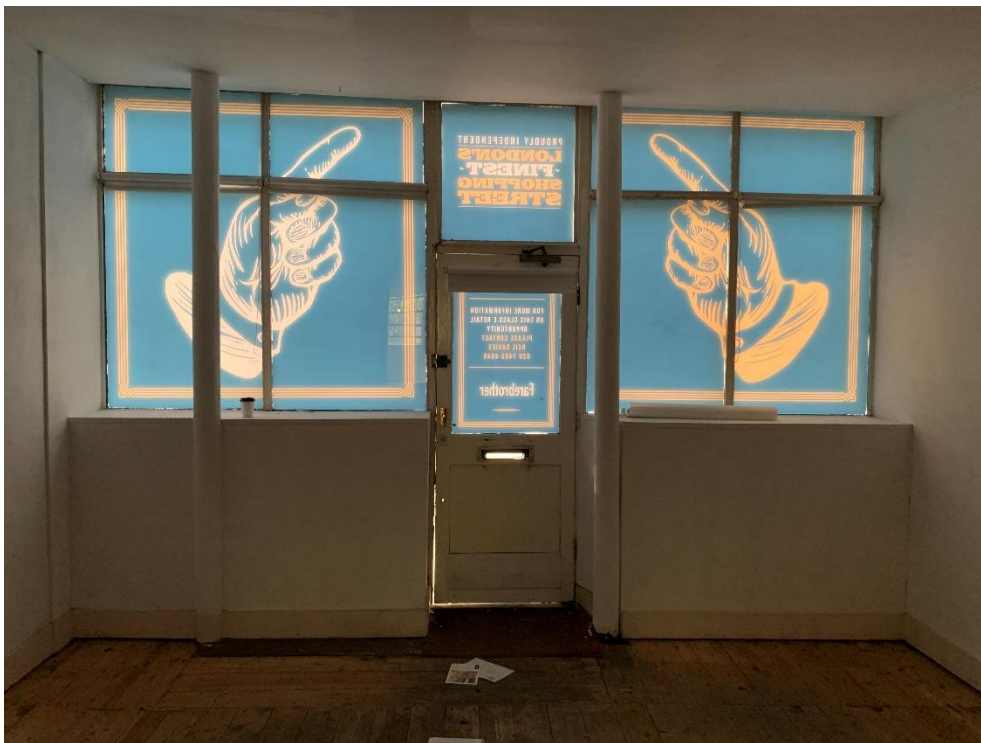
2. Shopfront internally

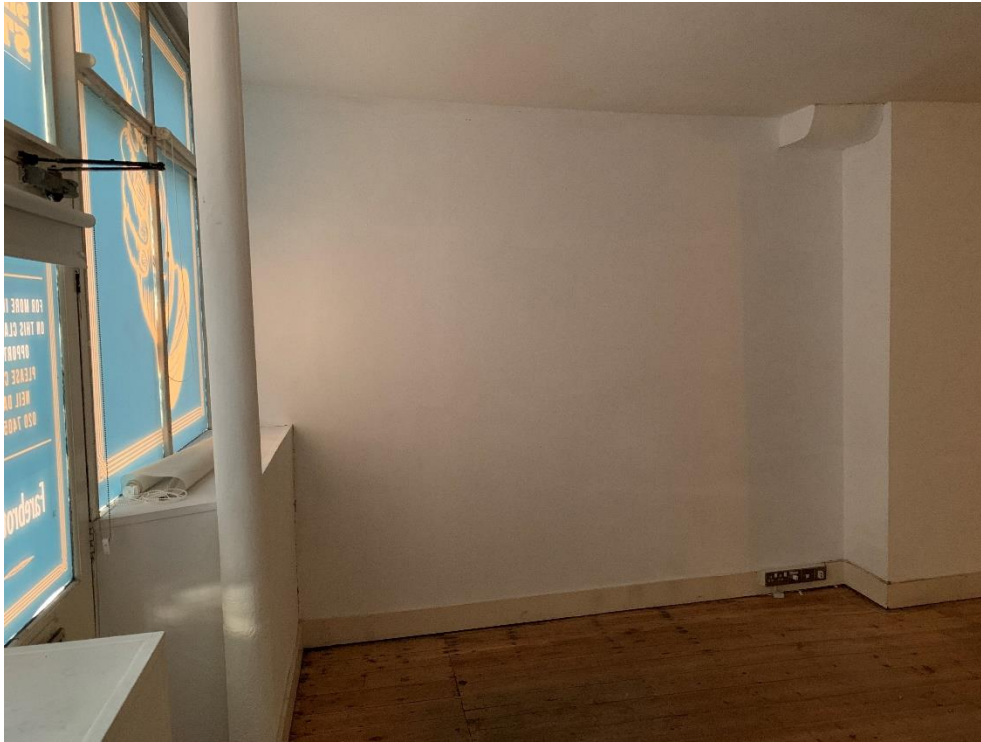
3. Party wall with No.57 (chimney breast no longer present)

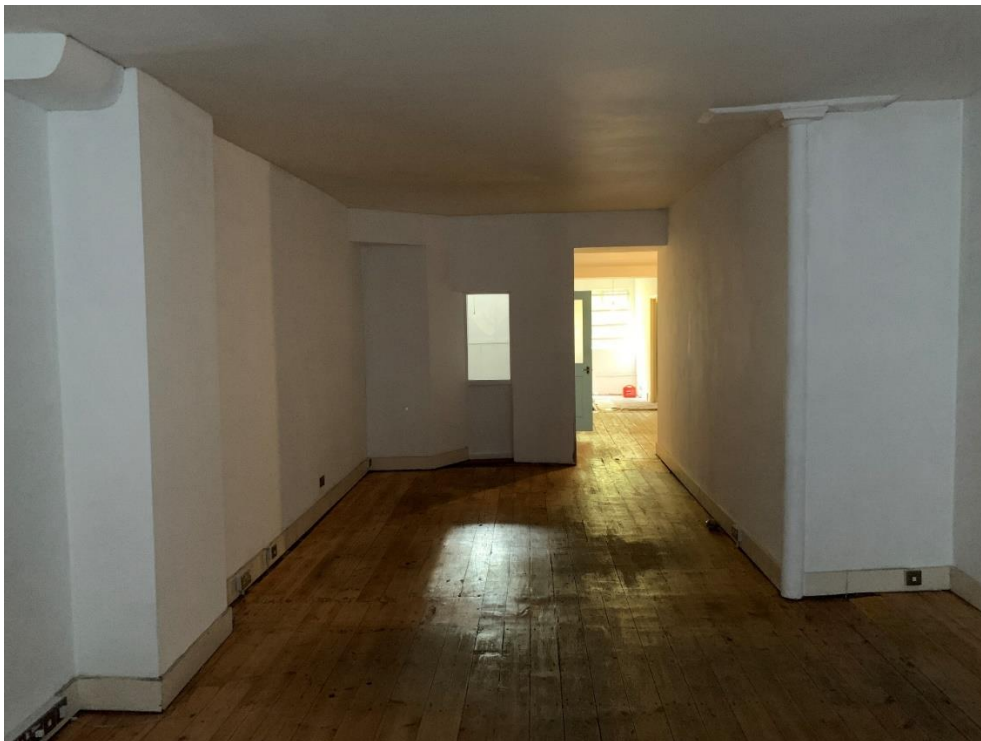
4. Ground floor facing towards rear - partition to right hand side adjoins common parts and is location where staircase is to be re-introduced.

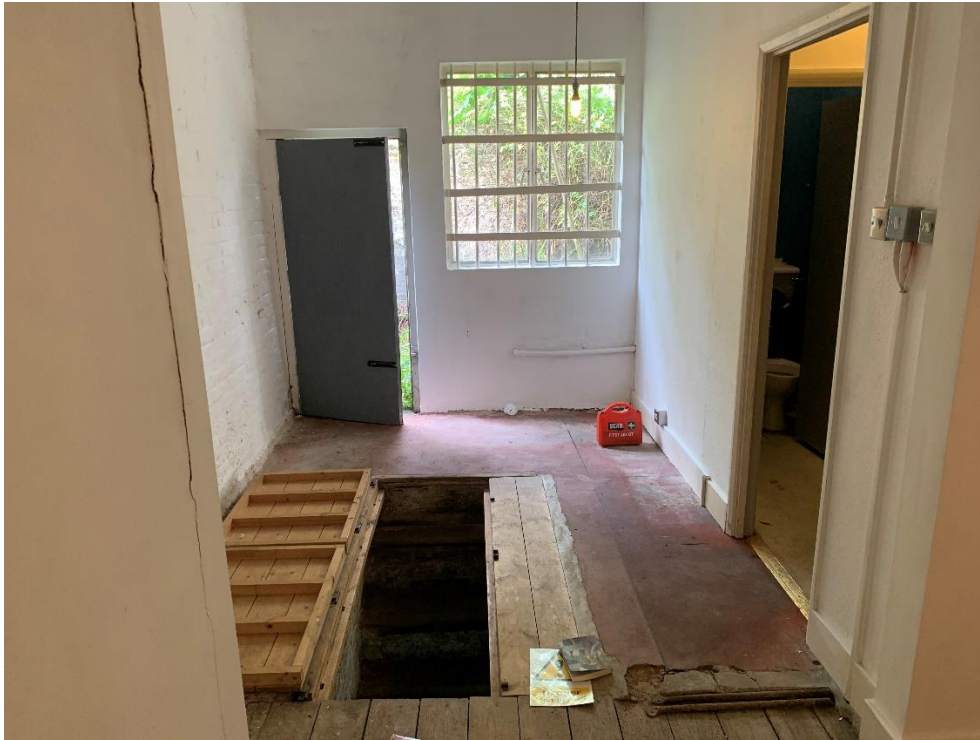
5. Rear part of shop, door to rear courtyard and WC and hatch to basement.

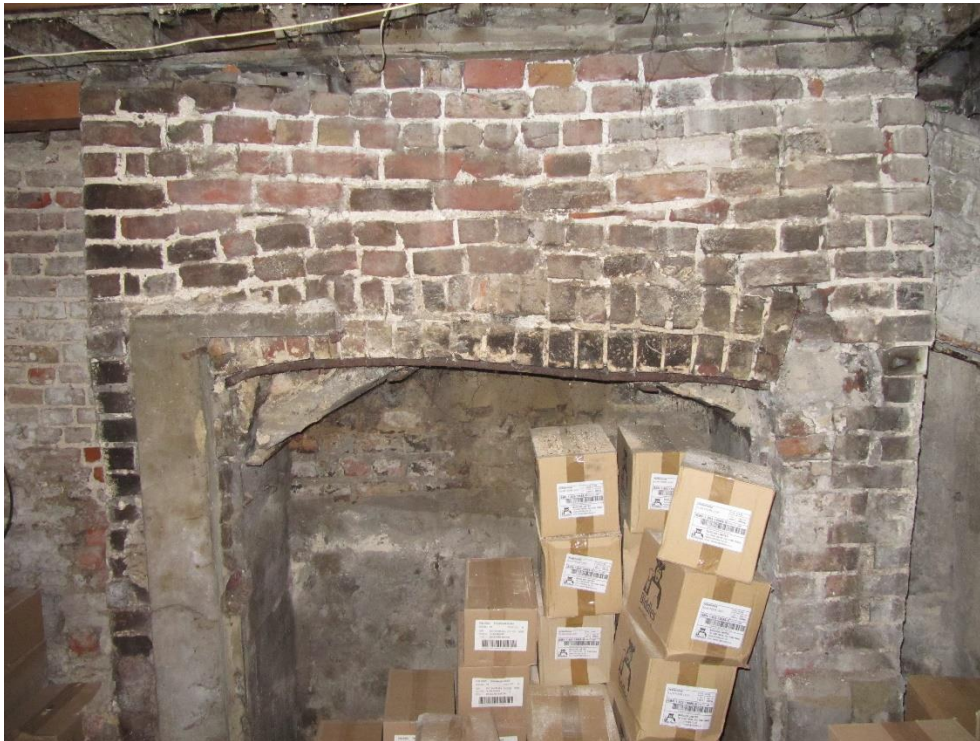
6. Basement chimney breast prior to demolition

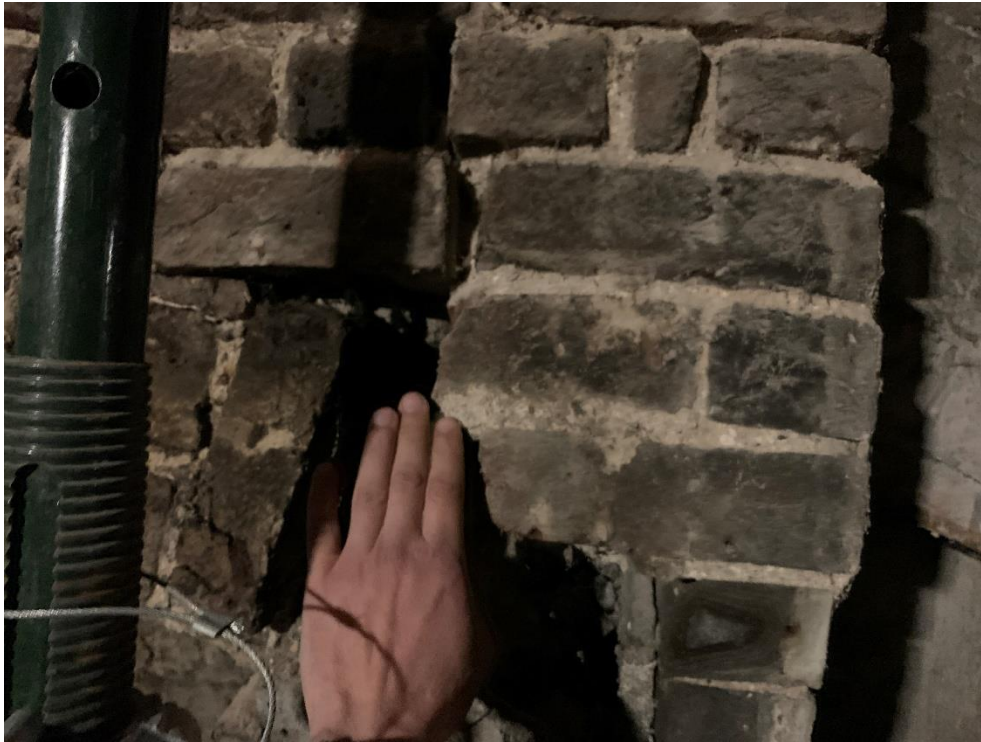
7. Fracture to chimney breast return prior to demolition

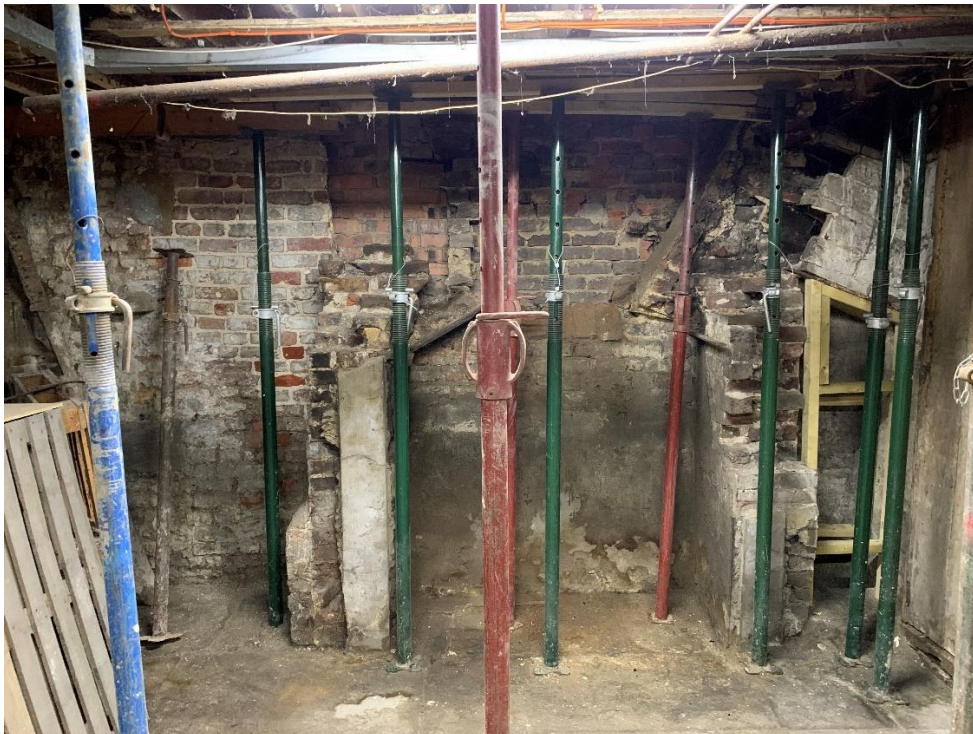
8. Basement chimney breast post partial demolition

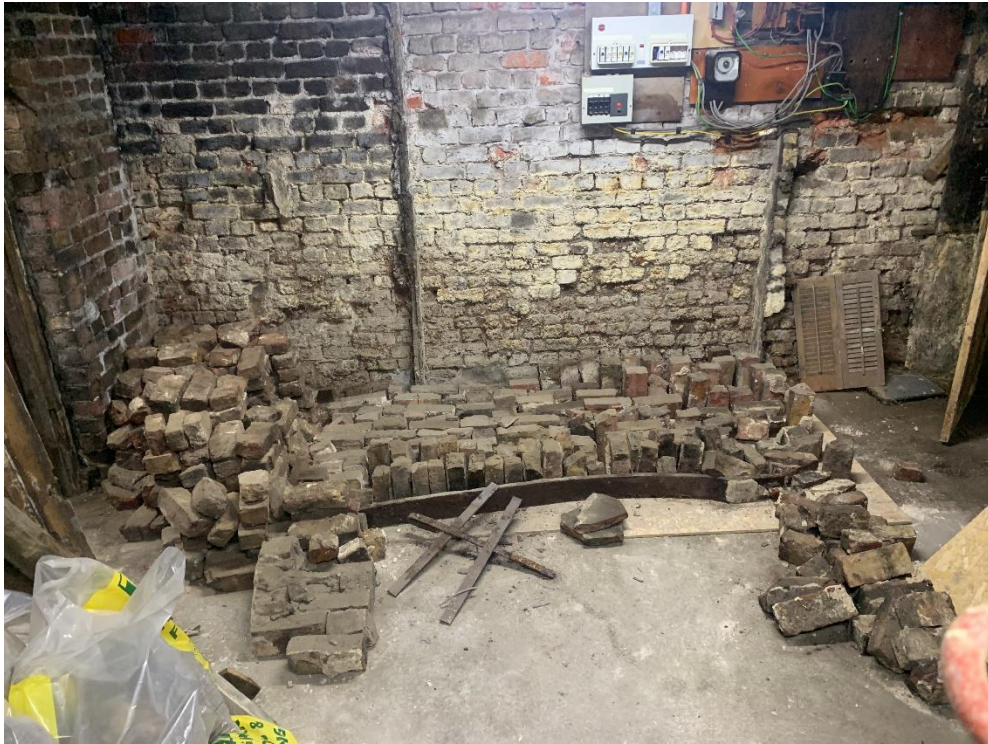
9. Salvaged brickwork from chimney breast

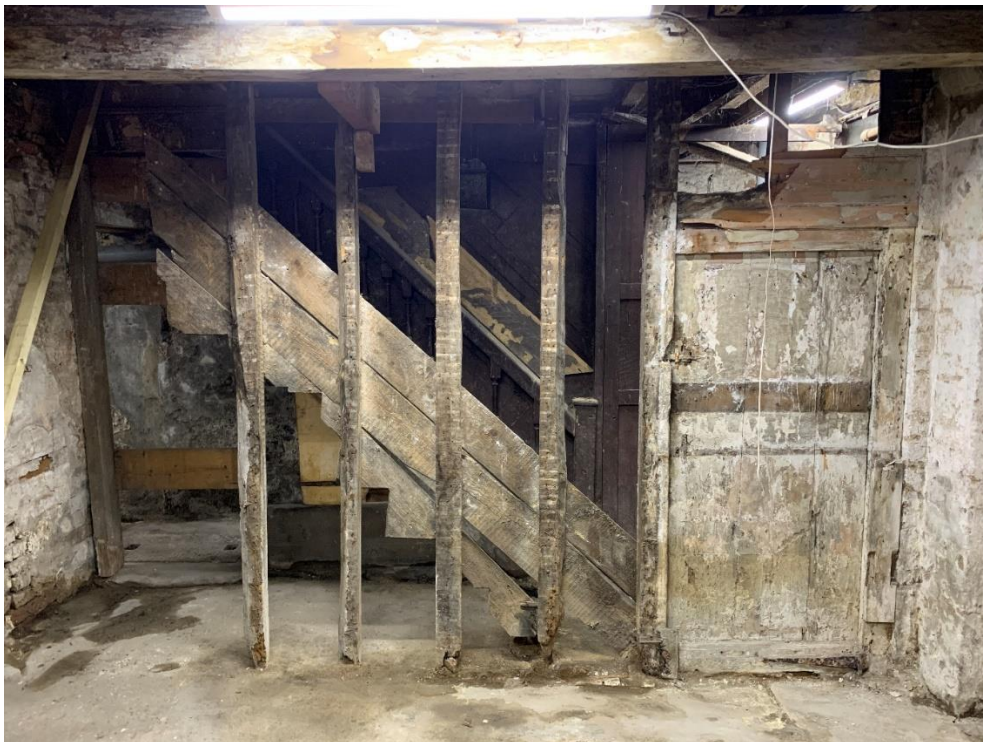
10. Remains of redundant staircase between basement and ground floor

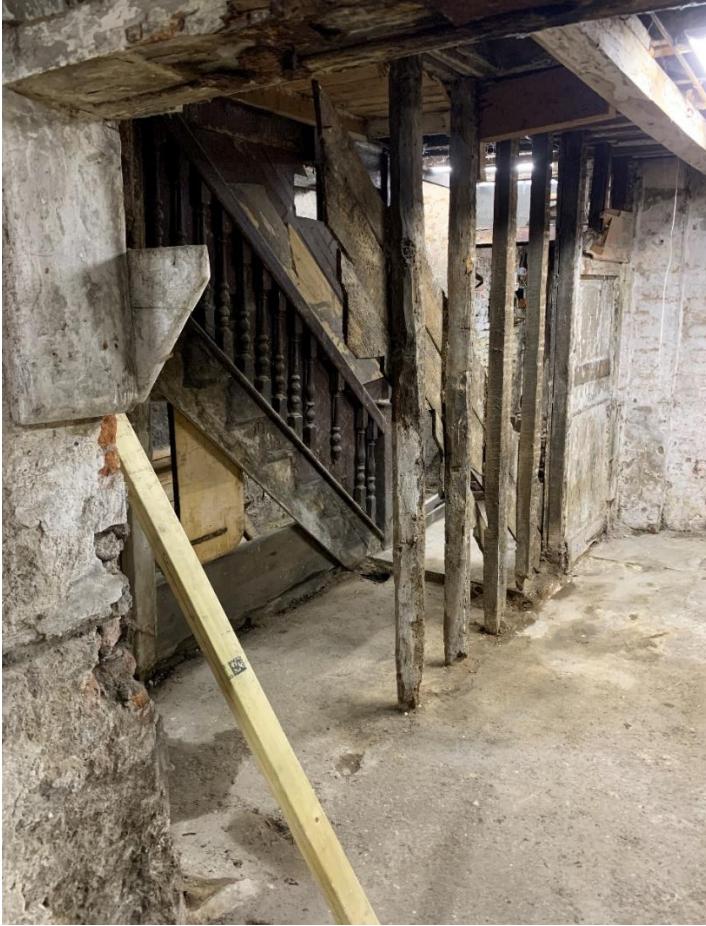
11. Remains of redundant staircase between basement and ground floor

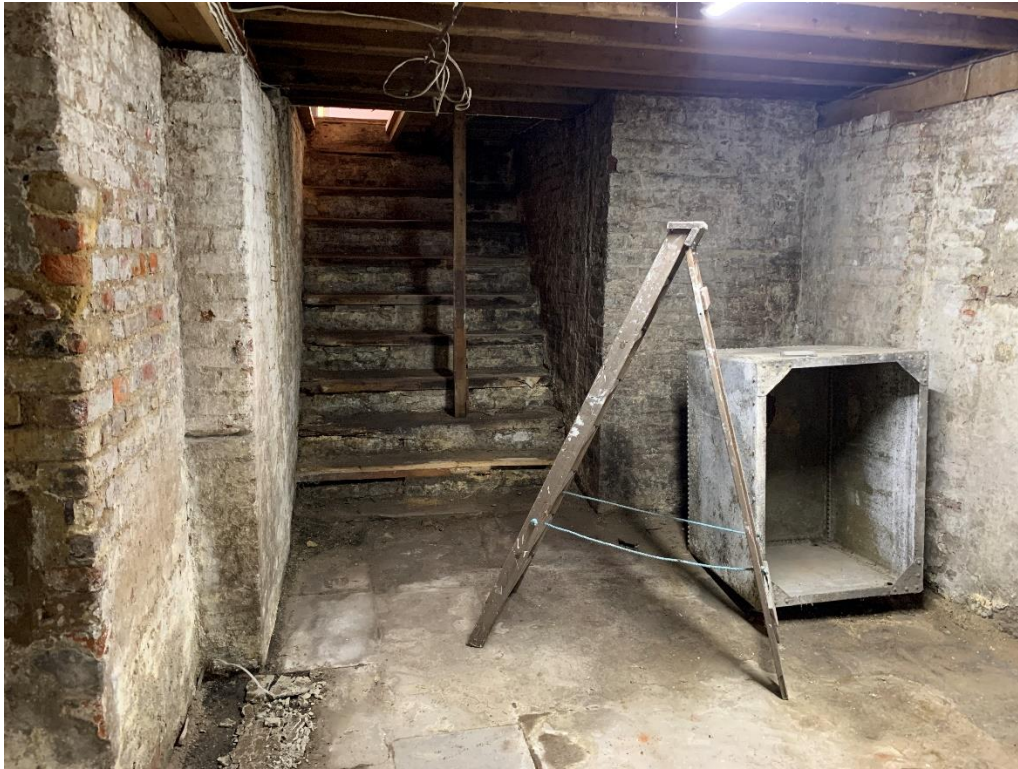
15. Timber tread / brick stair at basement level with access hatch to ground floor

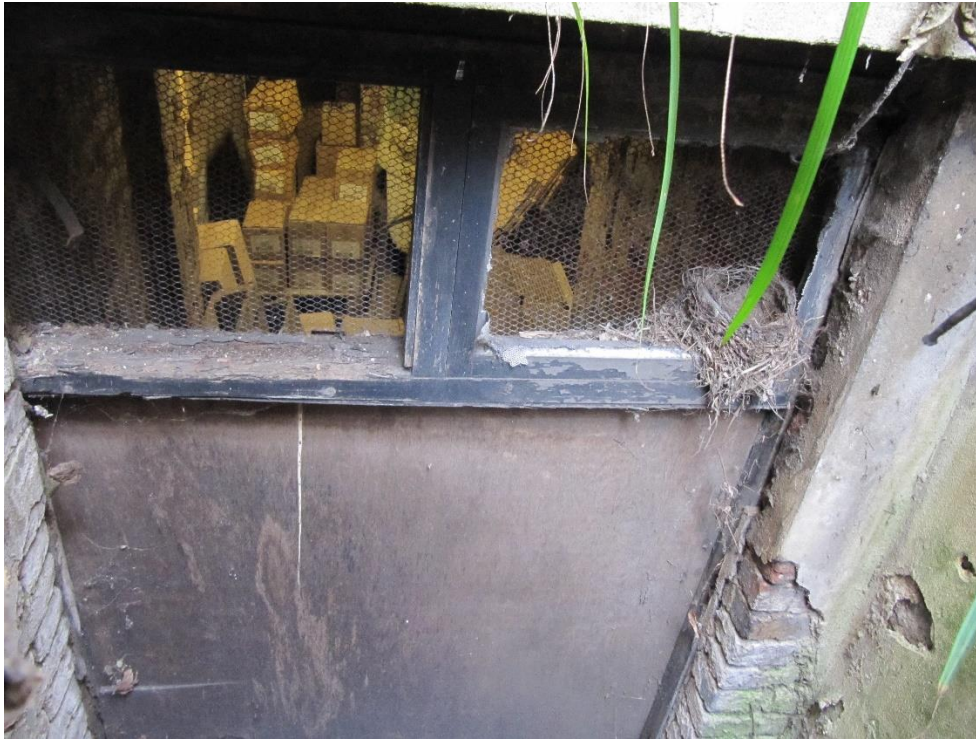
17. Rear lightwell window

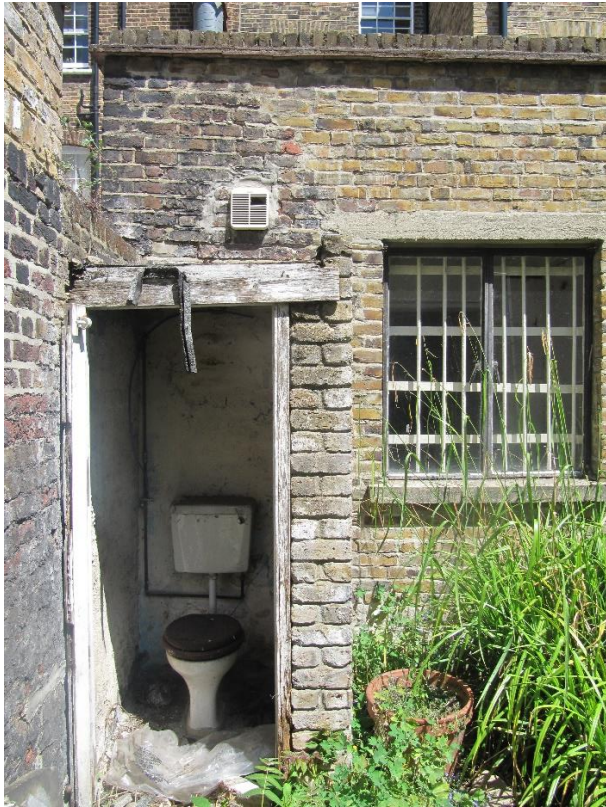
21. Disused external WC
