ADDENDUM ENGINEERING REPORT

Our Reference [REDACTED]
Claim Reference [REDACTED]
Prepared for Co-op Insurance

Report Date 10 May 2018
Claim address 160 Camden Road
London
NW1 9HJ

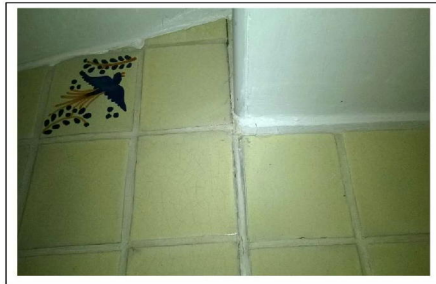
The damage is fully detailed in our initial Engineer's Report dated 30 October 2011. The main cracking is evident in the basement bathroom with cracking through the tiling at the junction between the main house and the porch structure. Cracks have been previously filled but continue to open seasonally. Similar cracking is evident externally and the paving slabs are very uneven along the front path and adjacent to the steps. The front gate pillar is leaning over severely and is also being physically pushed by the tree, along with the front boundary fence. The base of the tree is now protruding into the public footpath creating a trip hazard.

Cracking to Left Hand Wall in Bathroom

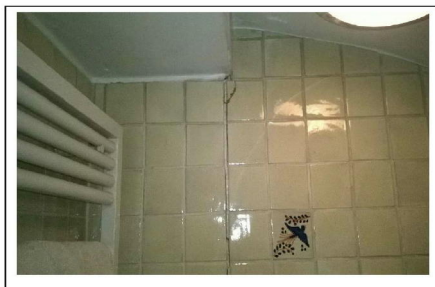
Cracking to Right Hand Wall in Shower Room

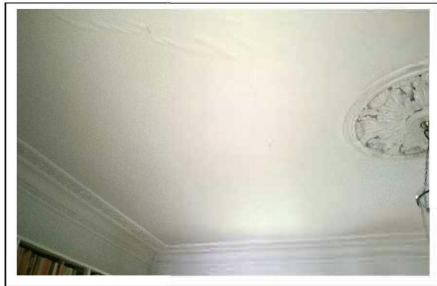
Pulling and Cracking of Kitchen Ceiling

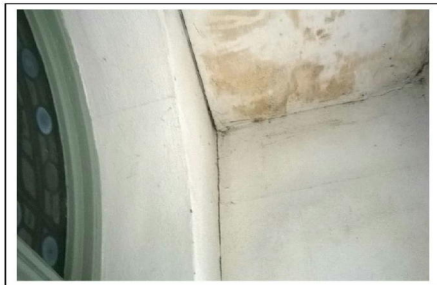
Movement Between House and Porch

It is evident that the works undertaken circa 1997 to the front porch have been effective in stabilising that part of the structure however, it is also clear that the front right hand corner of the main property is also subject to seasonal movement. The Plane tree is the only feasible cause of such movement. It is understood that the tree is subject to a three year pruning cycle however, this has not been sufficient to reduce the degree of seasonal movement sufficiently to prevent cracking to the superstructure. Given the location of the tree and the hard landscaping all around the tree will struggle for water and consequently the root growth will increase whenever there are prolonged dry periods of weather.

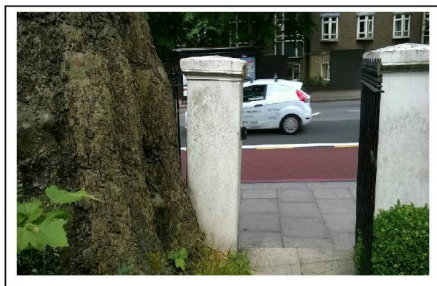
Leaning Gate Pillar - Gate Unable to Close

Given the size and location of the tree it is recommended that it is removed. If it is not removed then the gate pillar will need to be demolished to prevent it from collapsing into the public footpath and the paving will continue to be uneven, representing a trip hazard to anyone visiting the property. The base of the tree is already protruding into the public footpath creating a trip hazard. Further pruning or pollarding may be effective in the short term but in the medium term it will fail as the root system of the

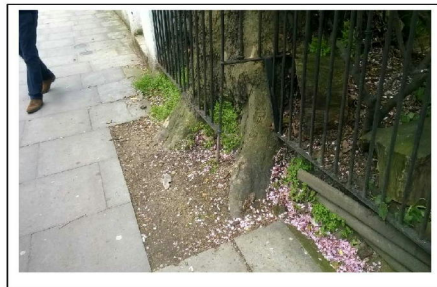
Tree Protruding into Public Footpath

It is strongly recommended that the Plane tree is removed to allow the property to stabilise. Whilst the degree of cracking and movement is not severe, it will continue to recur periodically whilst the tree remains in place, regardless of any pruning regime. In addition the damage to the external landscape will continue whilst the tree is in-situ and the risk of tripping on the public footpath will increase.

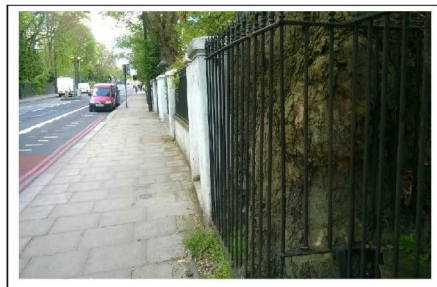
Gate Pillar Leaning into Public Footpath

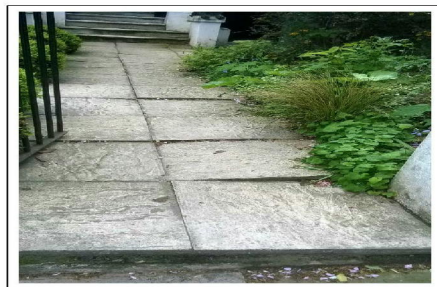
Uneven Paving to Front Path
