# GEOTECHNICAL

160 Camden Road, London, NW1 9HJ

## Drainage Investigation Report

**Risk Address:** 160 Camden Road, London, NW1 9HJ

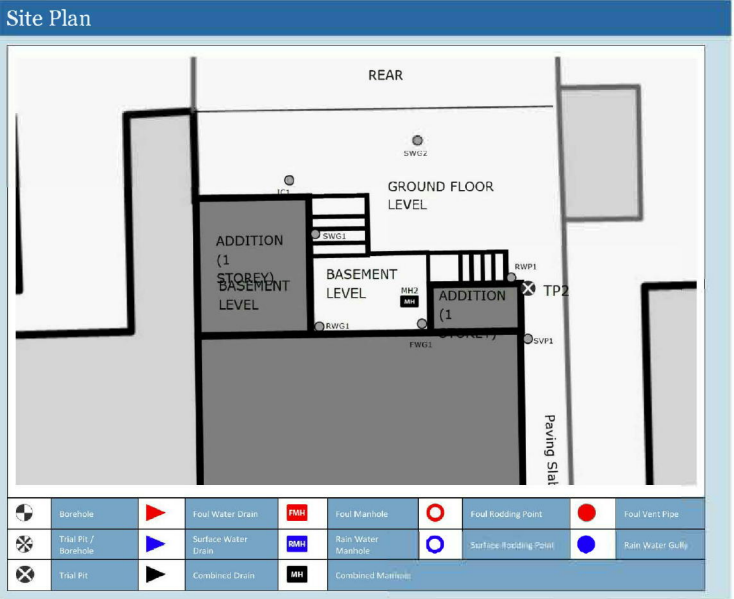
### Foundation Detail

-- End of borehole at 1.20m --  
 Trial pit excavated to 1.20m bgl. Trial pit completed by hand held percussive window sampler. Root  
 encountered to 1.20m bgl. Groundwater strikes not encountered.

Excavation did not expose the underside of the Porch/ Steps foundation. The underside of foundation (USF) was estimated to be 2.20m bgl in TP/BH1. The underside of the foundation was not exposed or confirmed due to being unable to safely extend trial pit to the underside of foundation (USF).

Addition foundation was partially exposed to 1.20m bgl but the underside of foundation (USF) was unable to be confirmed or checked in TP/2. The foundation was not exposed or underside confirmed due to buried services within the trial pit.

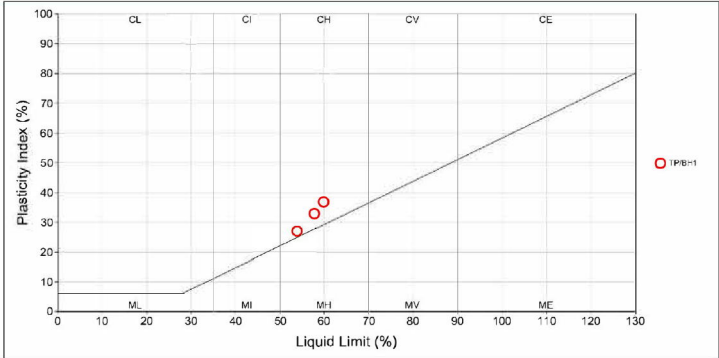
Plasticity Chart for Casagrande Classification

Lab Ref	Depth (m)	Description	BS:5930	NHBC Chapter 4.2
Samples from TP/BH1				
001	2.20	Brown CLAY with rare sand and fine gravel including brick fragments and clinker	CH	Medium
002	2.70	Brown CLAY with occasional sand and fine gravel including brick fragments and clinker		
003	2.90	Brown slightly sandy CLAY with occasional fine to medium gravel including flint	CH	Medium
004	3.20	Brown CLAY with rare sand and fine gravel	CH	Medium
