Engineer's Report

Our Reference [REDACTED]
Claim Reference [REDACTED]
Prepared for **The Co-operative Insurance**

Report Date **30 October 2011**
Policyholder [REDACTED]
Address **160 Camden Road, London, NW1 9HJ**

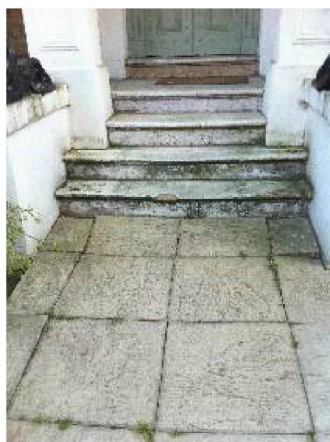
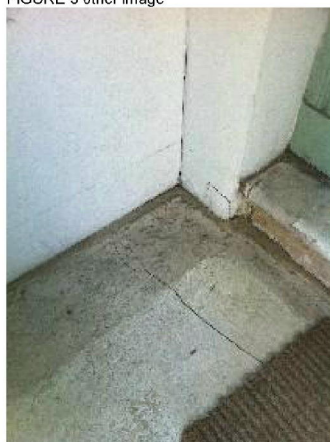
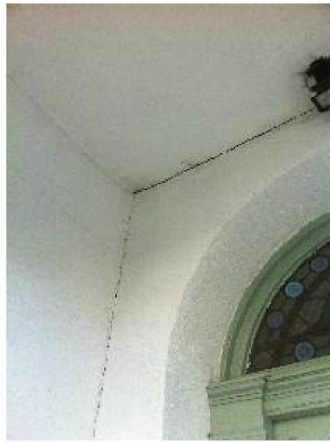
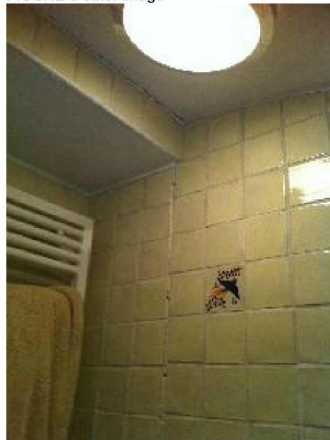
The damage internally consists of cracking to the ground floor bathroom within the basement. There is an existing movement joint between the section under the porch and the remainder of the property. This has now moved beyond the maximum scope that it was designed for. Within the two reception rooms there is minor cracking (1-2mm) above the entrance doors and into the cornice work.

There is also some minor movement between the rear projection and the main house.

Externally, the main damage to the property is at the junction between the porch and the main house. The maximum separation is between 3-4mm. There is significant cracking on the floor of the porch at the junction of where the porch and threshold of the house meet. There is also some cracking to the front elevation at low level with a maximum crack width of 2mm.

It is common practice to categorise the structural significance of the damage in accordance with the classification given in Table 1 of Digest 251 produced by the Building Research Establishment. In this instance, the damage falls into Category 2 (Slight).

The diagonal aspect of the cracks, together with the fact that they increase in width with height is indicative of subsidence as a result of shrinkage of the clay subsoil due to the moisture extracting influence of the London Plane within the front garden.

Provided the property stabilises as expected, no foundation stabilisation works are considered necessary, with structural repairs of the superstructure being required only, together with internal redecoration of the damaged rooms.

Generally cracks 1mm wide or less will be filled (internal) or re-pointed (external). Internally, where the cracks are wider than 1mm, but less than 5mm the underlying brickwork or blockwork will be exposed and prior to making good the plaster finishes the cracking will be covered with expanded metal lath. Where cracks are 5mm across or wider, some form of bed joint reinforcement will be introduced.
