PROJECT TITLE: GLOUCESTER LODGE

PROJECT NUMBER: 2104287 FILE: Site Visit Report 20220610

SITE VISIT BY: MW DATE: 10 June 2022

ADDRESS OF SITE: MEWS HOUSE, PART OF 12 GLOUCESTER GATE, LONDON NW1 4HG

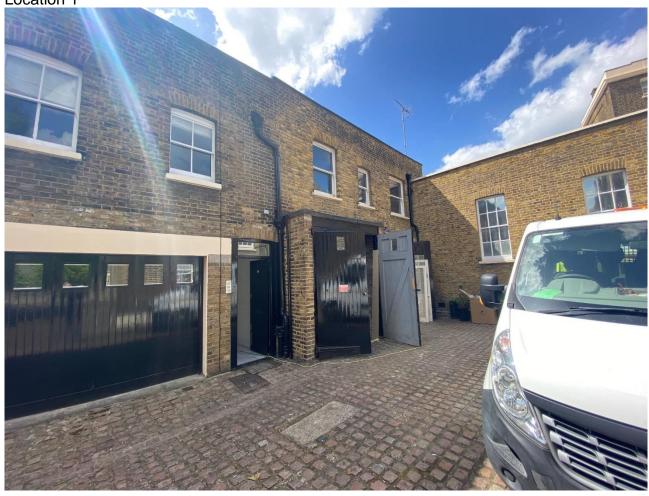
Gloucester Gate Mews. North End showing East Elevation of Mews House, part of 12 Gloucester Gate

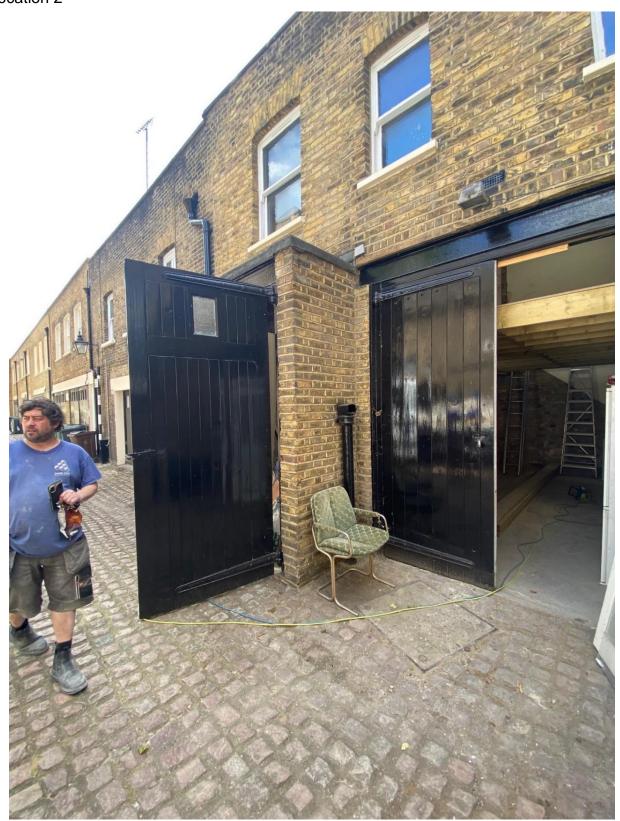
Entrance door. Mews house, part of 12 Gloucester Gate

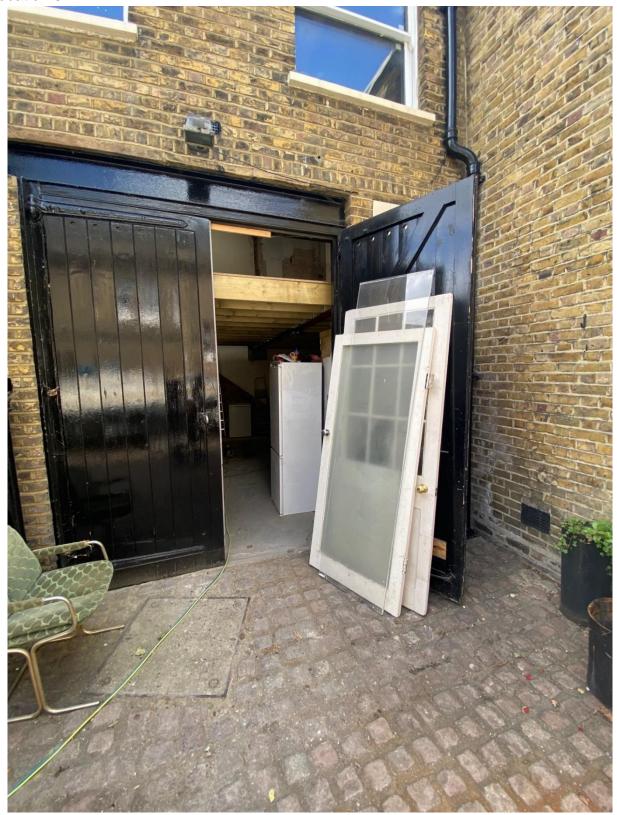
Entrance door, existing lintel retained. Mews house, part of 12 Gloucester Gate

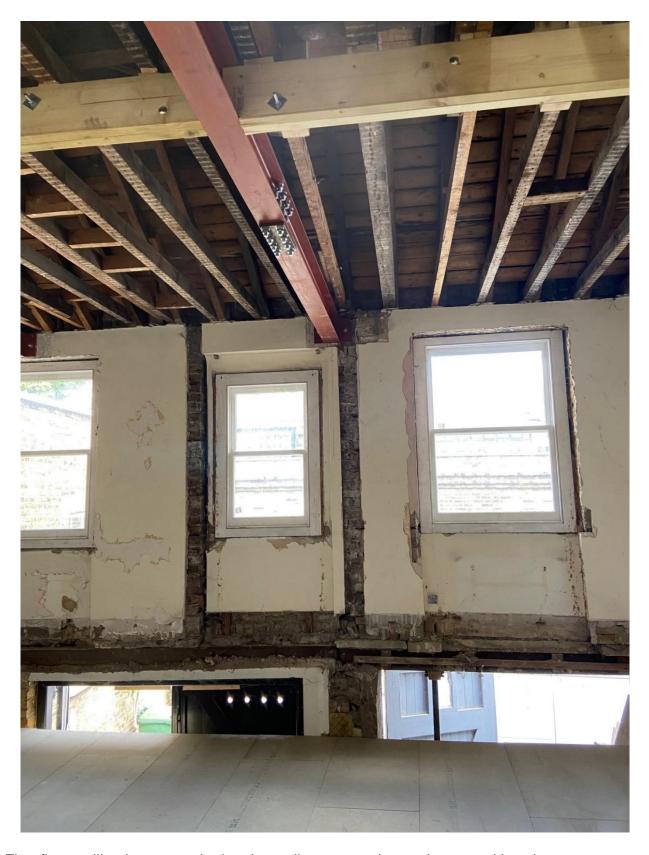
First floor ceiling beam south showing splice connection and east end bearing

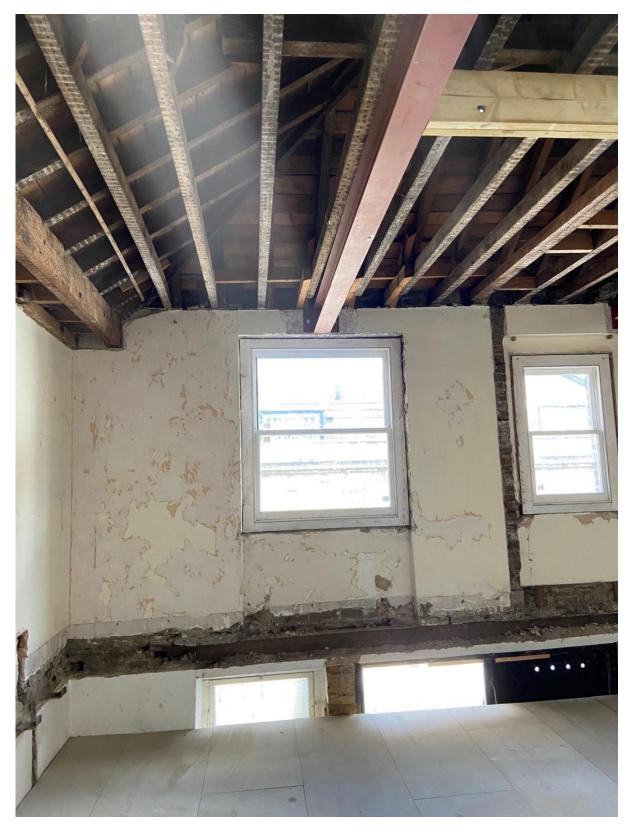
First floor ceiling beam north showing east end bearing

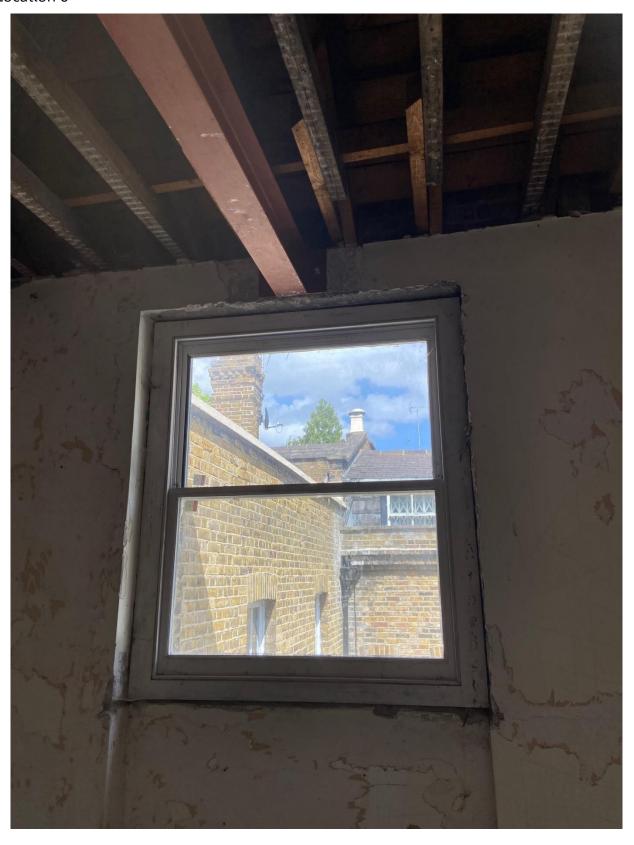
First floor ceiling beam north. East end bearing into existing window lintel

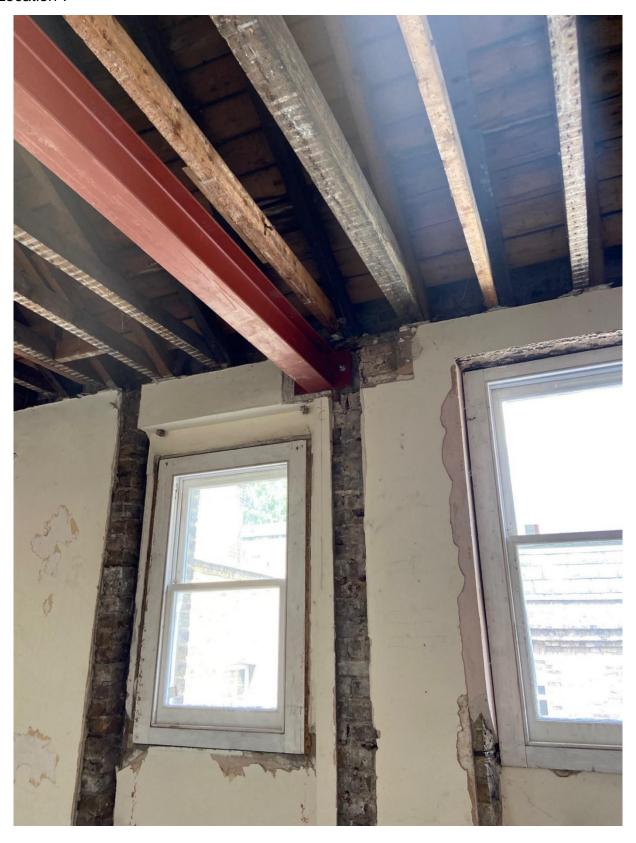
First floor ceiling beam south. East end bearing into existing brick pier

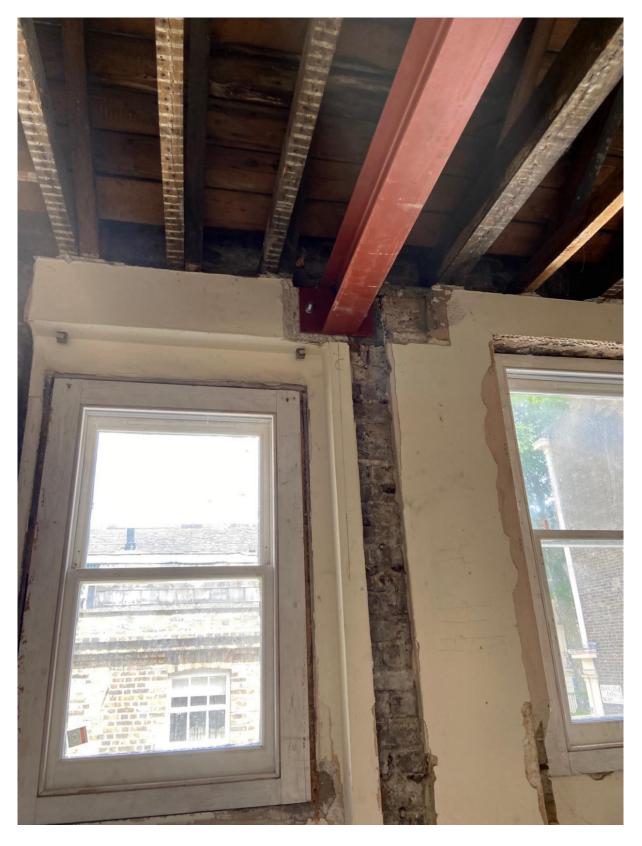
First floor ceiling beam south. East end bearing into existing brick pier

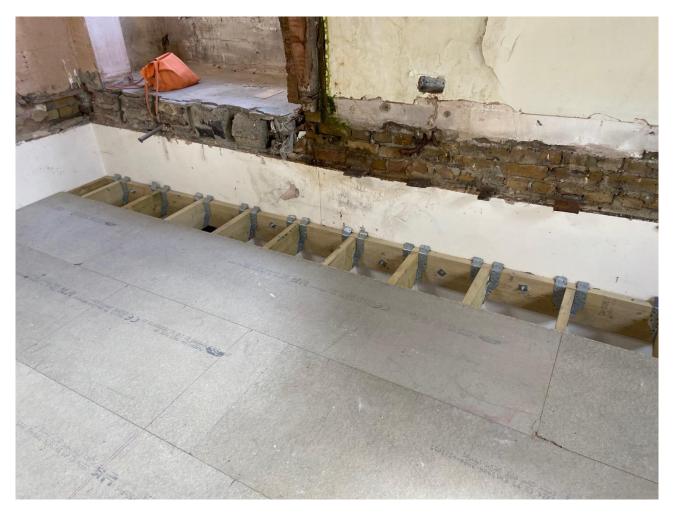
First floor, new floor north end bearing

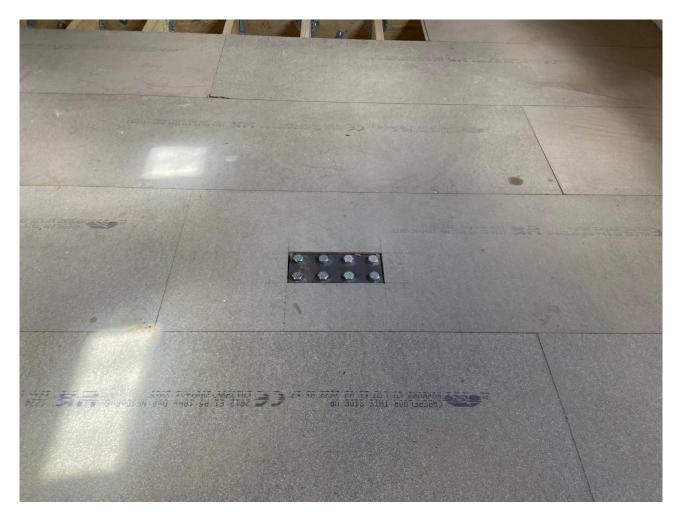
First floor, new floor main beam splice

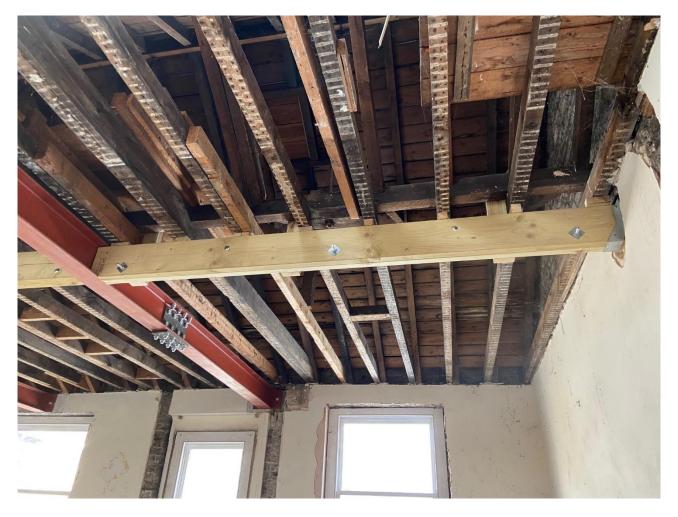
### Location 11,

Ceiling beam central binder south end

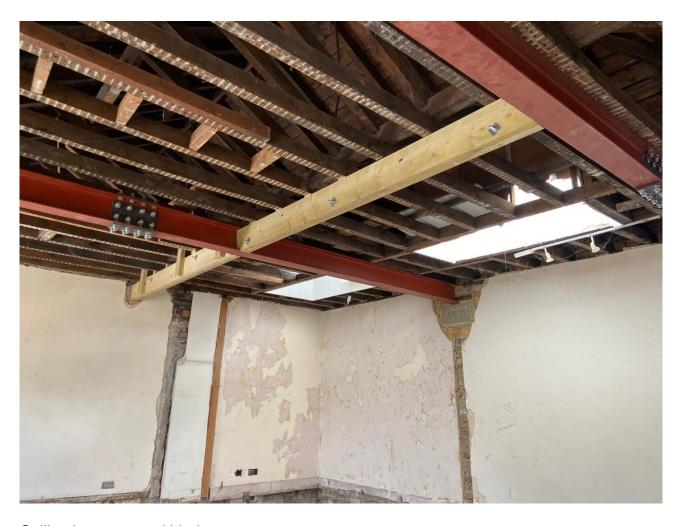
Ceiling beam central binder

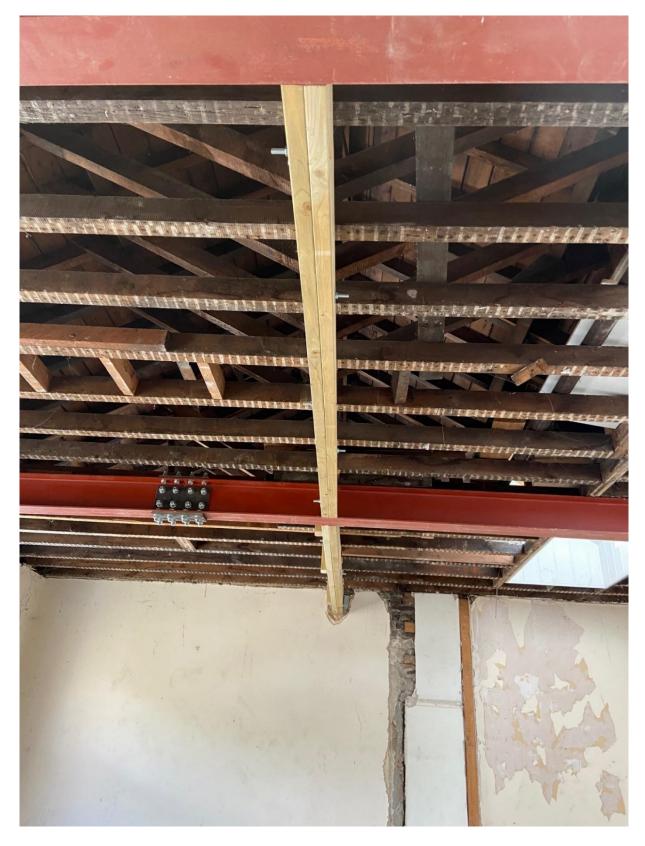
Ceiling beams, central binder

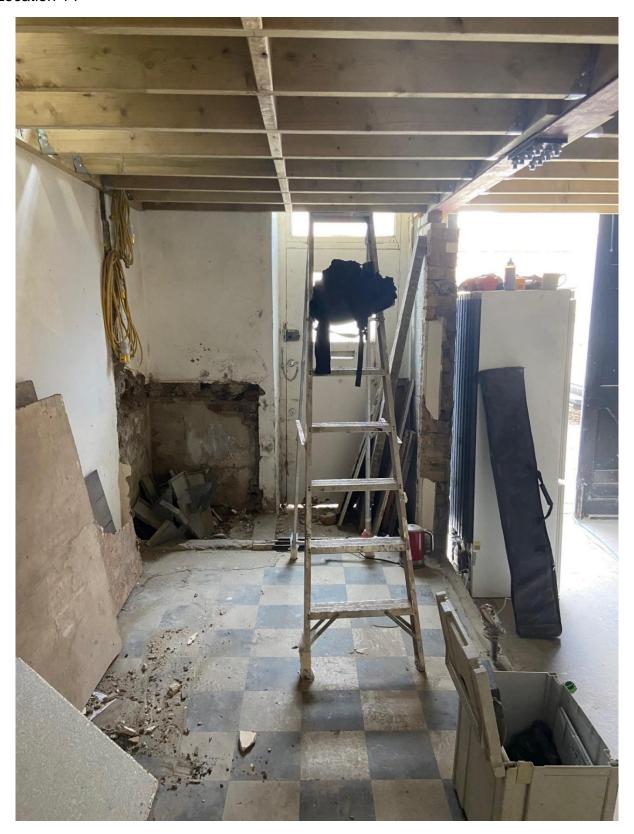
First floor blocking to joists

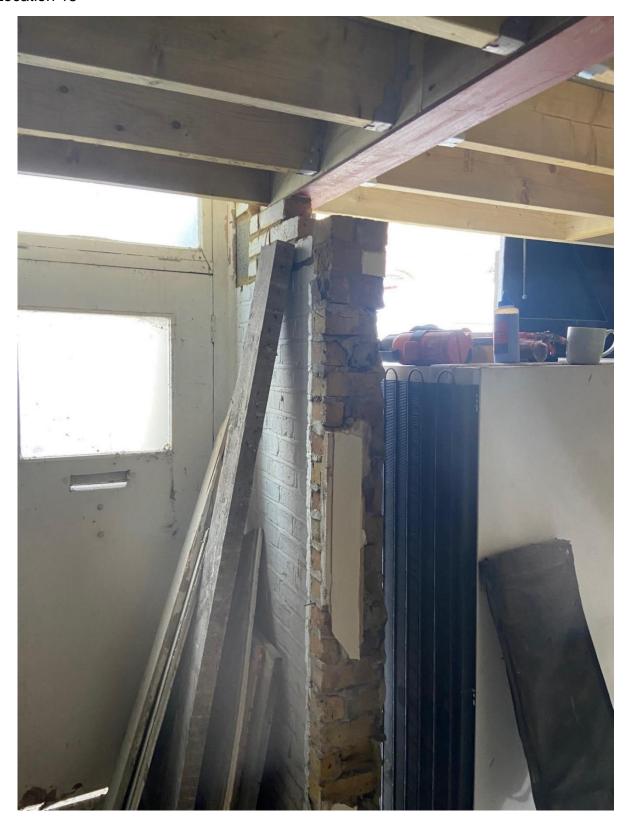
First floor main beam north, east end bearing

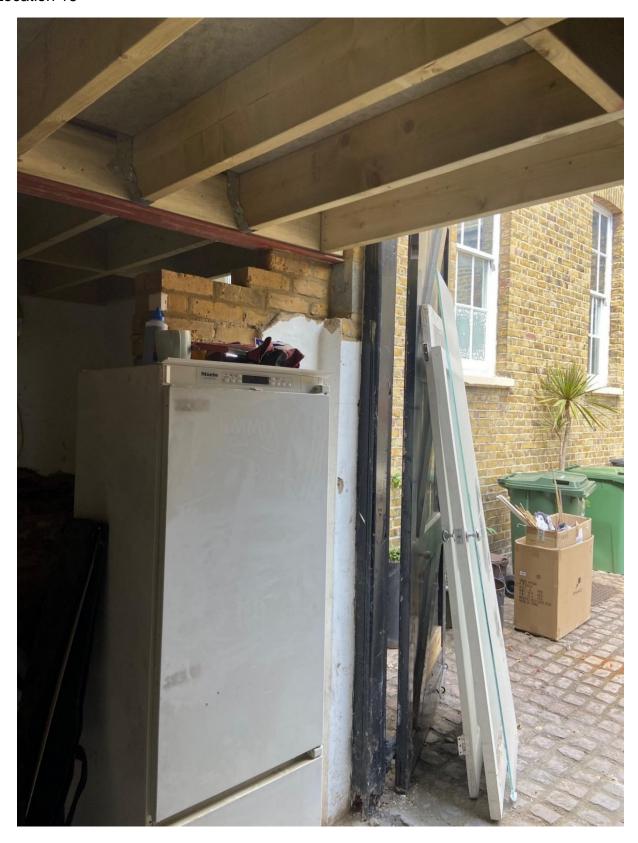
First floor main beam north, east end bearing

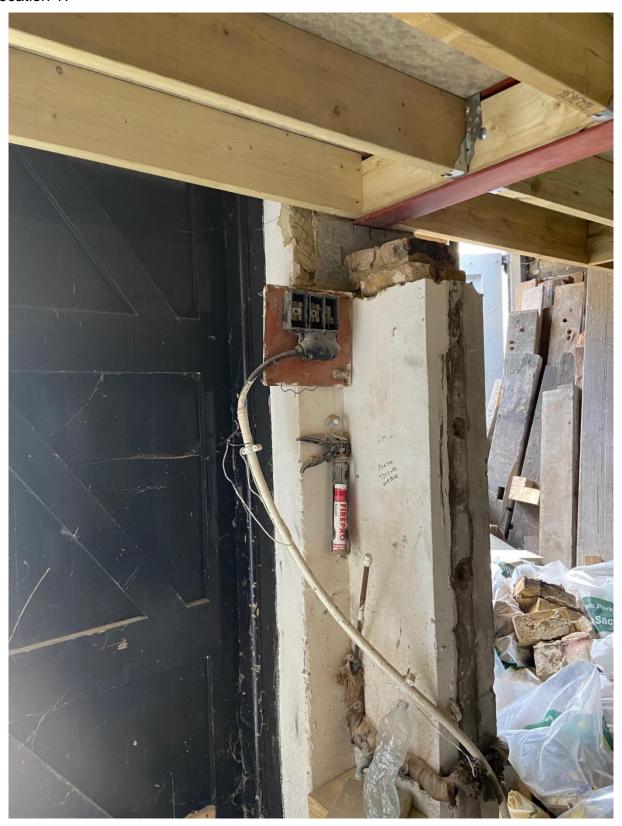
First floor main beam south, east end bearing

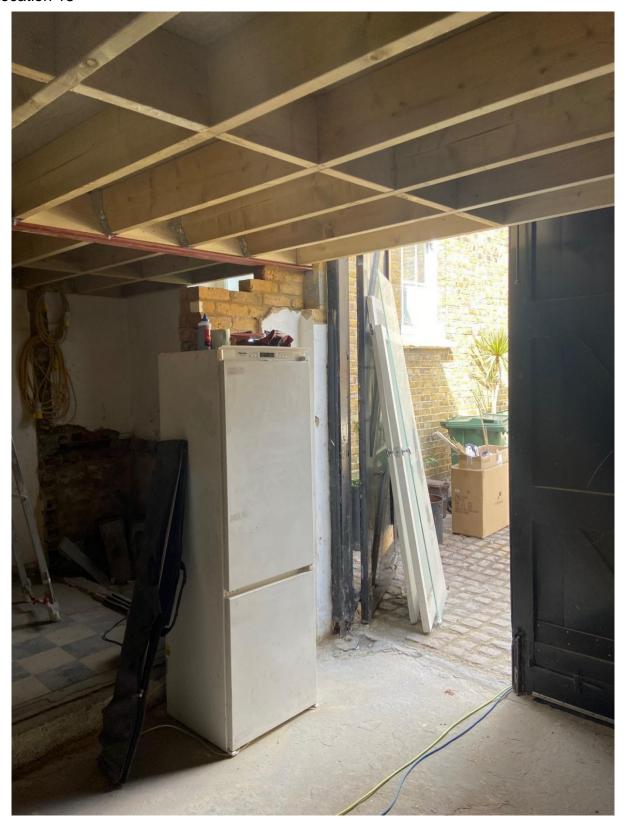
First floor main beam north, east end bearing

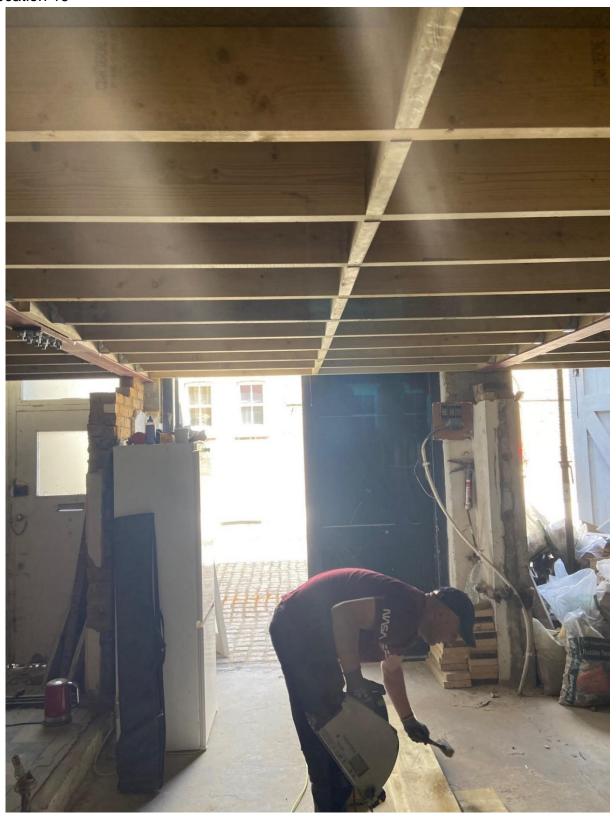
First floor timber blocking to joists

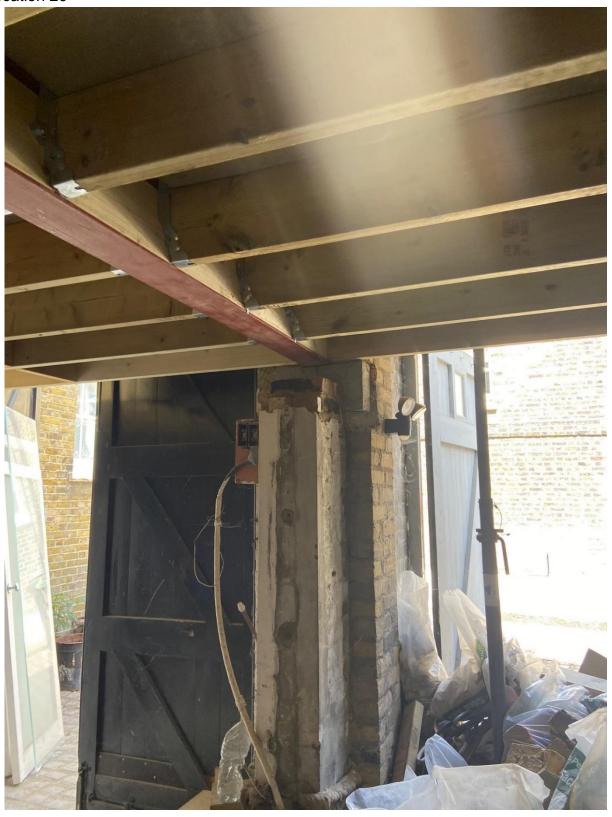
#### Location 20

First floor timber joist bearing onto main beam south

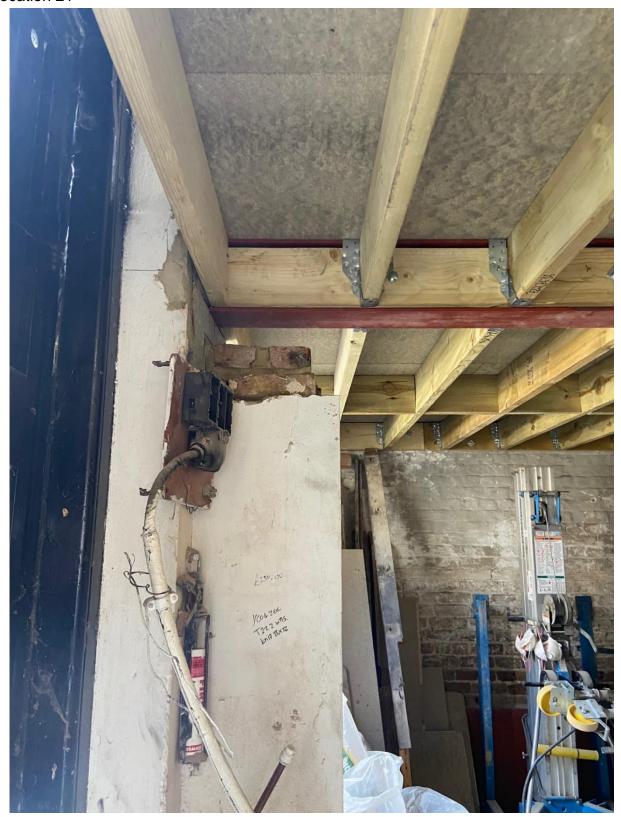
First floor main beam south, east end bearing

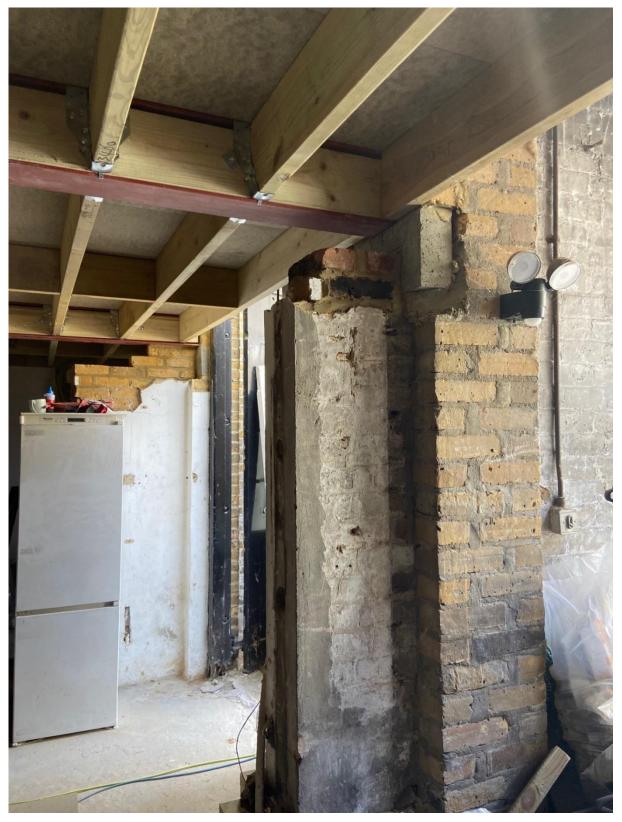
First floor main beam south, east end bearing

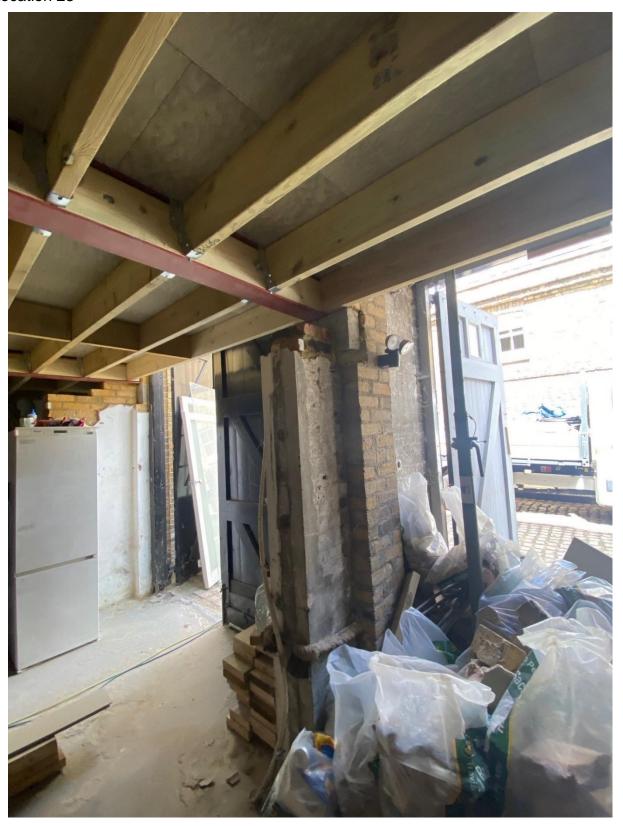
First floor main beam south, timber joist bearings

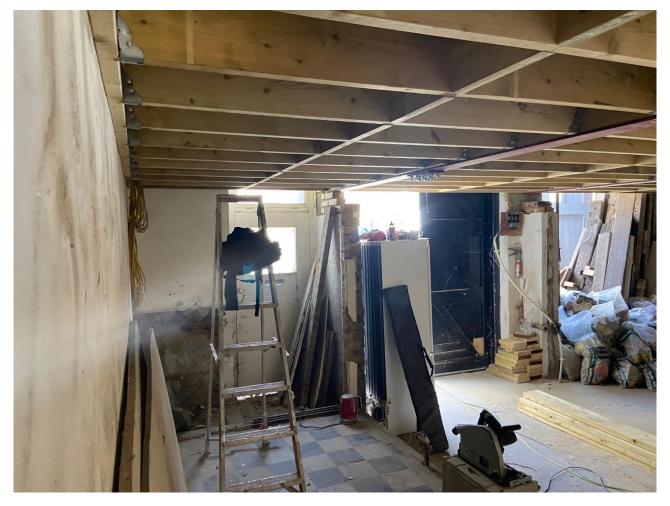
First floor, solid blocking to timber joists

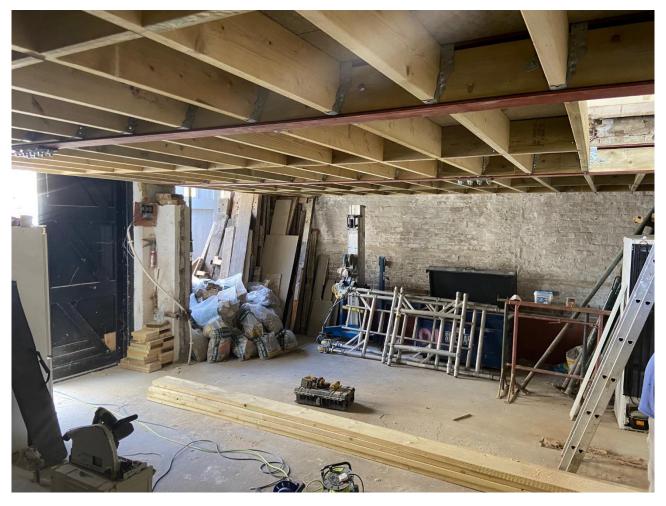
First floor structure

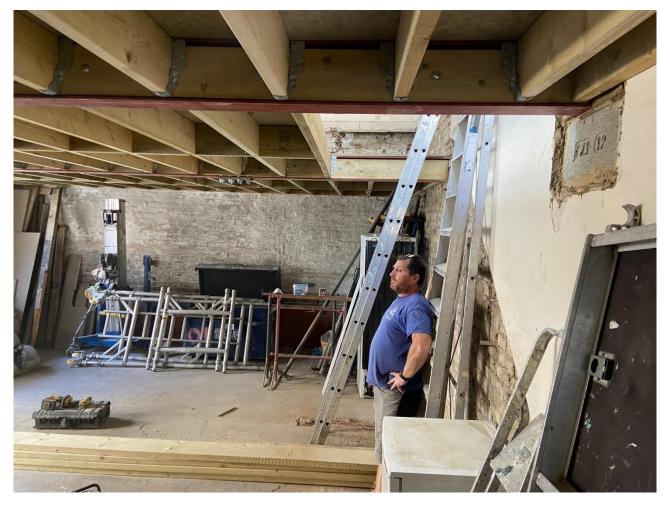
First floor structure, stair well
