CLIENT	ROK Planning Ltd					
PROJECT TITLE	Regents Canal 140 - 146 Camden Street					
SUBJECT	Waterway Wall Inspection					
DOCUMENT TITLE	Visual Survey Report					
DOCUMENT REF	1858-BRL-02-XX-RP-C-0001					
REVISION RECORD						
REV	STATUS	DATE	SUMMARY OF CHANGES	PREP	CHK	APP
P01	S2 – Suitable or information	01/08/2022	First Issue for Client Comment	MM	JM	JM
P02	S4 – Suitable or Stage Approval	01/08/2022	Final Issue	JM	JM	JM

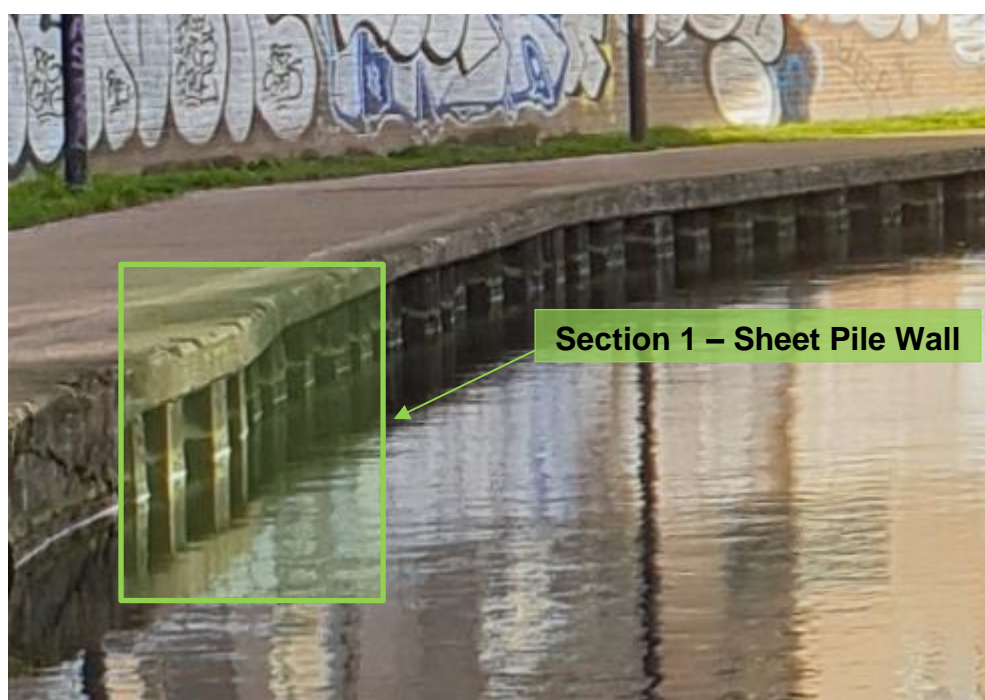
Figure 3.1: Photograph indicating Section 1- Sheet Pile Wall above water

3.1.2 There were no observable changes to the integrity of the sheet pile wall over the period during which works were being undertaken, with the sheet piles remaining without perforation, dents or buckling.

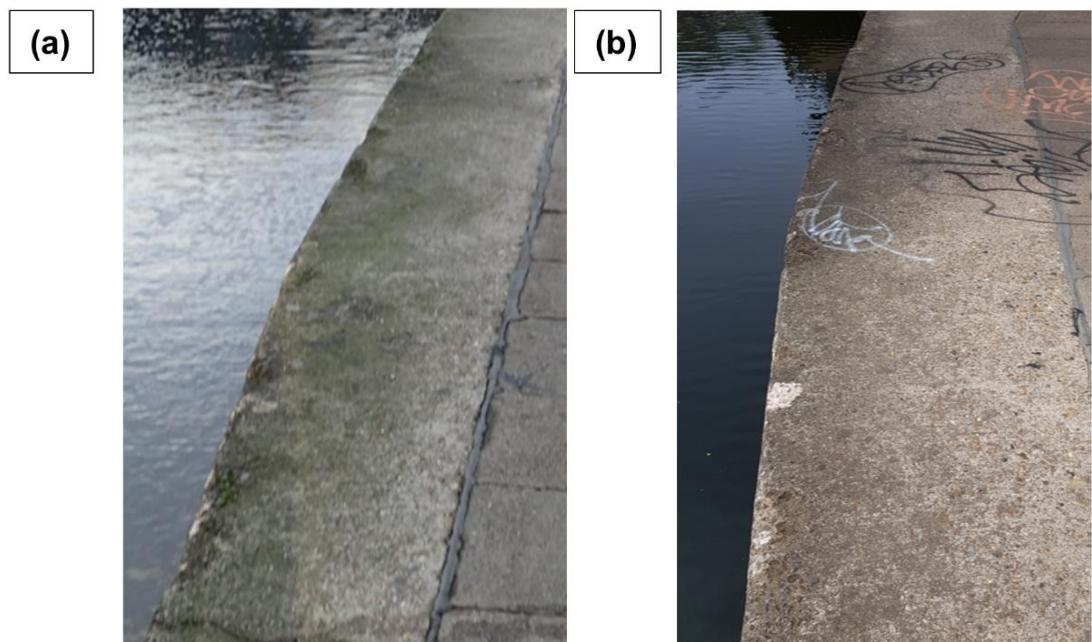
3.1.3 The localised damage to the concrete edge did not appear to have worsened over the period between the two site inspections. The extent of the damage observed during each visit is depicted in Figure 3.2. Additionally, the crack identified on the top surface of the capping beam has not increased in size and no other noticeable cracks have formed.

Figure 3.2: (a) Damaged edge observed during (a) 2019 initial inspection (b) 2022 reinspection

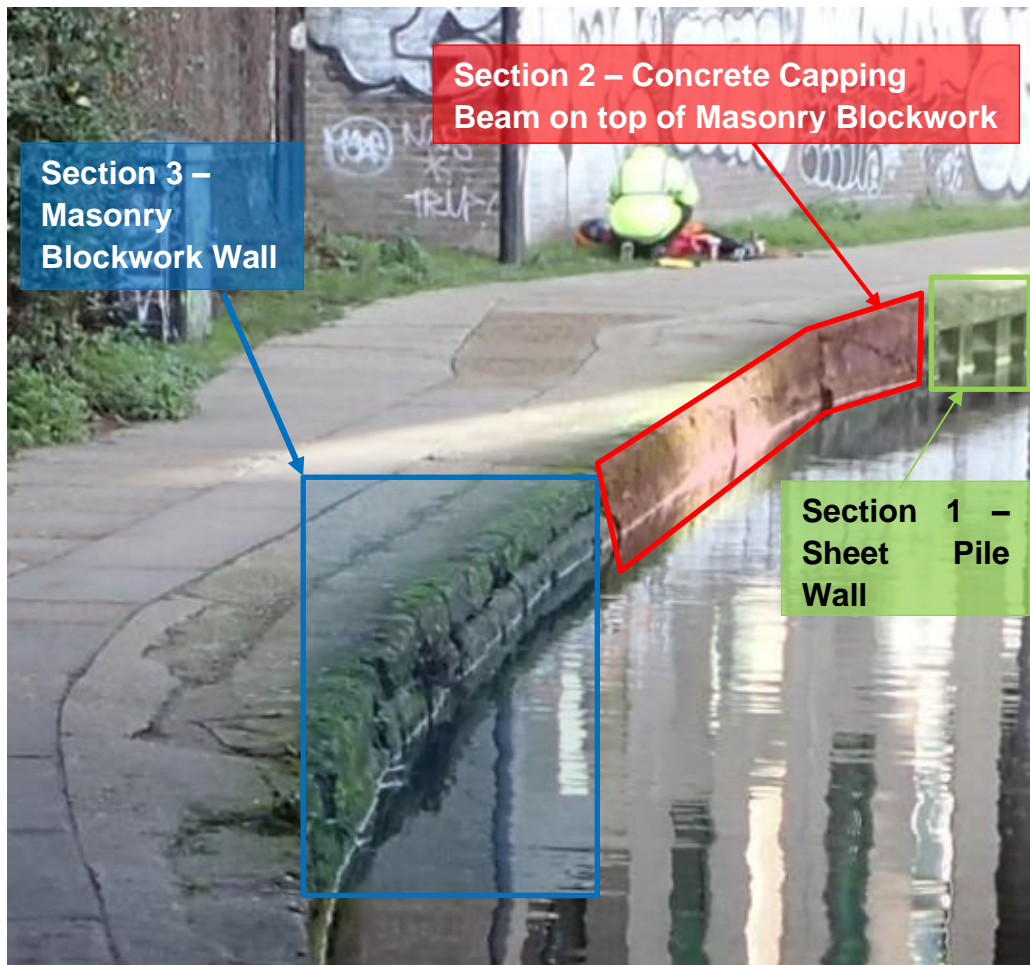
Figure 3.3: Photograph indicating Wall Section 1,2 & 3

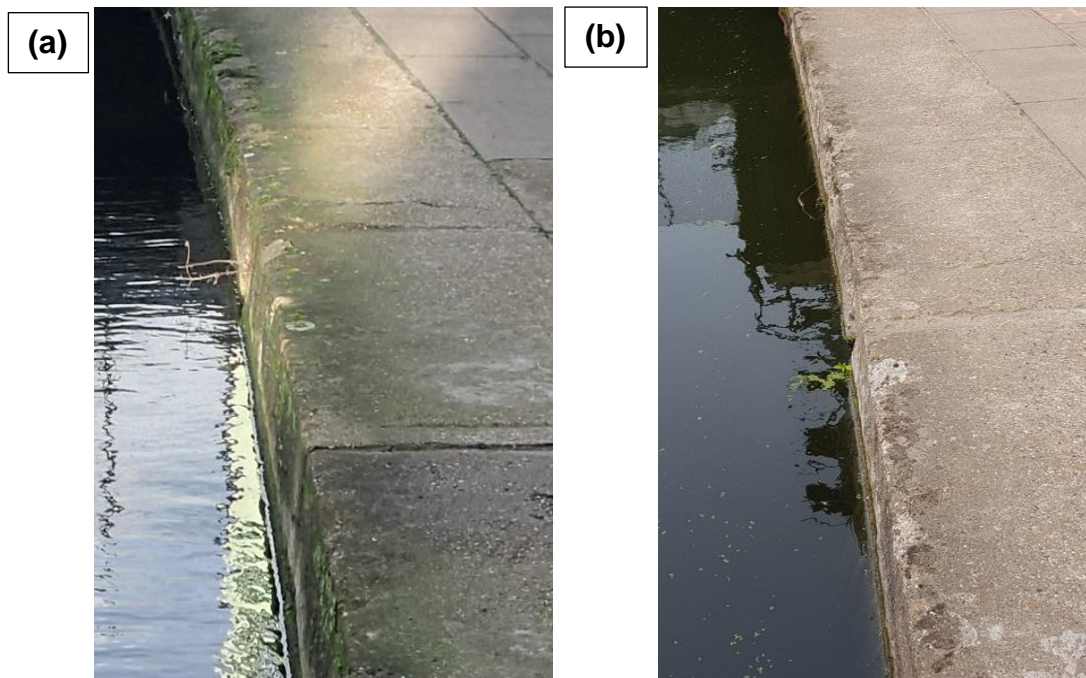
3.2.2 The capping beam extends below the water level and its total height is approximately 70cm. The size and number of cracks observed along the top of the capping beam has not changed, indicating that no significant settlement has occurred as a result of the nearby works. The beam was more damaged however, particularly along its edge. A comparison between the damage to the capping beam is shown in Figure 3.4.

Figure 3.4: Extent of damage to capping beam edge observed during (a) 2019 initial inspection (b) 2022 reinspection

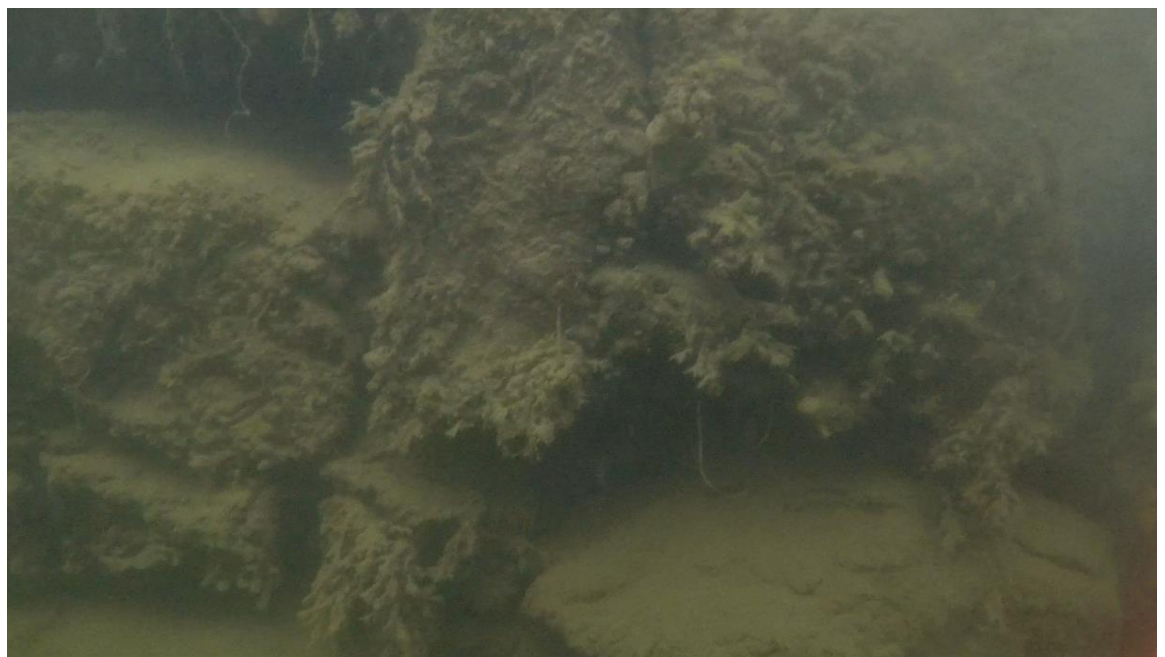
3.2.3 The condition of the masonry blockwork wall was poor during the initial inspection in 2019, with mortar being completely eroded between the blocks in numerous areas. During the reinspection, only a small amount of newly eroded mortar was identified, in the latter half of the section surrounding areas where masonry blocks had already been missing previously.

Figure 3.5: Typical gaps between blockwork due to mortar loss

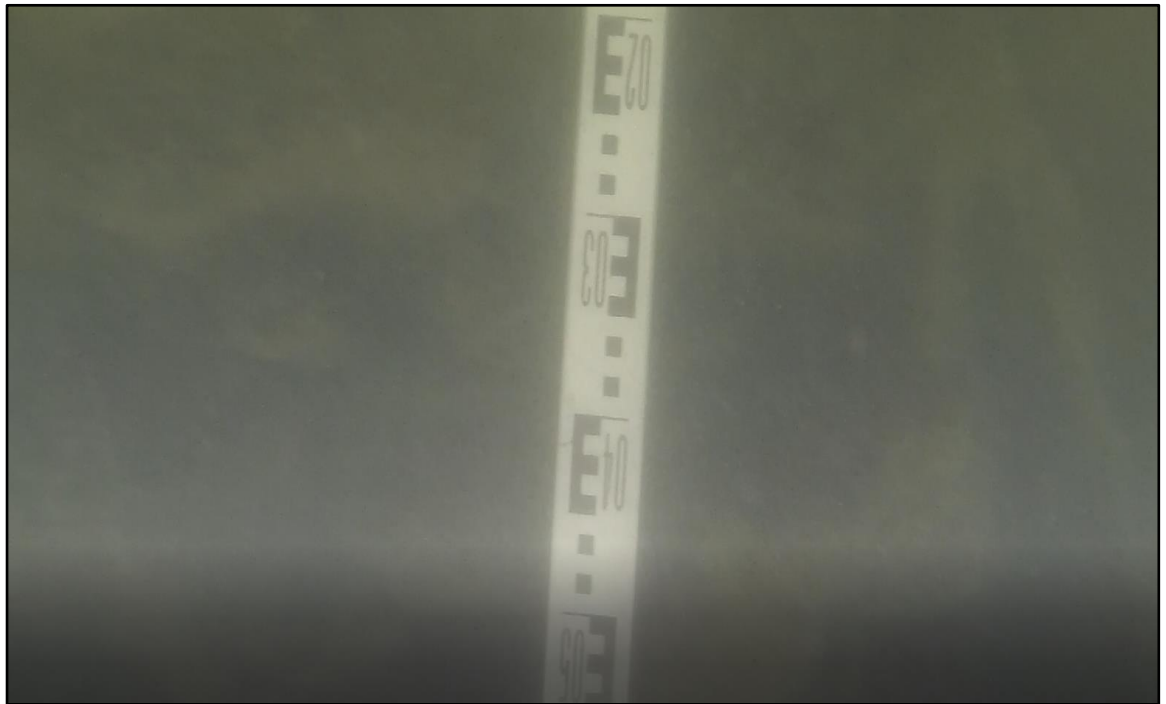
3.2.4 Only one new gap in the masonry wall was identified, thought to be newly missing/displaced masonry, at a chainage of approximately 7 metres. This is

shown in Figure 3.6. The updated locations and dimensions of the gaps are presented in Table 3.1 and in Appendix A. Due to the increased distance from the wall and water depth during the reinspection, slight variations in the observed locations and sizes of the faults identified have arisen between the two inspections. However, these were not deemed significant, and the previously reported values are more conservative; the extent of disrepair of this section is not believed to have worsened significantly over the course of the works.

Figure 3.6: Newly identified gap on the masonry blockwork wall at a chainage of 7m

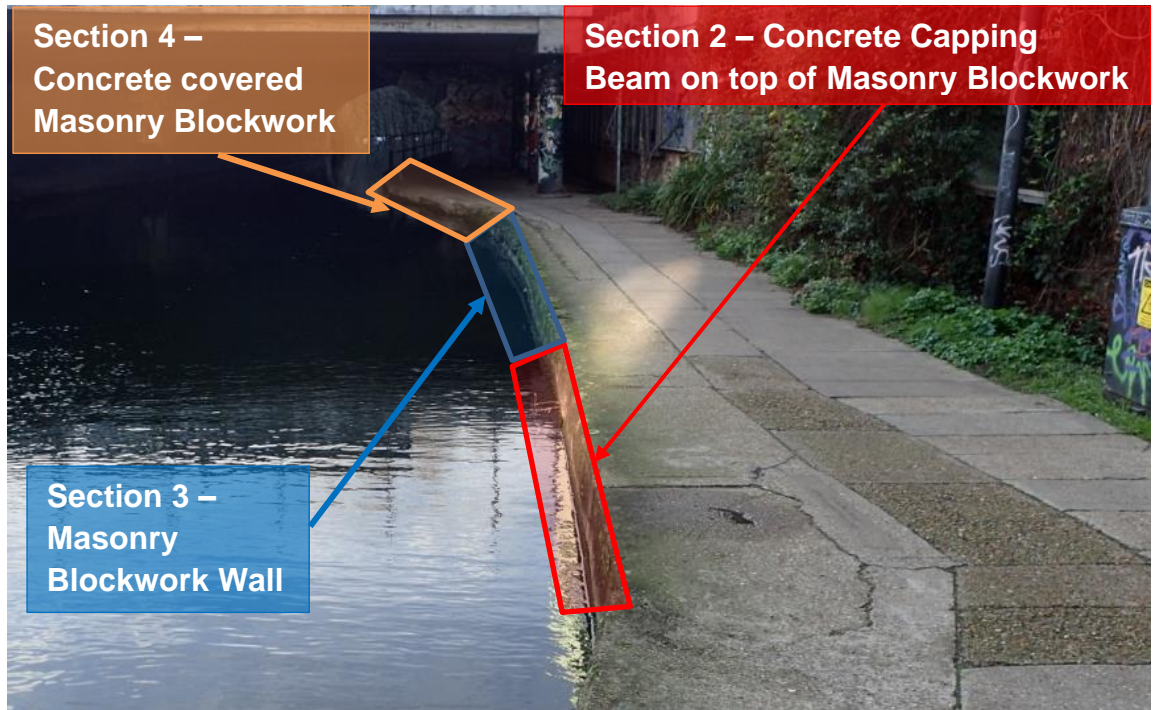
Figure 3.7: Photograph indicating Wall Section 2, 3 & 4

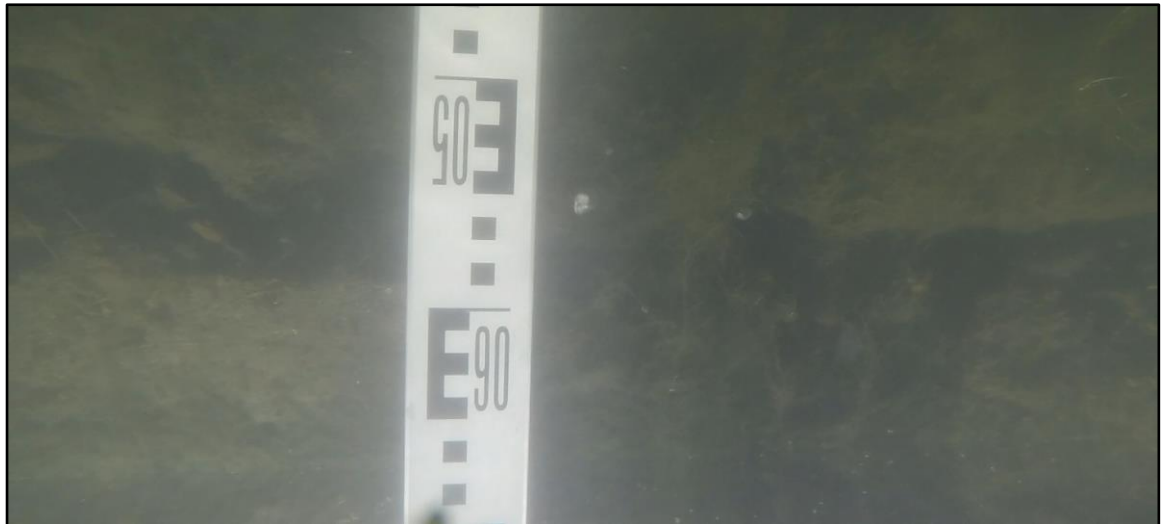
3.3.2 Within Section 3, areas featuring localised poor conditions have been observed across the length of the wall. The mortar between the joints in these areas is completely eroded, leaving large gaps between the blockworks. The amount the missing mortar has increased, particularly within the first 15cm below water surface level. This erosion, originally spanning approximately 2.5m of the section, has developed horizontally and now spans almost the entirety of the section between chainages of 15-24.5m. The typical extent of this localised erosion is shown in Figure 3.8. Mortar erosion was also observed at a lesser extent closer the bed at chainages of approximately 23-24m. The remainder of the wall exhibited only minor signs of erosion and remains in a fair condition.

Figure 3.8: Typical mortar erosion observed across the majority of Section 3.

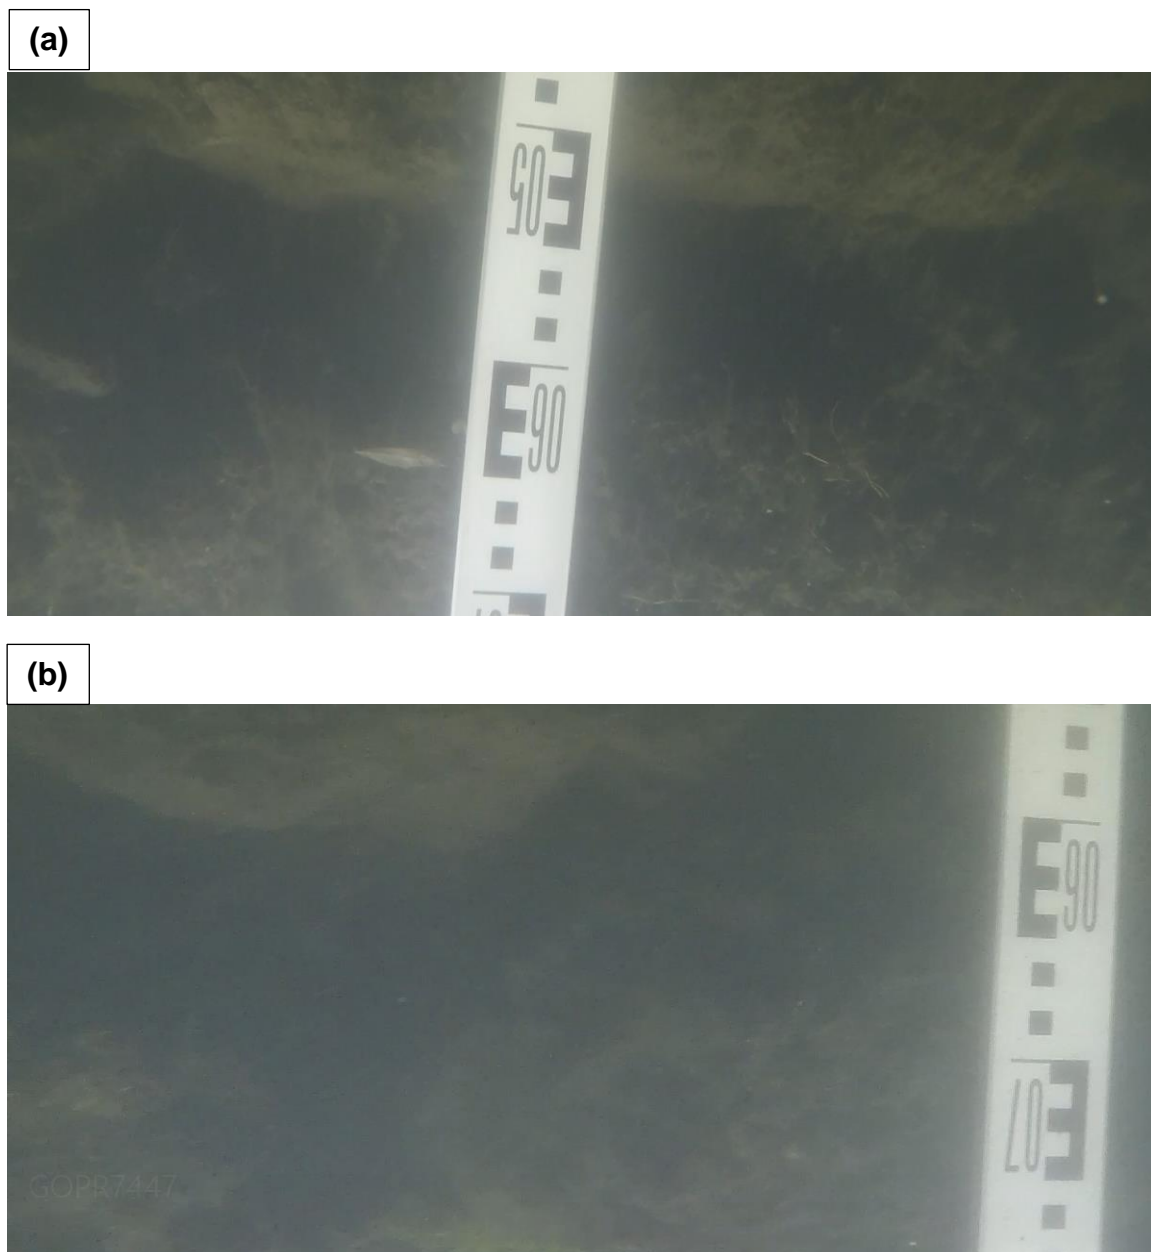
3.3.3 The level of deterioration close to water level was observed to be more severe at chainages 23.5-25m. Whereas the thickness of eroded mortar did not typically exceed 5cm across the section, here the size of the gaps between blocks were approximately 10-12cm tall, occurring at similar depths to the rest of the erosion. These larger gaps are shown in Figure 3.9. With some of the masonry blocks used in this part of the wall being of similar height, it is believed that a few blocks of masonry have been displaced, potentially preceded by erosion of the surrounding mortar. The dimensions and locations of the missing masonry are presented in Table 3.2. The remainder of the section did not feature any missing masonry.

Figure 3.9: Images from recorded footage showing new missing masonry blocks at chainages of (a) 24m and (b) 25m.

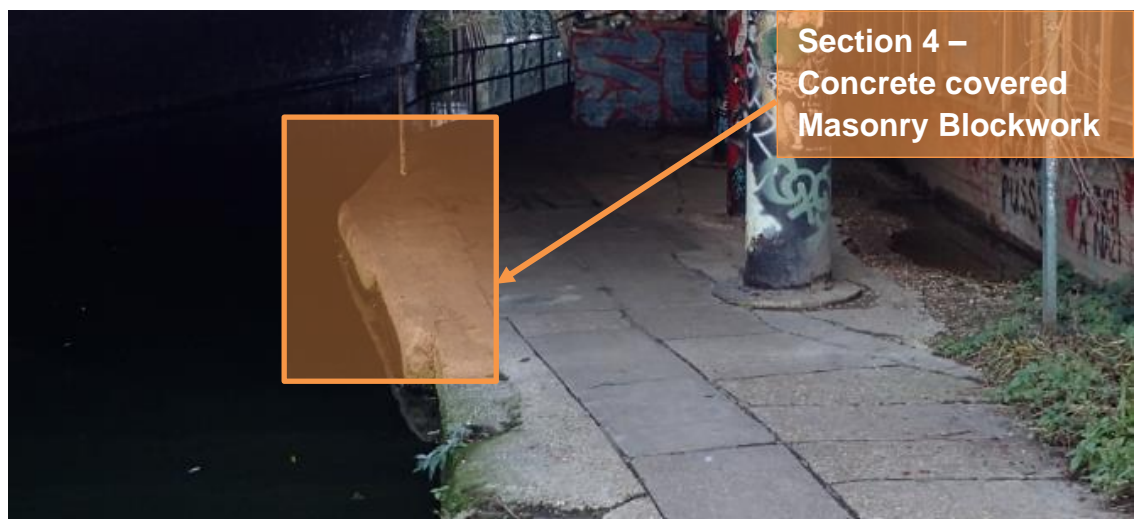
3.4.2 From observations on site, it was assessed that this section of the wall is composed of masonry blockwork structure, with a façade of concrete layered over the front blockwork of the wall. The concrete layer is thought to be approximately 20cm thick.

Figure 3.70: Photograph indicating Section 4 - Concrete covered Masonry Blockwork Wall

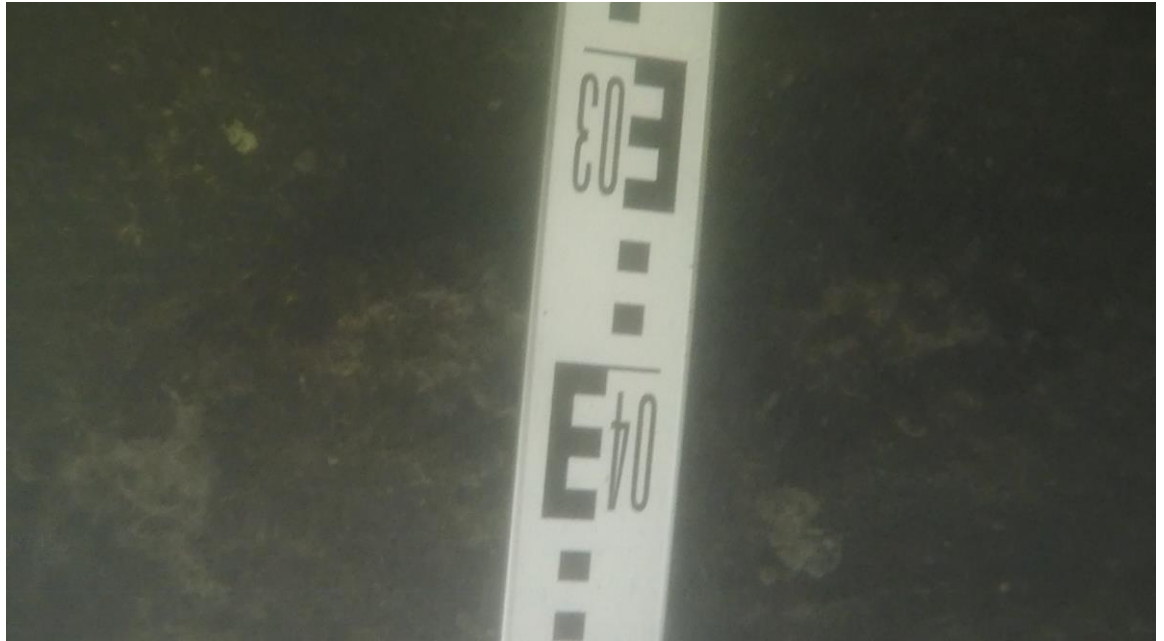
3.4.3 The discontinuity previously observed during the last inspection was identified as shown in Figure 3.1, however due to the increased distance of the camera from the wall and lower visibility closer to the riverbed its size could not be ascertained.

Figure 3.11: Image from video footage showing part of wall where the concrete layer is discontinued, and its thickness is reduced.
