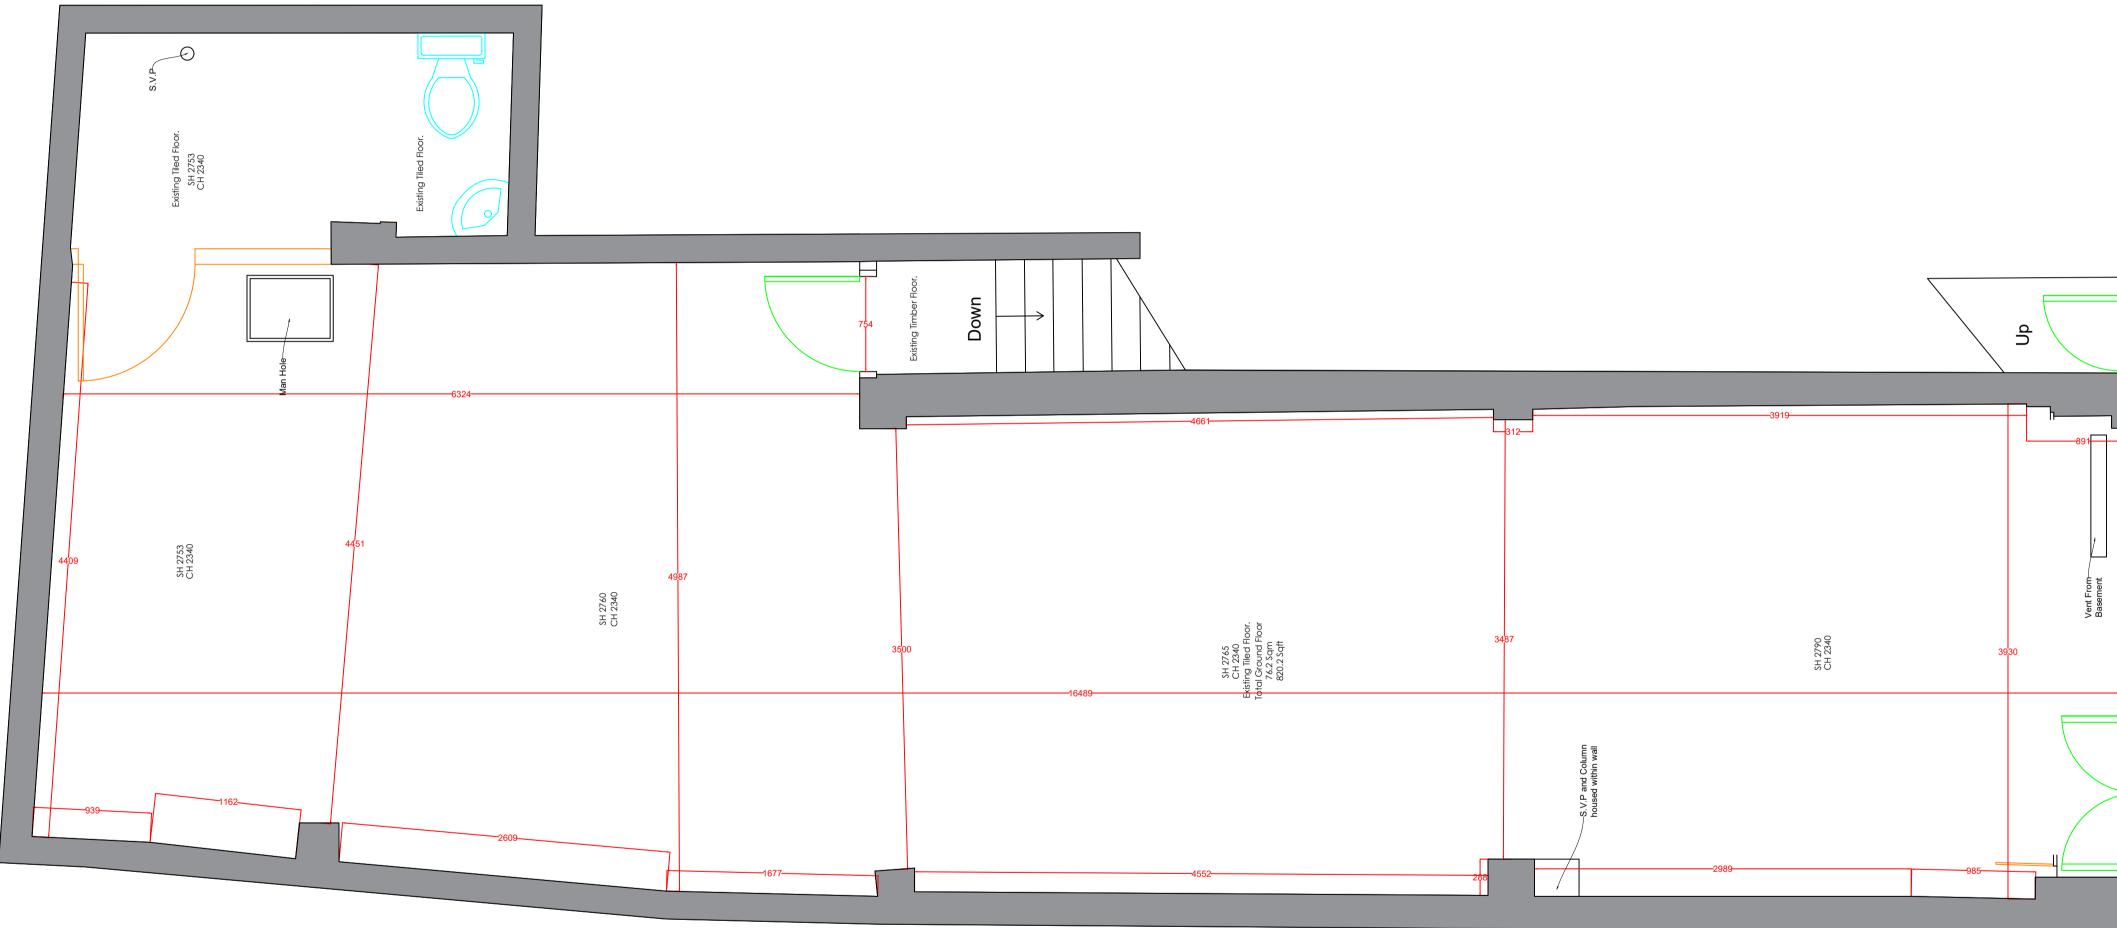
Existing Ground Floor Scale 1:30 @ A1

- FURTHER INVESTIGATION REQUIRED TO ASCERTAIN TRUE EXTENT OF COLUMNS AS HIGHLIGHTED ON THE PLANS.
- SIGNS OF WATER DAMAGE/ DAMP IN BASEMENT AT LOW LEVEL.
- EXISTING SHOP FRONT DOORS HAVE A STEPPED THRESHOLD.
- VENT LOCATED NEAR THE SHOP FRONT BETWEEN GROUND AND • BASEMENT.
