ATWORTH ARBORICULTURE LTD
PICUS TOMOGRAPH TEST ON A HORSE CHESTNUT AT
WESTFIELD HOUSE.

Carry out Picus Tomograph Decay detection test on main stem of Horse Chestnut tree at the location above.

Tree 106.

Horse Chestnut (*Aesculus hippocastanum*). Height 21m Diameter 1050mm

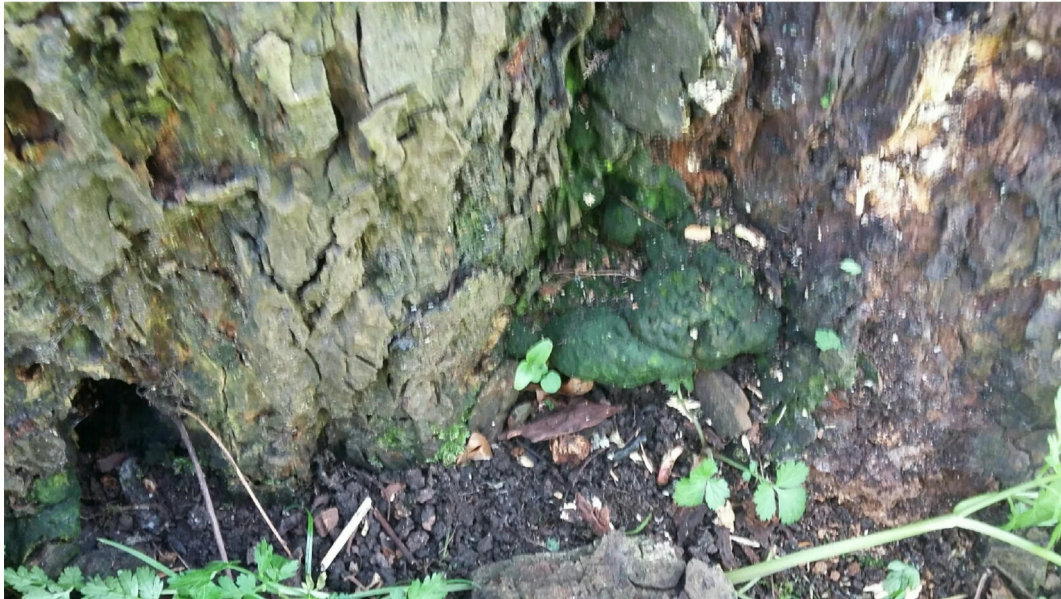
Photo 2.

This mature tree is situated in the communal gardens of Westfield House, with the building 50 metres to the north. The crown has new buds appearing and looks reasonably balanced. There are fungal fruiting bodies of most likely *Rigidoporus ulmarius* erupting at ground level to the north and west (Photo 2), with an area of bark necrosis and decay.

Whilst the tree could be retained in the short term, the long term viability of the tree is questionable. The degradation of the heartwood caused by the growth of the fungus over the past 5 years, indicates that the tree could become hazardous within the next 3-5 years, if the decay advances at the same rate.

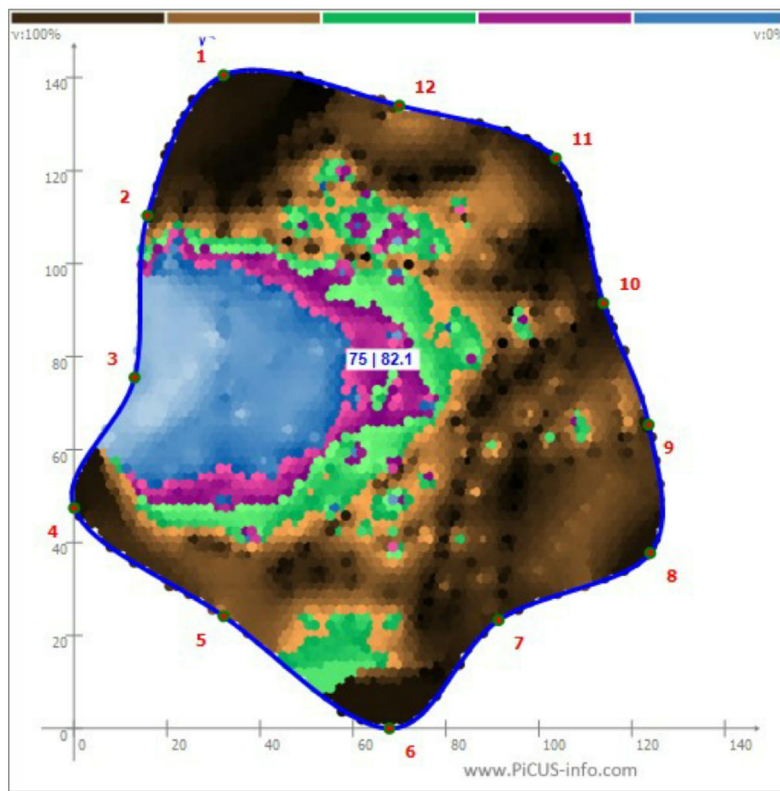
Picus Tomograph result at 10cm above ground level.

The area of decay to the west, with a cavity indicated by the blue colour, and further decay indicated by the purple and green colours, shows a marked increase in severity and size compared to the Picus test that was performed in 2016. (See below).
