KNAPP HICKS & PARTNERS LTD

37740A/L/001A/DALC/dalc
19th November 2021

**RE: COMMUNAL STAIRCASE TO 4 HANDEL STREET, LONDON,
WC1N 1PB.**

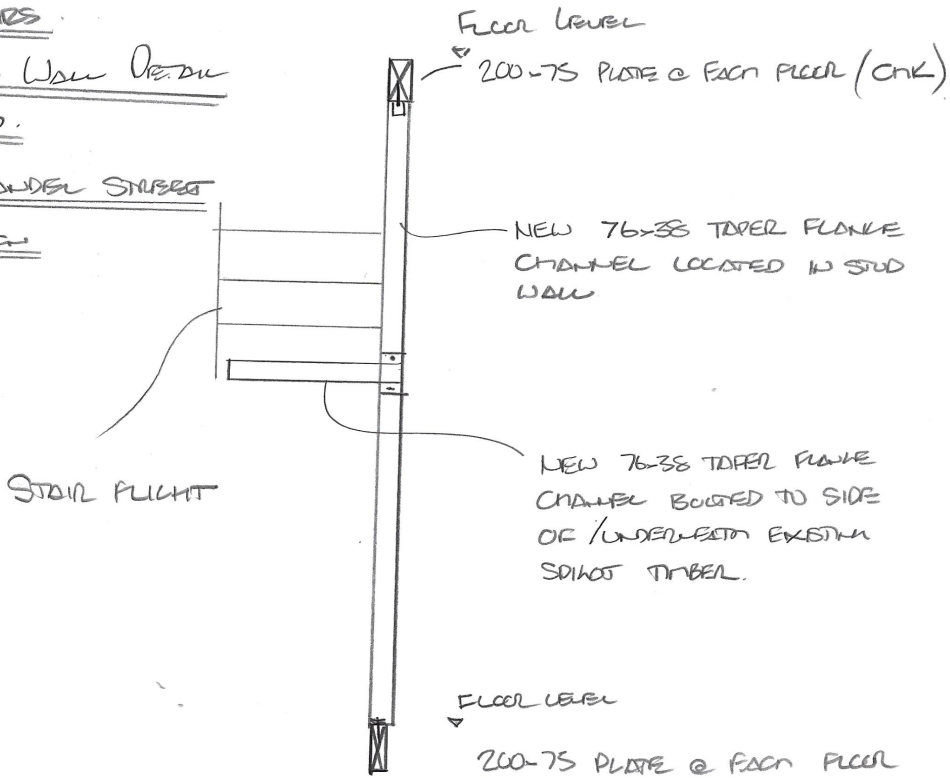
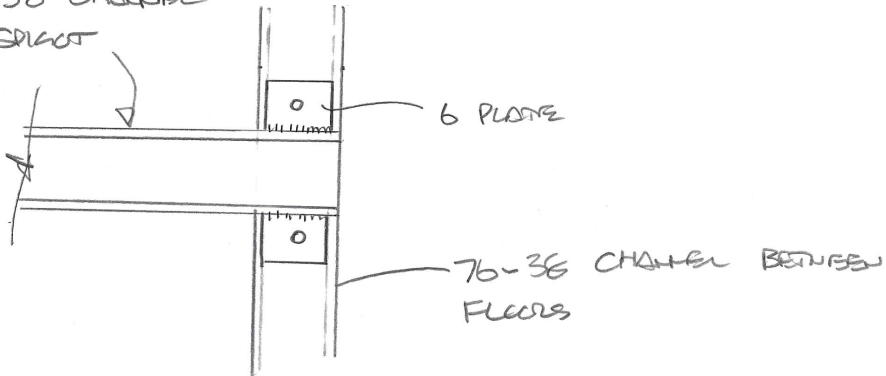
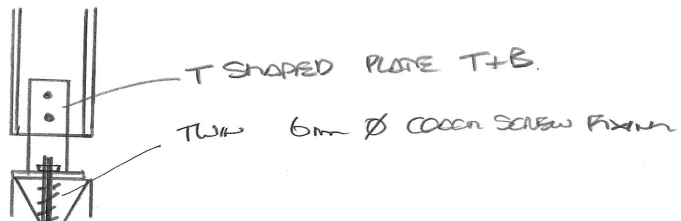
Strengthening of flights adjacent to stud partition wall.

We looked at providing steel sections within the stud wall which would be small enough to fit in the envelope between the sheets of plasterboard. It is possible to still obtain 76x38 Taper Flange Channels. These could be fixed between the 8x2.5inch joists at each floor level and have a spigot attached to support the stair flights, again fabricated from 76x38mm channels. A sketch detail is attached to this report. Some temporary support to the flights would be required while these works are implemented, as this would compromise the existing support at the end of the stair flights

Subject to further opening up works we can provide spigots of sufficient strength to support the stair flights adjacent to the stud wall.
