Arboricultural Appraisal Report

Subsidence Damage Investigation at:

52 Fellows Road
London
NW3 3LJ

CLIENT:	Crawford & Company
CLIENT REF:	 
MWA REF:	
MWA CONSULTANT:	Andy Clark
REPORT DATE:	04/10/2021

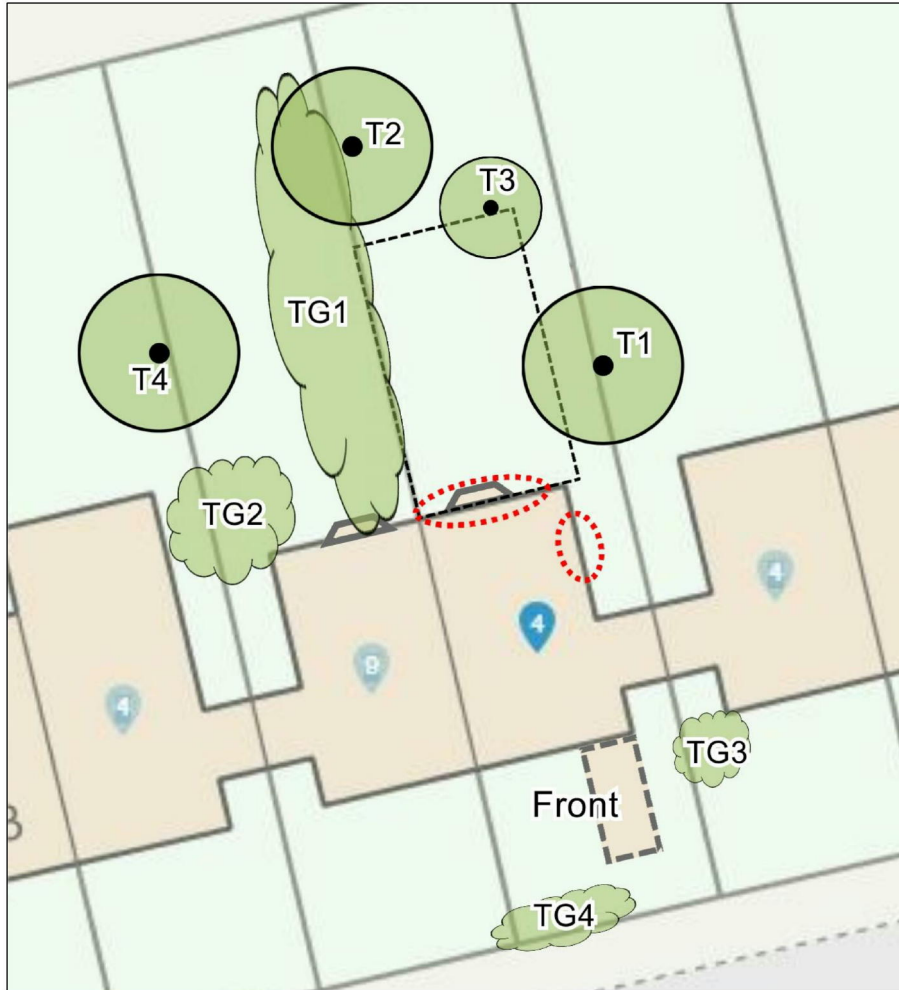
Site Plan

Approximate areas of damage
