Arboricultural Appraisal Report

Subsidence Damage Investigation at:

52 Fellows Road
London
NW3 3LJ

CLIENT: Crawford & Company
 CLIENT REF: [REDACTED]
 MWA REF: [REDACTED]
 MWA CONSULTANT: Andy Clark
 REPORT DATE: 04/10/2021

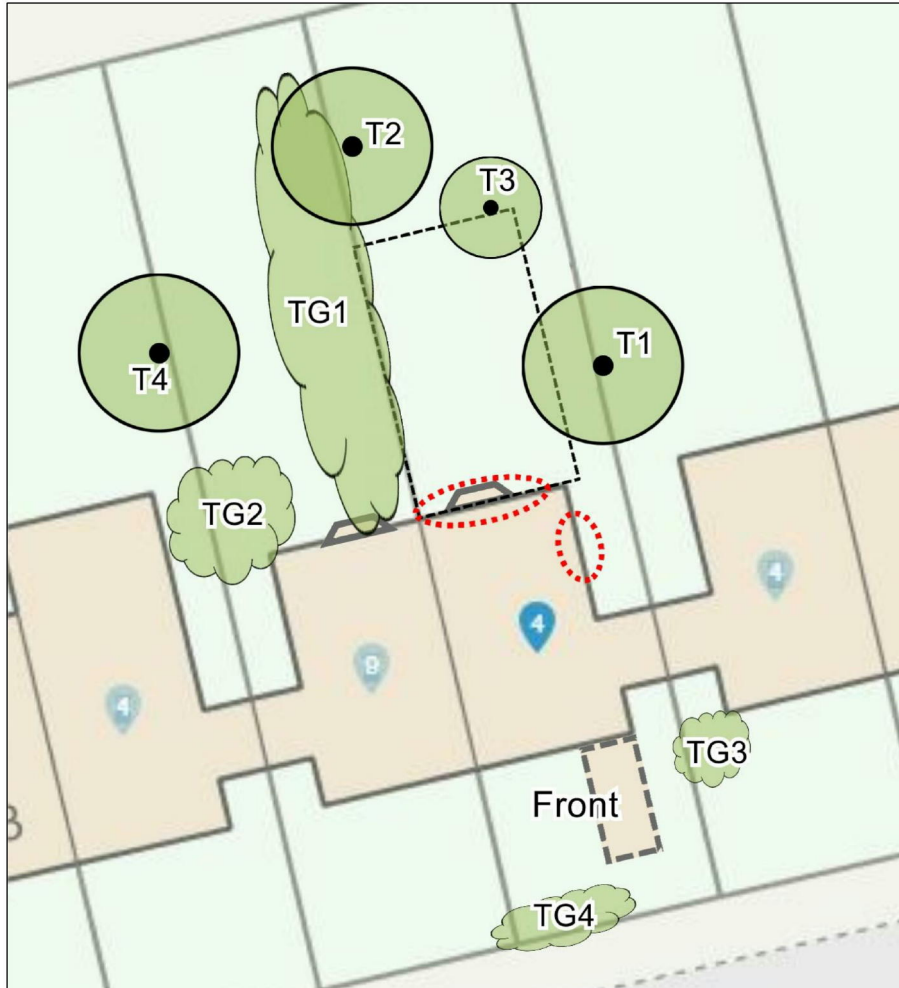
Site Plan

Approximate areas of damage

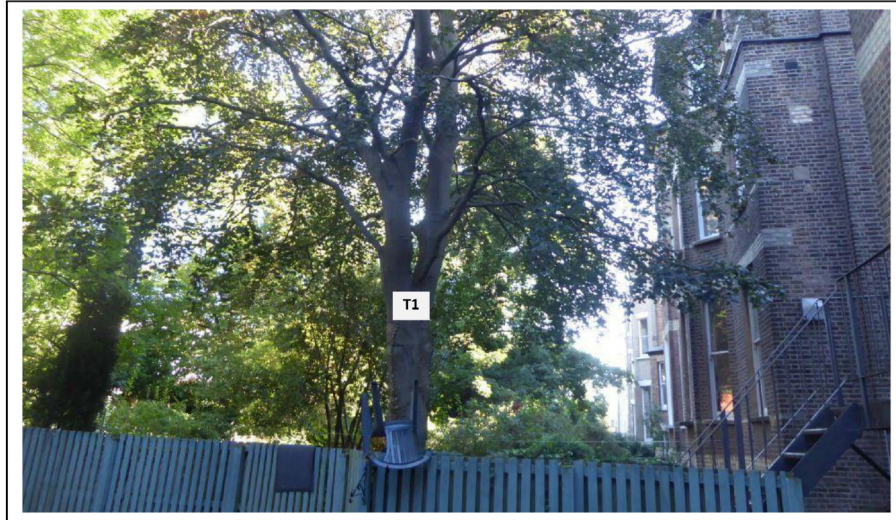
Our survey has identified vegetation within influencing distance of the building with a current potential to influence soil volumes below foundation level; the most significant of which in relation to the current damage are T1 Beech, T2 Poplar and T3 Ash.

View of T1 Beech

If an arboricultural solution is to be implemented to mitigate the influence of the trees/shrubs considered to be responsible for the damage we recommend that T1 Beech, T2 Poplar and T3 Ash are removed. Other vegetation recorded presents a potential future risk to building stability and management is therefore recommended. Recommended tree works may however be subject to change upon receipt of additional information.

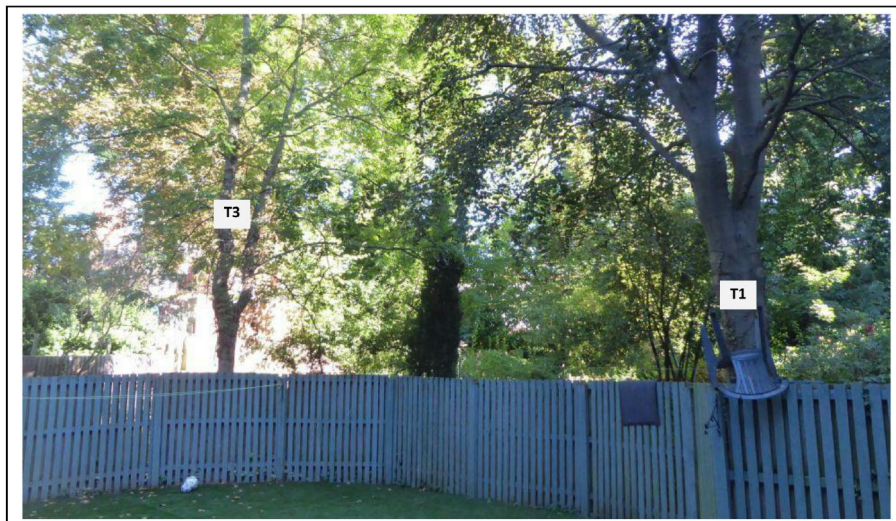
View of T1 Beech and T3 Ash

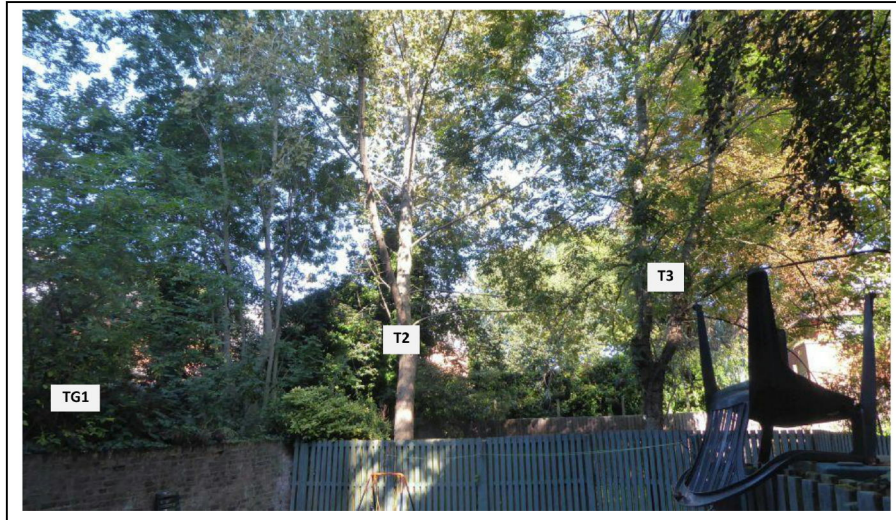
View of T2 Poplar, T3 Ash, with TG1 group visible to left of frame

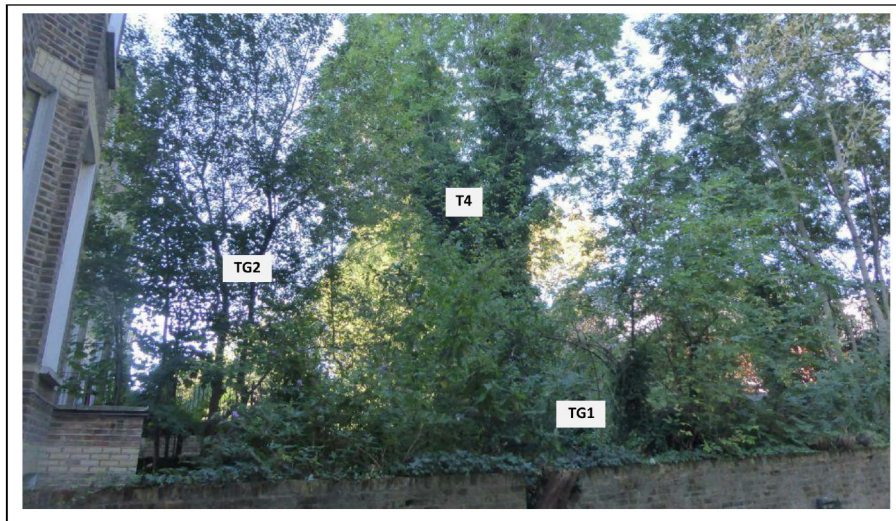
View of T4 Ash and TG2 group, with TG1 group visible to foreground
