### Level and Crack Monitoring

| Address: | 70 - 75 Auden Place |
| Town: | LONDON |
| Post Code: | NW1 8ND |

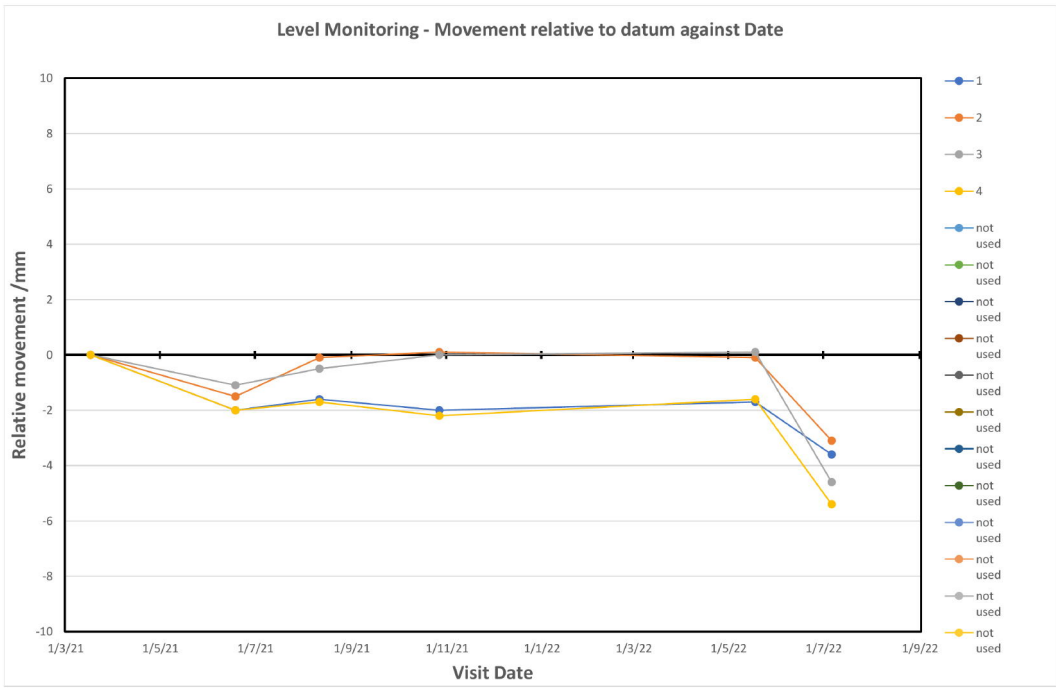
| Reading Date | 17/3/21 | 18/6/21 | 11/8/21 | 27/10/21 | 18/5/22 | 6/7/22 | 26/8/22 | | | | | |
|---|---|---|---|---|---|---|---|---|---|---|---|---|
| 1 | 10.8844 | 10.8824 | 10.8828 | 10.8824 | 10.8827 | 10.8808 | 10.8777 | | | | | |
| 2 | 10.7960 | 10.7945 | 10.7959 | 10.7961 | 10.7959 | 10.7929 | 10.7815 | | | | | |
| 3 | 11.2411 | 11.2400 | 11.2408 | 11.2411 | 11.2412 | 11.2365 | 11.2280 | | | | | |
| 4 | 11.3191 | 11.3171 | 11.3174 | 11.3169 | 11.3175 | 11.3137 | 11.3025 | | | | | |

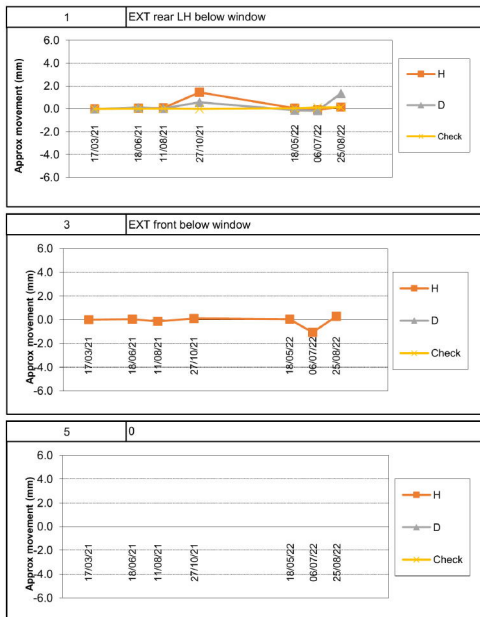
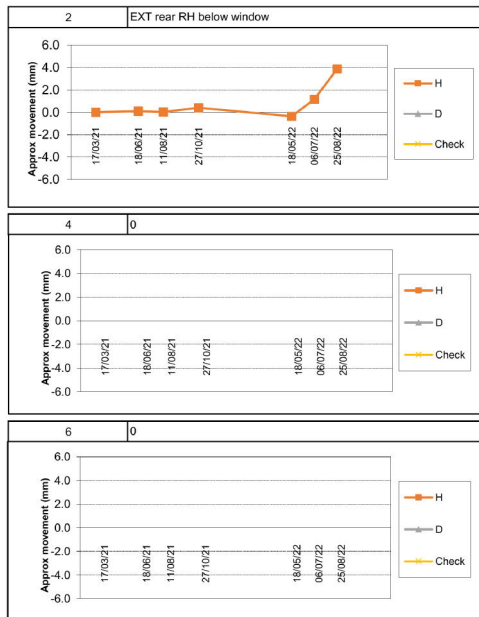
**Crack Monitoring - Movement Against Time**

| Studs nos | Align-ment | Visit Date | 17/03/21 | Visit Date | 18/05/21 | Visit Date | 11/06/21 | Visit Date | 27/10/21 | Visit Date | 18/05/22 | Visit Date | 06/07/22 |
|---|---|---|---|---|---|---|---|---|---|---|---|---|---|
| 1 | H | 52.09 | 1.08 | 52.16 | 1.17 | 52.17 | 1.15 | 53.63 | 1.67 | 52.14 | 1.50 | 52.00 | 1.55 |
| 1 | D | 91.61 | 1.82 | 91.73 | 1.93 | 91.65 | 1.89 | 92.19 | 2.45 | 91.49 | 2.30 | 91.45 | 2.37 |
| 2 | H | 74.73 | 0.78 | 74.62 | 0.85 | 74.75 | HL | 75.13 | HL | 74.36 | HL | 75.67 | 2.12 |
| 3 | H | 65.58 | HL | 65.63 | HL | 65.44 | 1.05 | 65.69 | 1.35 | 65.63 | 1.40 | 64.61 | 1.20 |
