<b>P.H.D. ASSOCIATES</b> ARCHITECTS BREXKVAH HOUSE WATER LAKE WATFORD M20 8BQ TEL: 01279 817342 MAIL: PHD@PHDASSOCIATES.CO.UK	Project Oxford House 23 Wick Place, London W1C1 9RE	Date 22-06-2022
	Drawing Repairs to Mansard Roof and Bedroom Floor	Drawn By SHD

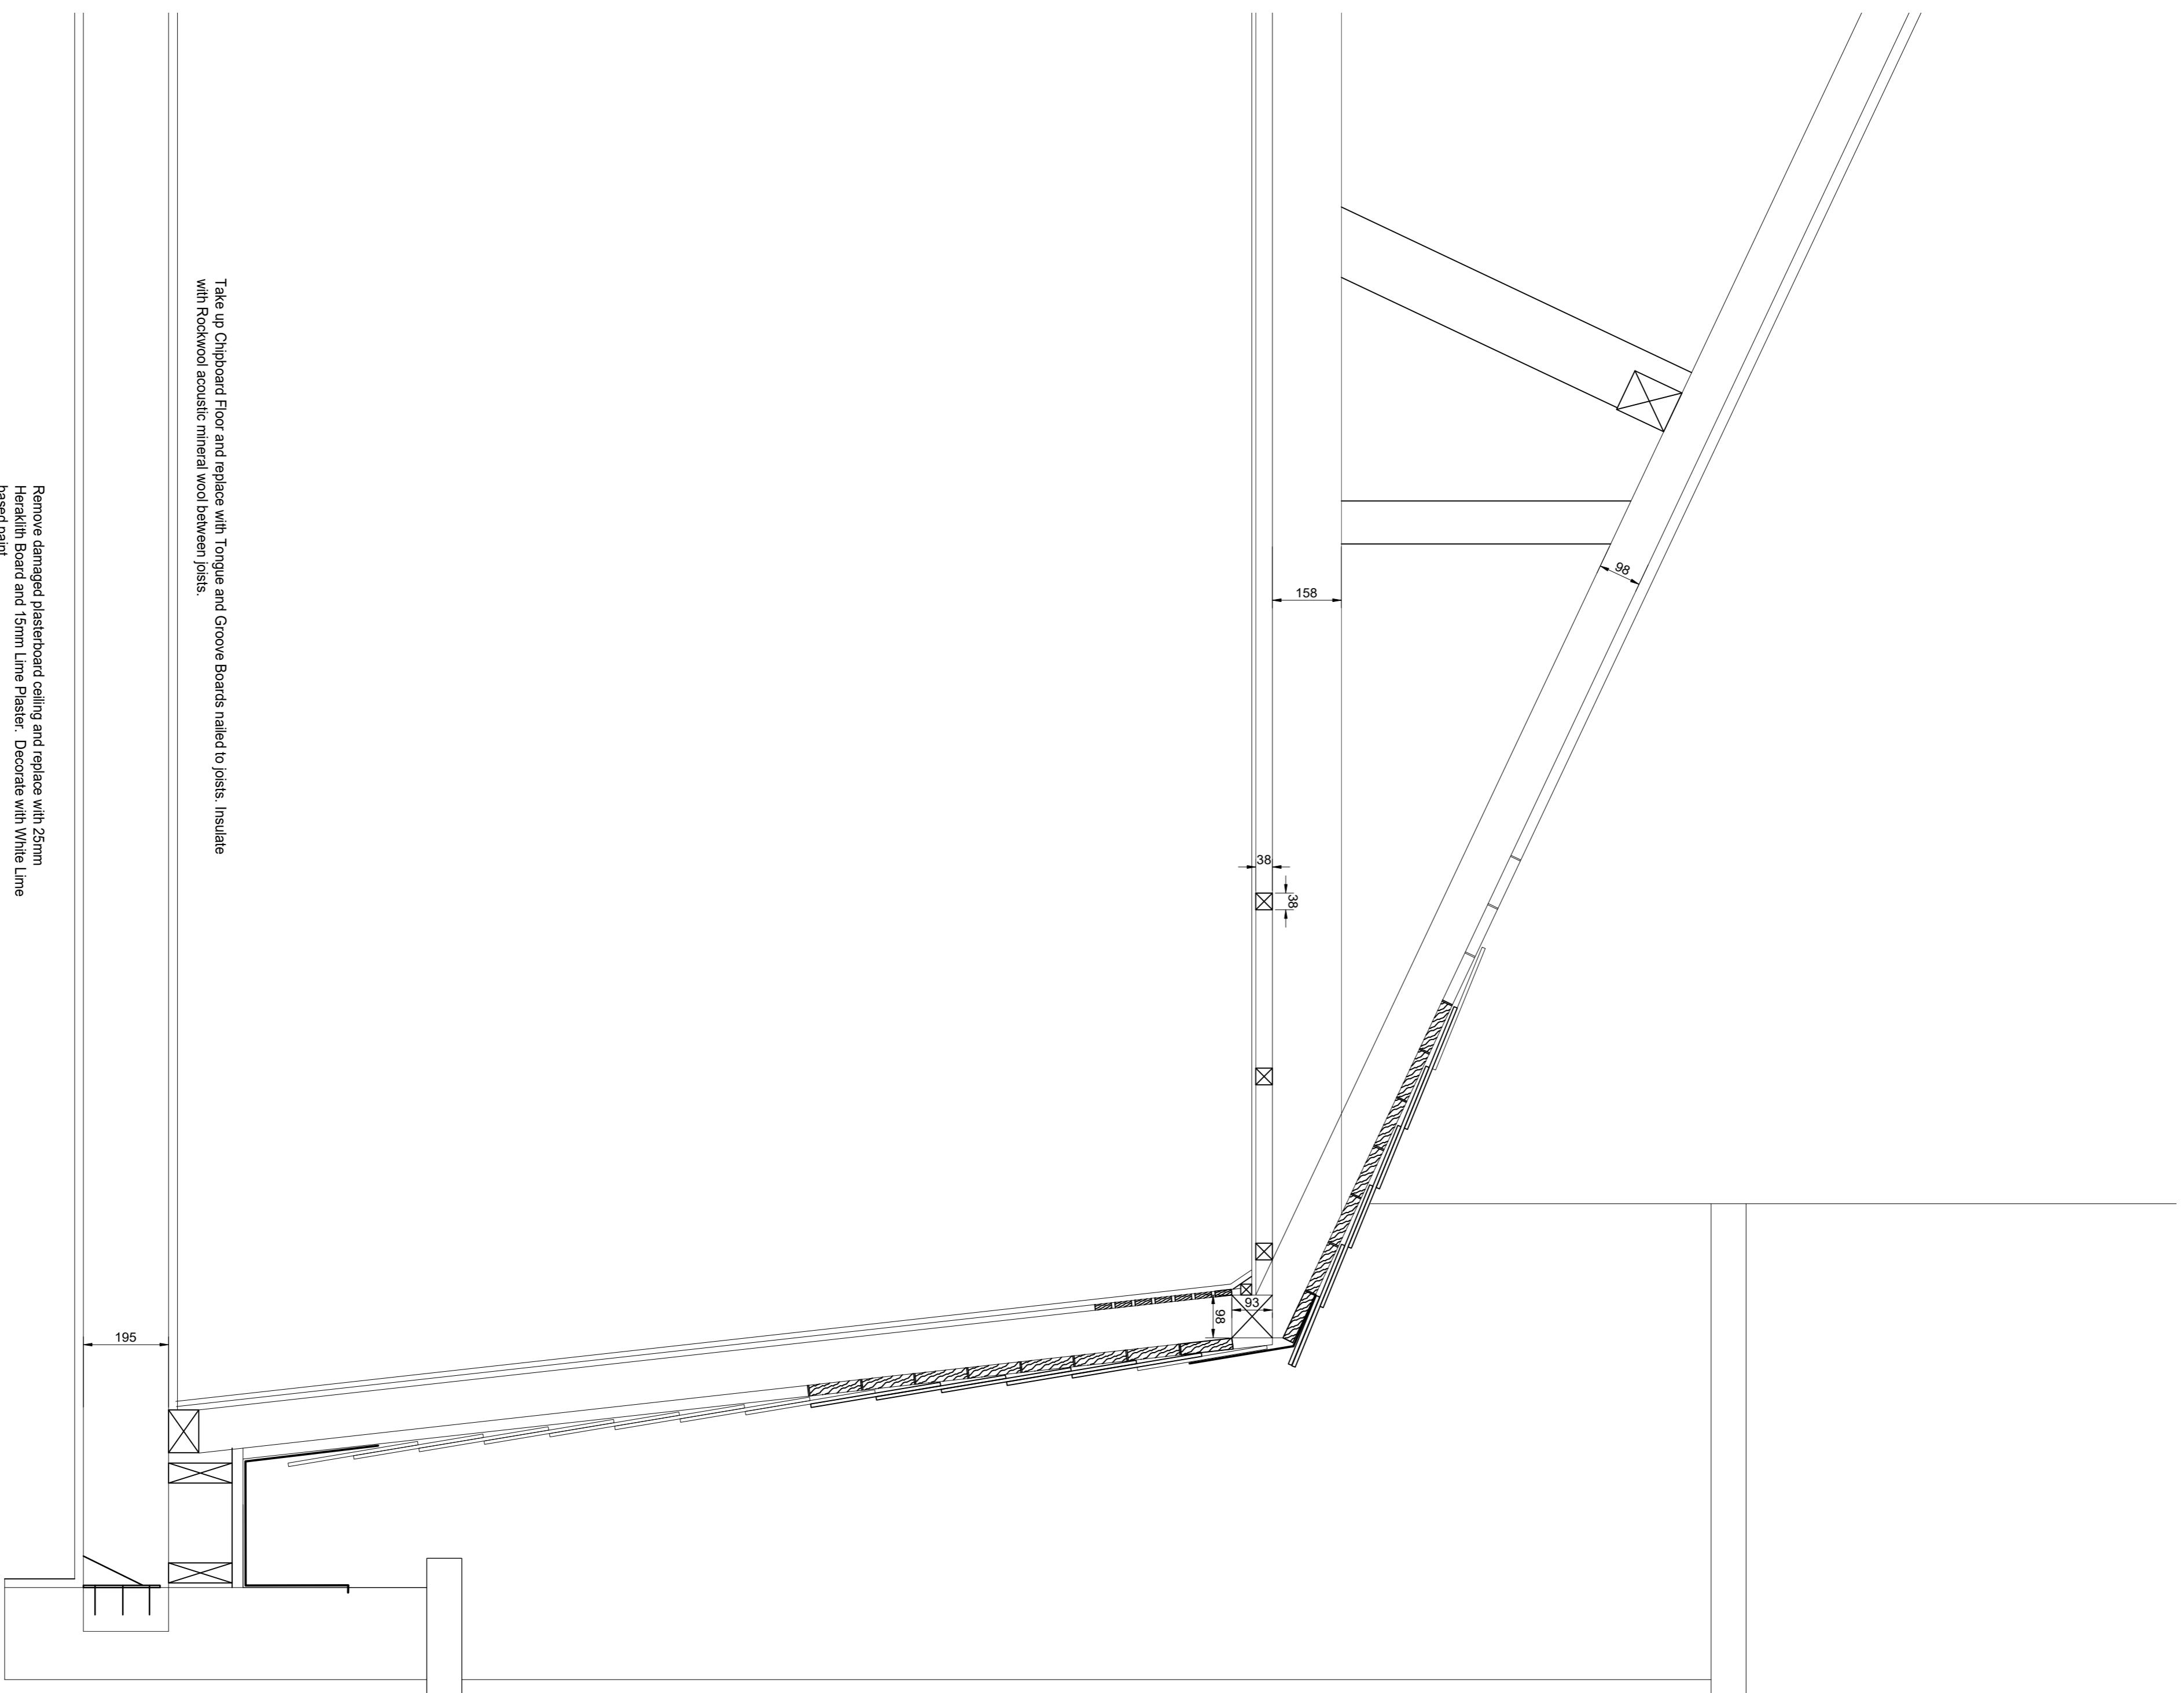
Cause of damage to internal finishes is broken and missing slates at the junction of the roof and mansard. The lead flashing has slipped and requires replacing along with the broken slates.

Internal face of Mansard is left and plaster. Many laths have suffered from water ingress and the lime plaster has become very friable and needs to be removed and replaced with reinforced plaster. Alternatively remove all laths and insulate between studs with Rockwool Mineral Wool and refine the mansard with Herakith board and apply lime plaster finish.

Ceiling has been replaced with 9mm plasterboard fixed to 38x38 counterbattens nailed to ceiling joists. Remove 9mm boards and apply 25mm Herakith board and 15mm Lime Plaster finish.

Box gutters and outlets are sound and require no repairs. Box gutter discharges to uPVC hopper and downpipe.

Ceiling in bedroom below Mansard room has been lost due to water ingress. Existing joists are sound but some have had additional timbers added alongside the existing. Propose to retain the existing and added timbers and install new treated timber joists in between the existing joists spanning from the load bearing inner partition to the external wall. Existing joists are built into the brick wall. New joists to be supported at the external brick wall on Simpson Strong Tie resin fixed joist hangers backed with DPC to protect sawn ends of new joists.

Take up Chipboard Floor and replace with Tongue and Groove Boards nailed to joists. Insulate with Rockwool acoustic mineral wool between joists.

Remove damaged plasterboard ceiling and replace with 25mm Herakith Board and 15mm Lime Plaster. Decorate with White Lime based paint.

Slates are Welsh Blue-Grey laid 600 wide to 300mm course using 600x600 slates nailed to sarking boards with no sarking felt. Remove broken slates and replace with matching new or salvaged matching slates nailed to existing sarking boards. Supply and fix new Code 5 lead flashing extending at least one board width under bottom courses of slates and nailed to sarking board. Dress flashing down over top course of slates to overlap at least 2 courses of slates by min 75mm. Bottom edge of lead to be fixed with Code 6 lead clips nailed to sarking boards between slates.

Insulate roof space with min 300mm Rockwool mineral wool laid in min 2 layers at 90 degrees, first layer laid between ceiling joists, 2nd layer laid over.

Clean and repoint existing lead gutter and outlet. Remove uPVC Hopper and Downpipe and replace with Cast Iron Black Painted Hopper and Downpipe.
