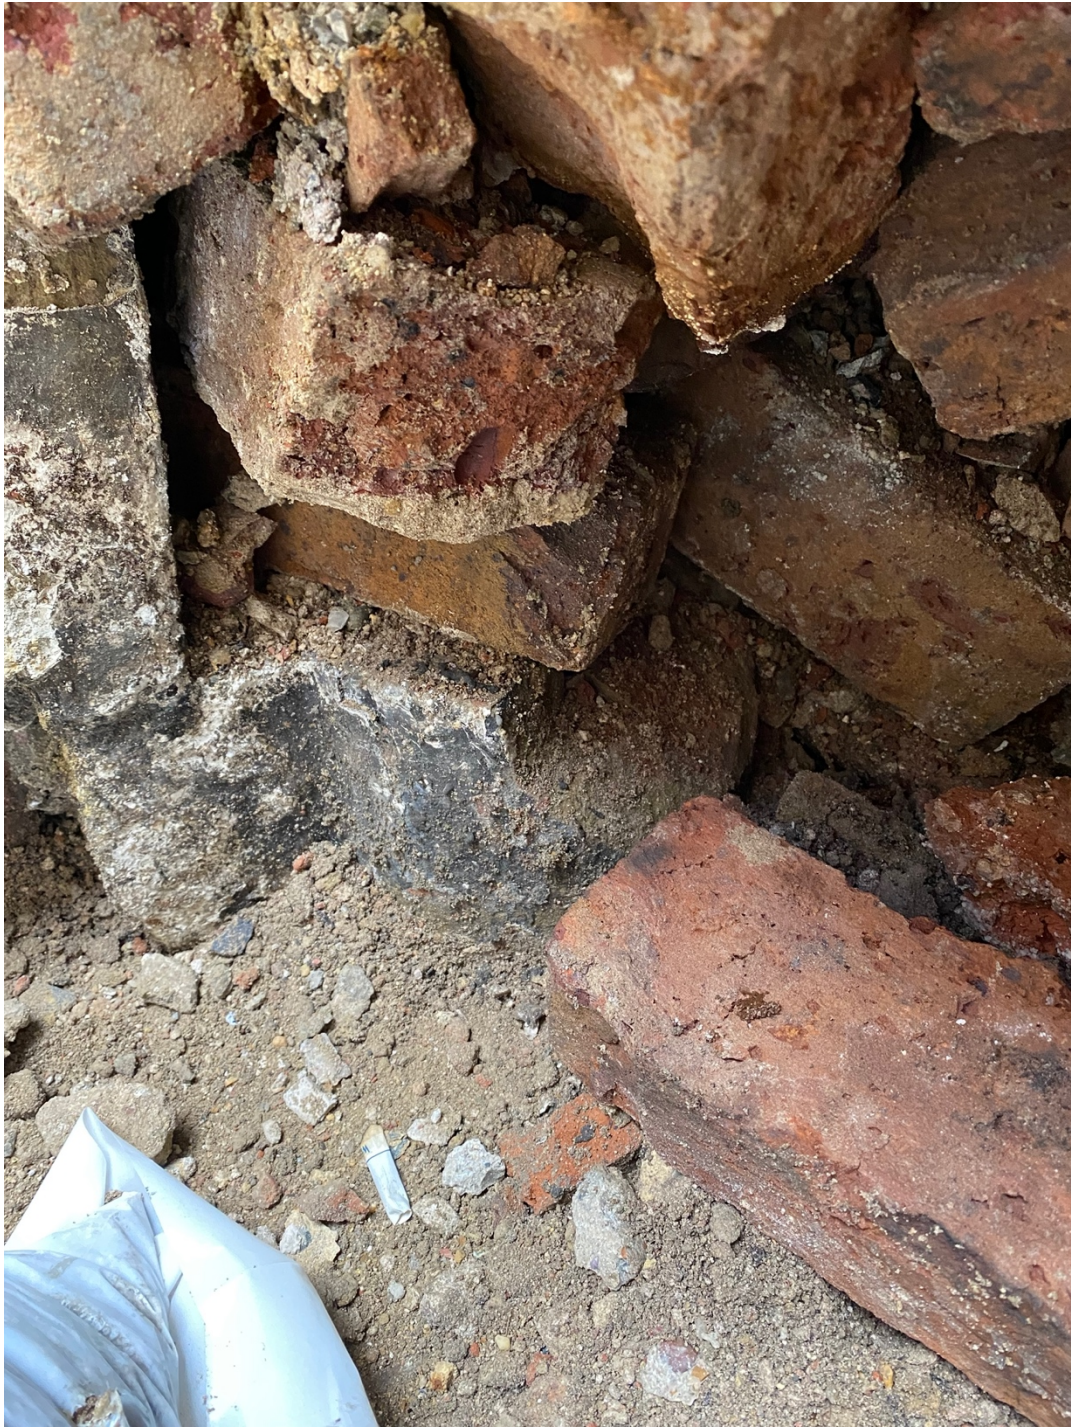
Photo 1: Original buried bottom step to existing stair, with non-original brick back fill

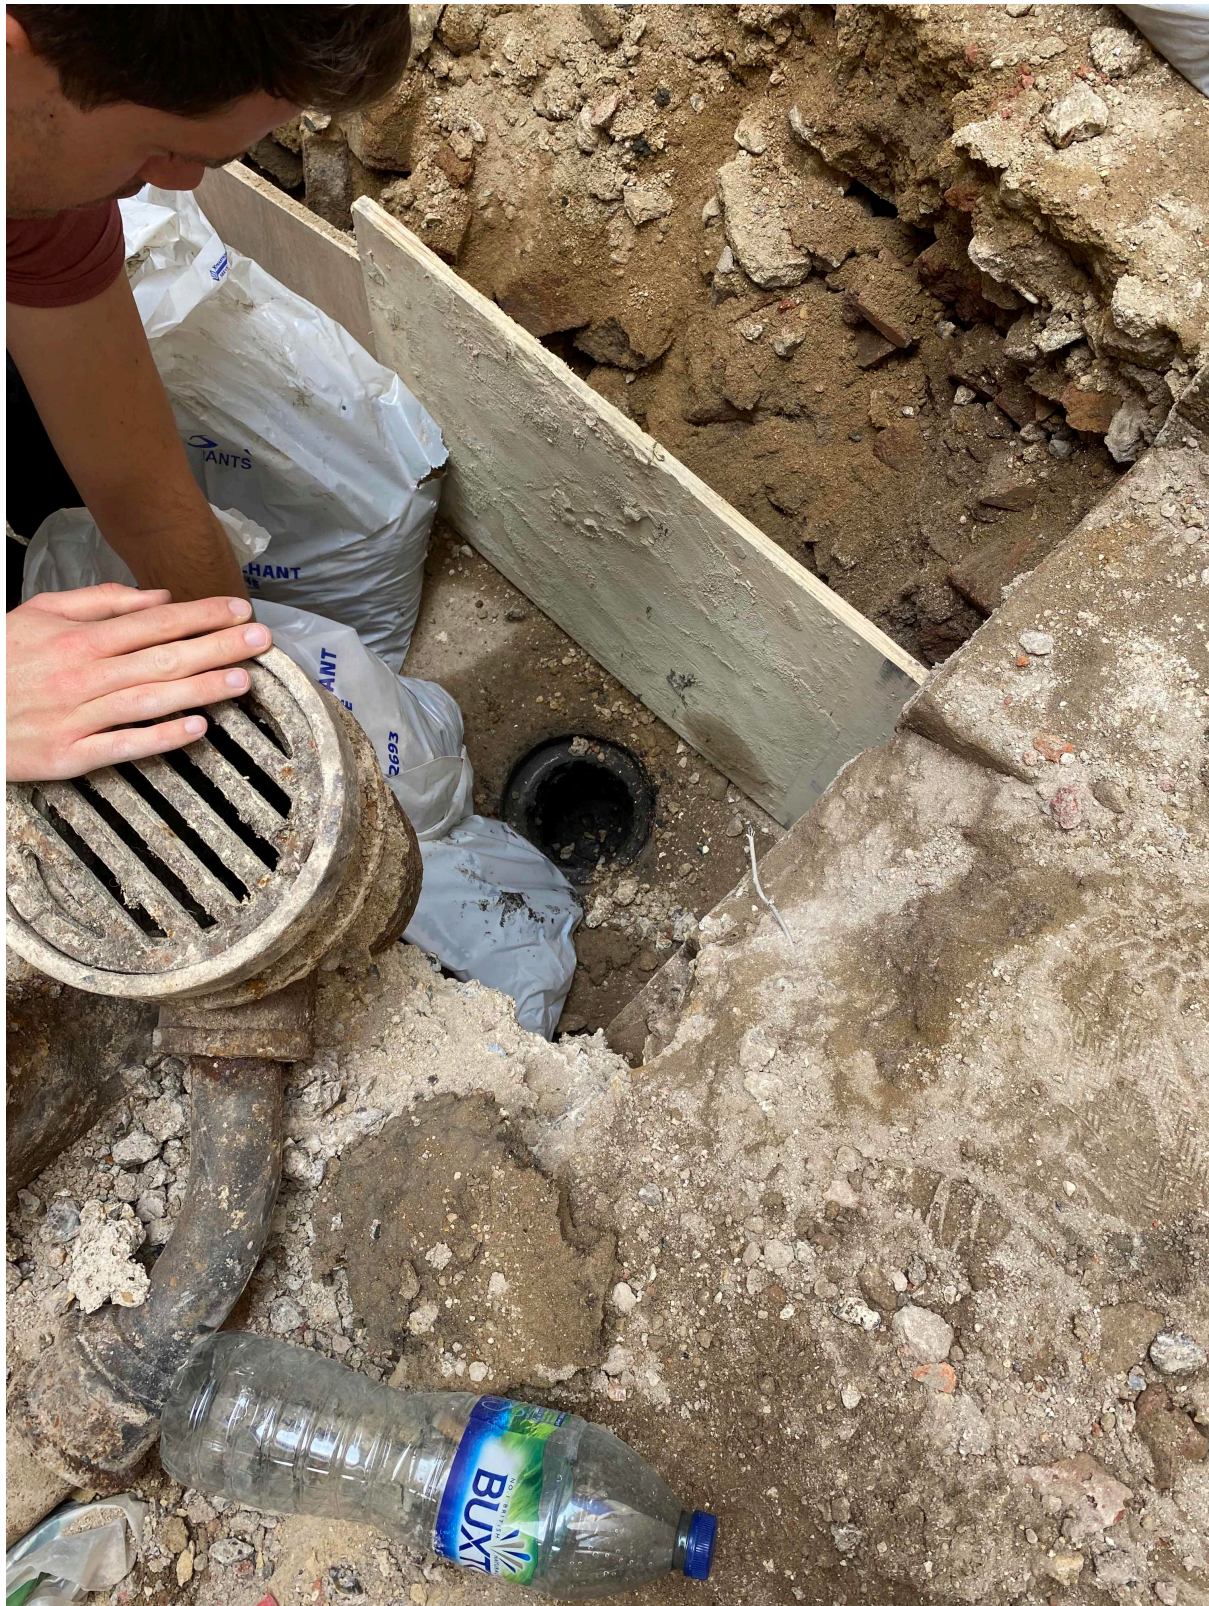
Photo 2: Original historic buried gully in comparison with non-original gully showing difference in level, with non-original back fill surrounding

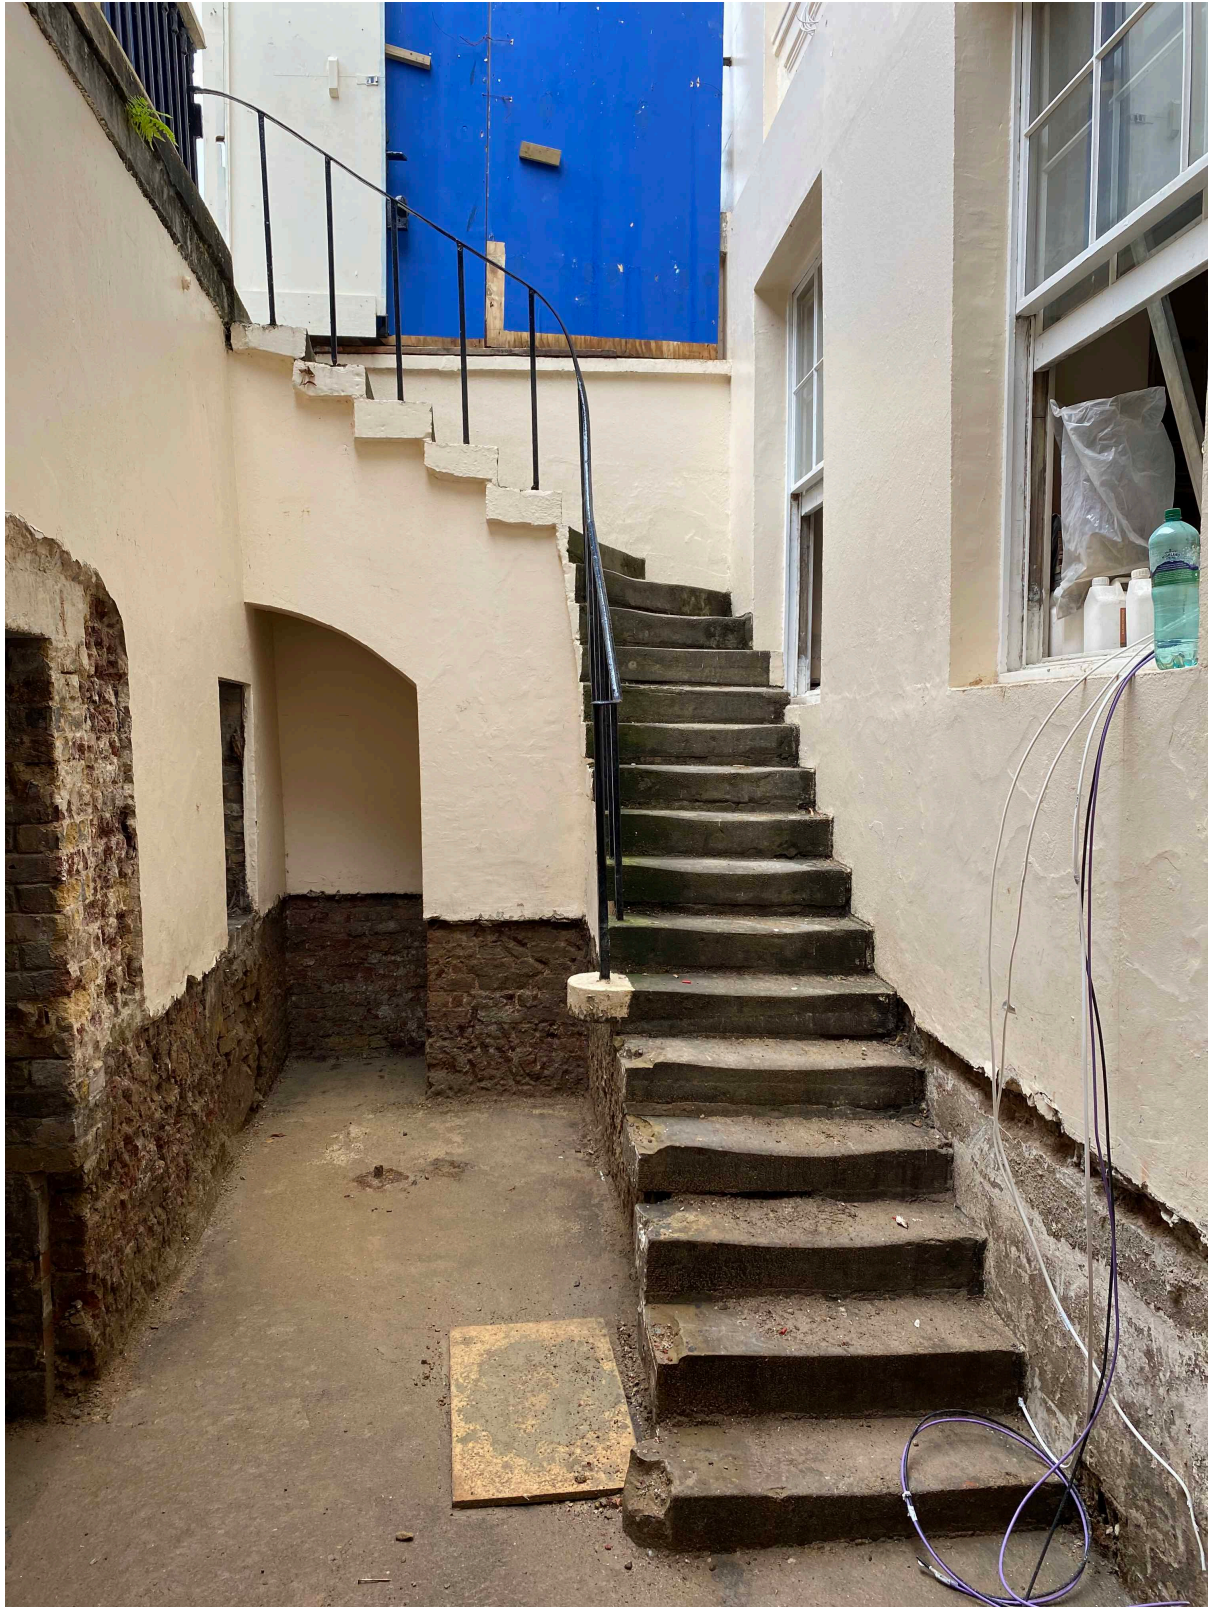
Photo 3: Non-original back fill removed, exposing full length of original historic stair and original concrete slab

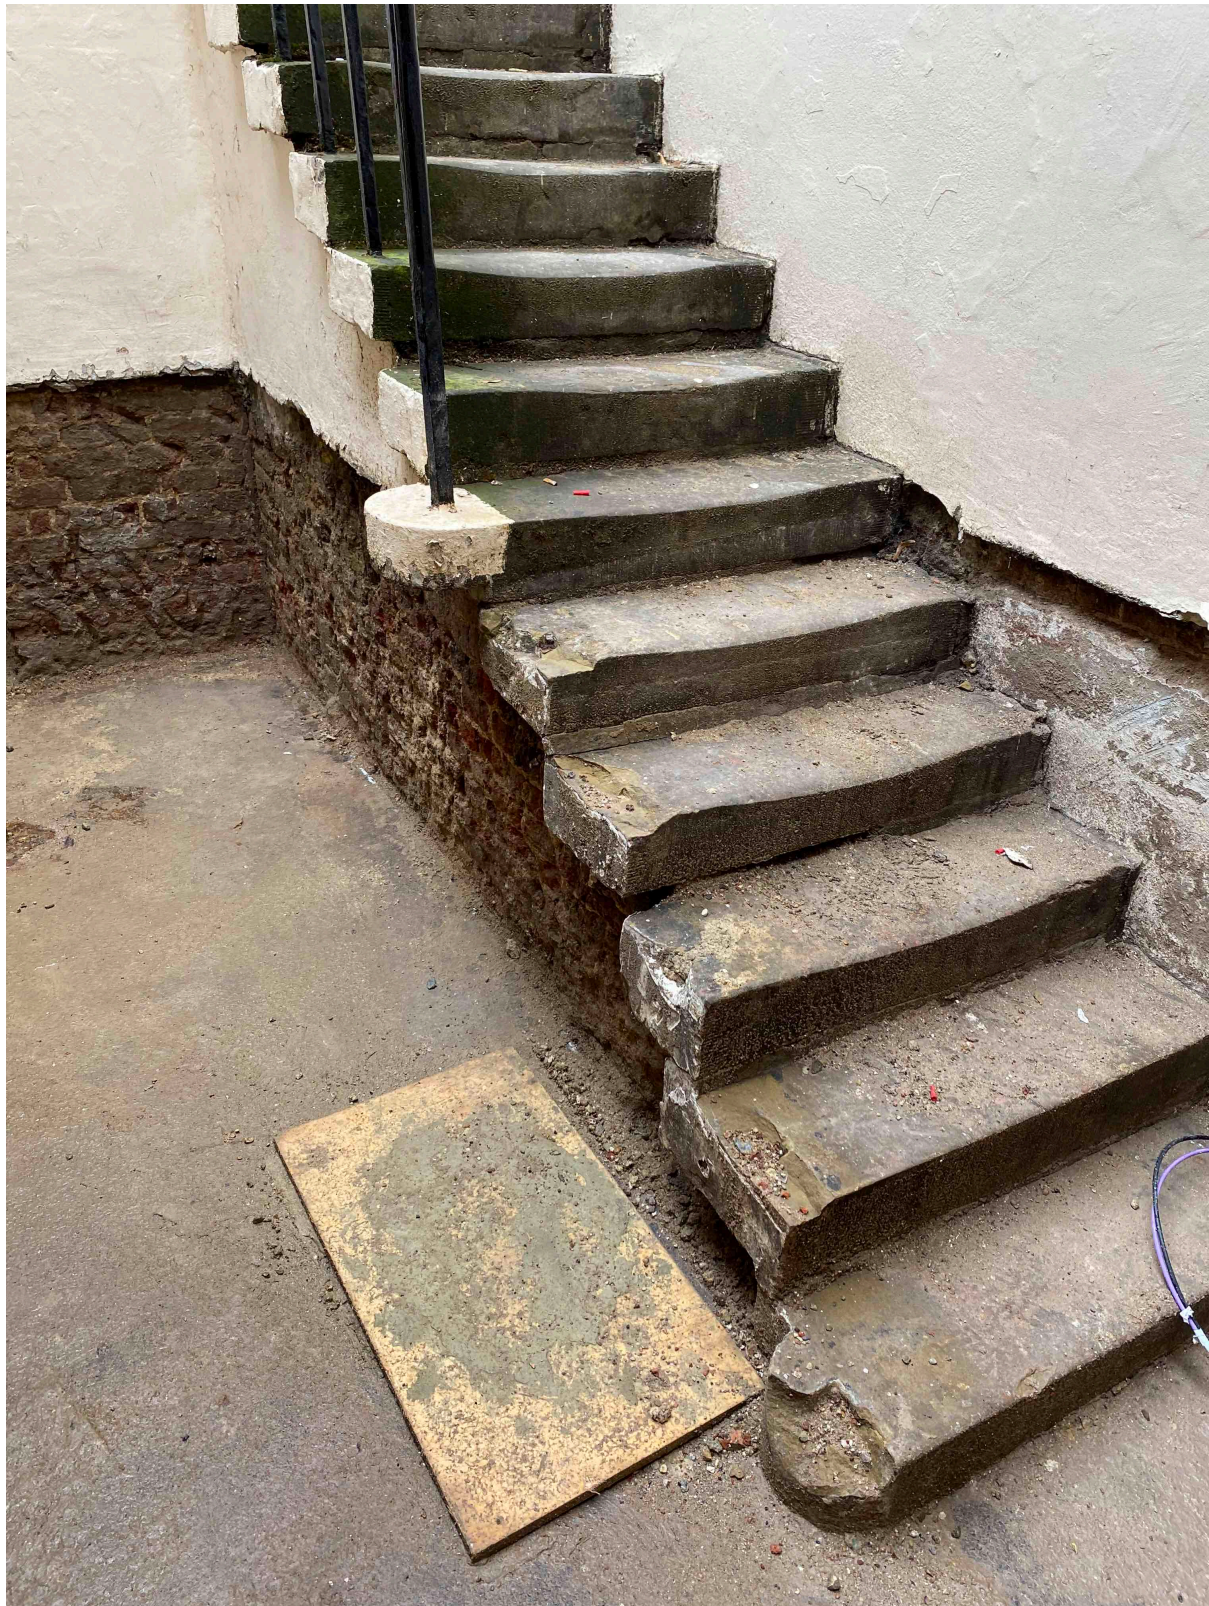
Photo 4: Close up photo highlighting the following:

- Original newel post relocated
- Rounded end spliced onto existing square tread at bottom of non-original stair location
- Fixing points for historic balustrade on each buried historic tread
- Buried historic treads are worn down in centre showing relatively recent infill
- Original historic bottom step showing rounded end
- Existing gully under board

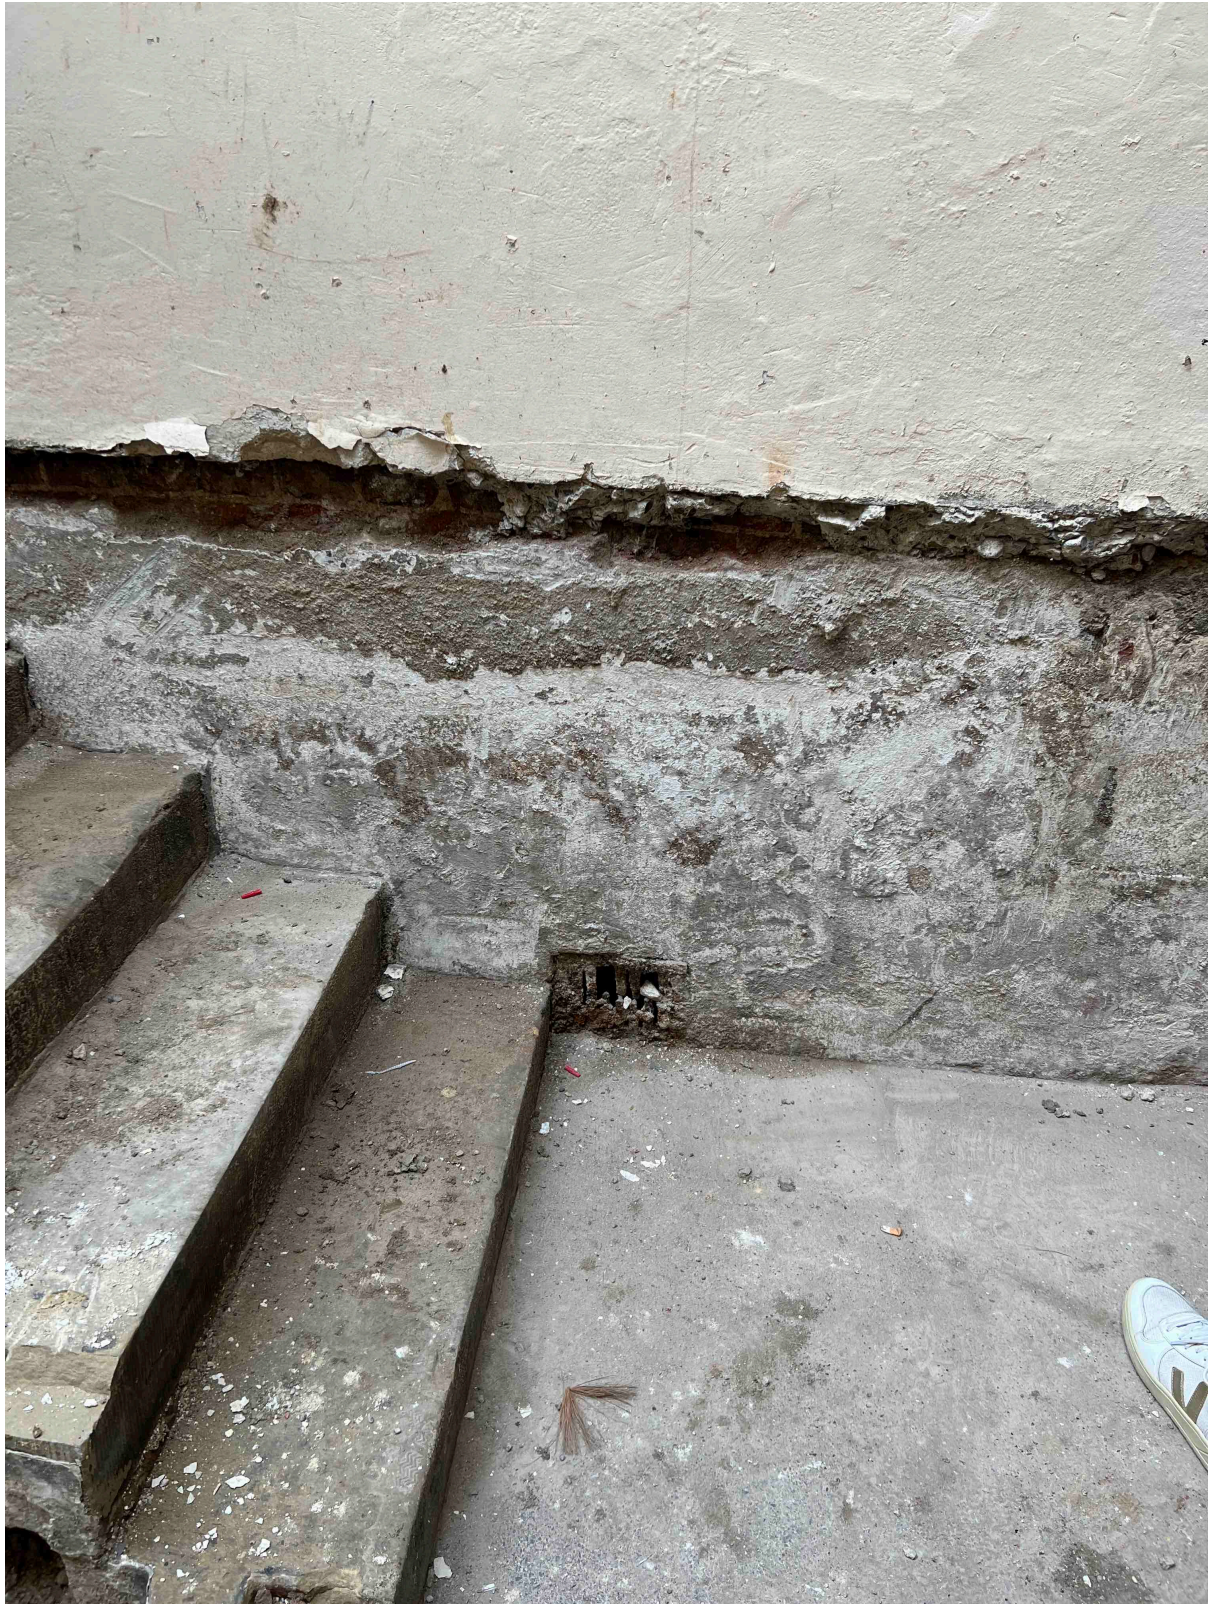
Photo 5: Original historic air brick located at bottom of the historic stair, showing that the original lightwell level was significantly lower than the existing
