12 & 13 PRIMROSE HILL STUDIOS
CONDITION SURVEY AND BUILDING CONSERVATION PROPOSALS
MAY 2022
REV A - JULY 2022

12 & 13 PRIMROSE HILL STUDIOS
CONDITION SURVEY AND BUILDING CONSERVATION PROPOSALS
CONTENTS

Purcell were commissioned by Rory and Barbara Campbell-Lange in May 2022 to carry out a non-intrusive condition survey of two properties at 12 & 13 Primrose Hill Studios, to inform and set out proposals for conservation of the building as part of a Planning and Listed Building Consent application for renewed studio and residential use.

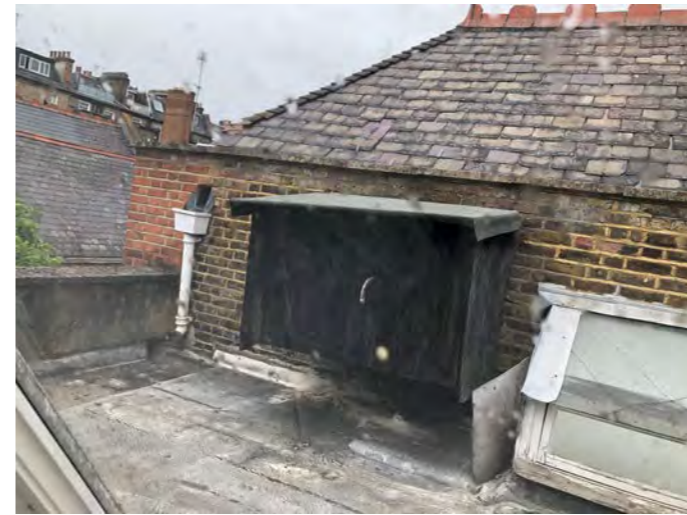
DEFECT NO	LOCATION A	LOCATION B	DEFECT TYPE	REPAIR TYPE	SIZE	UNIT	PRIORITY	IMAGE NO	SEng	NOTES
R01/01	North Wall	West low level adjacent downpipe	B2	RB2	4	No	3	003	-	-
R01/02	North Wall	West downpipe	A2	RA2	1	No	4	003	-	Inspect if cracks are present. Replace if cracks present
R01/03	North Wall	West low level adjacent downpipe	C4	RC4	0.2	sqm	4	003	-	Allow for pointing to adjacent brickwork and fixings to downpipe
R01/04	North Wall	Above water tank housing	C4	RC4	2	lm	4	003	-	-
R01/05	North Wall	Brickwork behind water tank housing	-	-	2	sqm	4	003	-	Inspect subject to water tank housing removal
R01/06	North Wall	Modern lantern rooflight lean-to box.	IA4B	RIA4B	1.5	m3	3	002	-	Suggest flashing to be replaced
R01/07	North Wall	Brickwork above glazed lantern	B2	RB2	1	lm	4	002	-	-
R01/08	North Wall	East brickwork	M1	RMI	3	lm	4	001	-	-
R01/09	The Studio and The Lodge	Roofs	A3	RA3	3	No		-	-	Remove redundant aerials and clear away

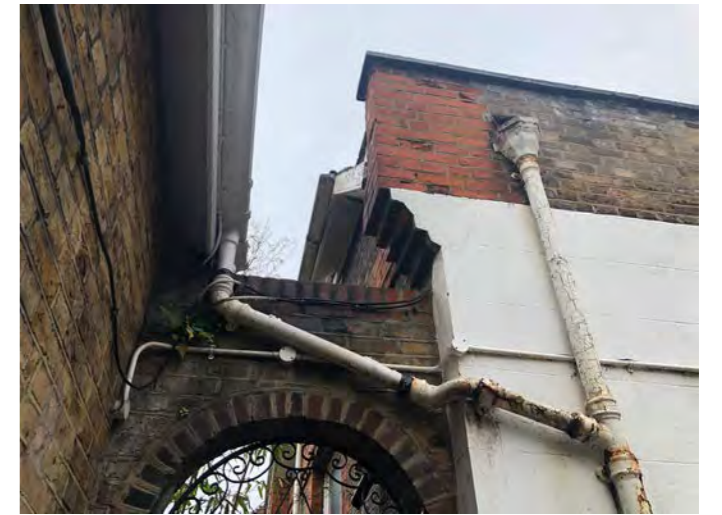
DEFECT NO	LOCATION A	LOCATION B	DEFECT TYPE	REPAIR TYPE	SIZE	UNIT	PRIORITY	IMAGE NO	SEng	NOTES
SB/01	West Brickwork	High Level adjacent hopper	B2	RB2	10	no	3	004	-	-
SB/02	West Render	High Level adjacent hopper	R1	RR1	2	lm	3	004	-	2no cracks approx 1lm each
SB/03	West Gate	Above opening	V1	RV1	1	no	3	005	-	-
SB/04	West Gate	Brickwork above opening	B5	RB5	1	sqm	4	005	-	-
SB/05	West Gate	Timber door	IA4A	RIA4A	1	no	4	006	-	Strip down, redecorate, piece in sections of warped/rotten timber
SB/06	West Gate	Render door jamb	R1	RR1	0.5	lm	3	007	-	2no cracks approx 0.25lm each
SB/07	West Gate	Brick above opening	M4	RM4	0.2	lm	4	008	-	-
SB/08	West Gate	Decorative metalwork within door opening	AM1	RAM1	1	no	4	009	-	-
SB/09	West Downpipe	Branch to gate	A2	RA2	3	no	2	010	-	Cracked cast iron branch and joints to be replaced
SB/10	West Downpipe	Full length	A2	RA2	5	lm	4	011	-	Inspect if cracks are present. Replace if cracks present

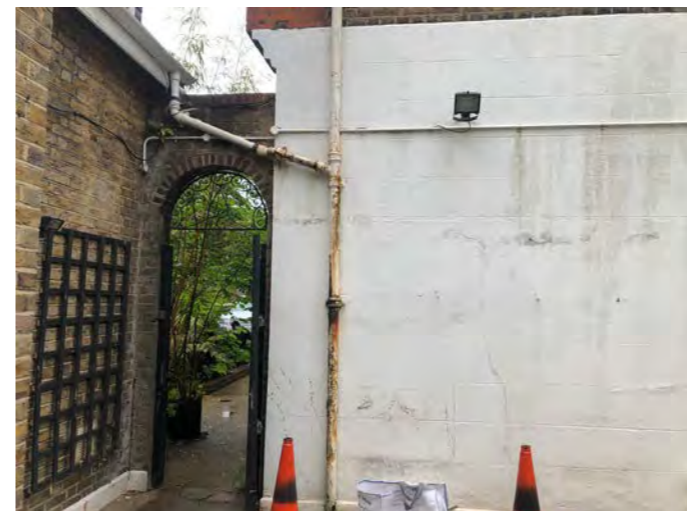
SB/11	West Downpipe	Hopper	A2	RA2	1	no	3	012	-	Refix joints where leaks present, reline lead and repoint
SB/12	Central & East Render	Midheight adjacent downpipe, within and above demolished garage render	R1	N/A	8	lm	4	011	✓	DAS (Design and Access Statement) proposes to hack off all existing cementitious render and re-render
SB/13	Central Render	Midheight above demolished garage roof	R1	N/A	6	lm	4	013	-	DAS (Design and Access Statement) proposes to hack off all existing cementitious render and re-render. We recommend this to be breathable lime render.
SB/14	Central Brickwork	High level above render	B5	RB5	4	sqm	4	014	-	-
SB/15	East brickwork	High level brickwork	V1	RV1	2	sqm	4	015	-	-
SB/16	East parapet	Coping Stone	ST2	RST2	1.5	lm	4	016	-	Coping stone missing, suggested to replace
SB/17	Central brickwork	Garage wall junctions	B4	RB4	5	lm	3	013, 017	-	Poor previous demolition with exposed brickwork to be carefully reinstated flush to sound surface

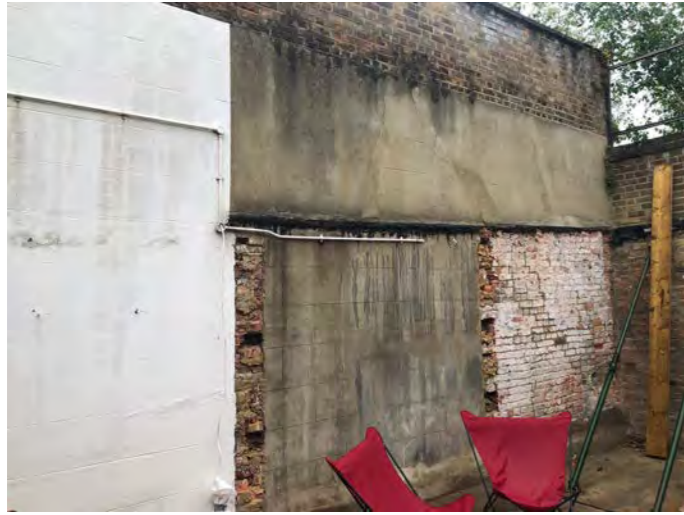
SB/18	Central wall	Conduit run	A1	RA1B	1	no	4	013	-	Unsafe cable exposed hanging. If redundant remove, otherwise reinstate
SB/19	Roof	Ridge	A4	RA4	3	no	4	061	-

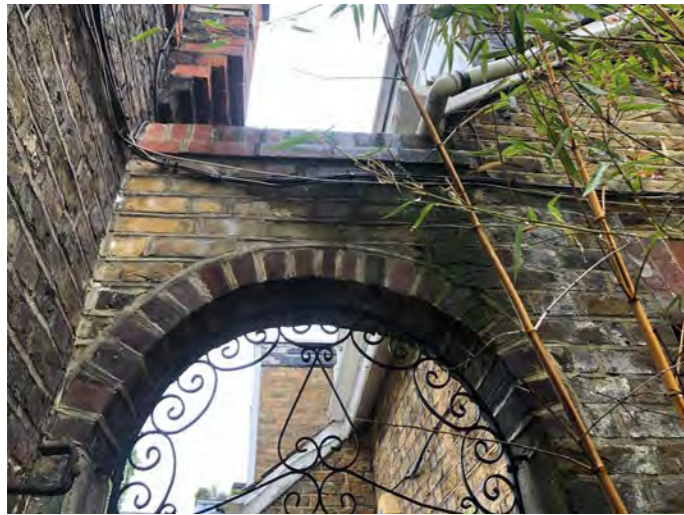
DEFECT NO	LOCATION A	LOCATION B	DEFECT TYPE	REPAIR TYPE	SIZE	UNIT	PRIORITY	IMAGE NO	SEng	NOTES
ED/01	East wall	Adjacent gate opening	-	-	2	sqm	2	025	-	Water runoff from gutter causing damp patch to brickwork. Remove water source and investigate brickwork once dry.
ED/02	East wall	Brickwork adjacent gate opening	B1	RBI	2	lm	3	026	-	3no bricks cracked to be replaced, 2no bricks poor previous mortar repair to be replaced
ED/03	East wall	Above ground floor window	B3	RB3	1	no	4	027	-	Remove redundant fixing and repoint to match adjacent
ED/04	East wall	Ground floor window	M5	RM5	1.5	lm	3	028	-	Poor previous repair, cracking through previous repairs
ED/05	East wall	Roof fascia / soffit board	T1	RT1	2	sqm	3	029, 030	-	Fascia / soffit board timber to be stripped back and redecorated. If rotten allow to replace.
ED/06	Central bay	Roof fascia / soffit board	T1	RT1	1	sqm	2	030	-	Fascia / soffit board rotten timber to be replaced, adjacent timber stripped back and redecorated throughout.

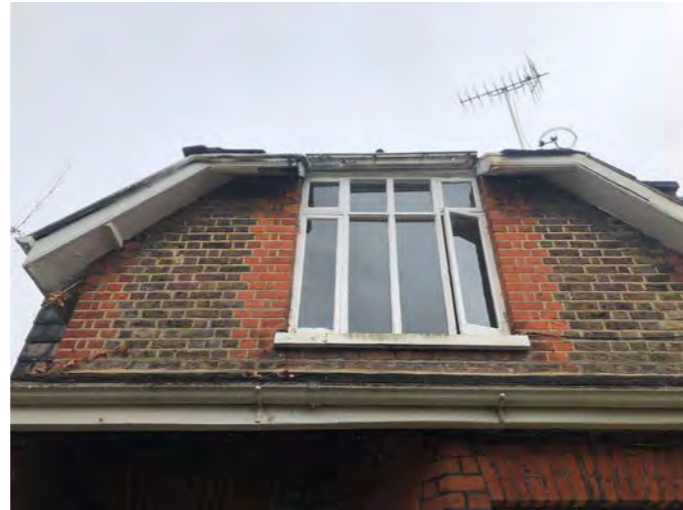
ED/07	Central bay	Gutter above first floor window	A2	RA2	1	lm	2	030	-	
ED/08	Central bay	Gutter west of first floor window	A2	RA2A	1	no	2	030	-	
ED/09	Central bay	Ground floor window heads	M5	RM5	5	lm	3	031, 032, 034	-	4no window heads
ED/10	Central bay	west fascia / soffit board	T1	RT1	4	sqm	2	033	-	Fascia / soffit board rotten timber to be replaced, adjacent timber stripped back and redecorated throughout.
ED/11	Central bay	Ground floor west window headers	B1	RBI	0.4	lm	3	034	✓

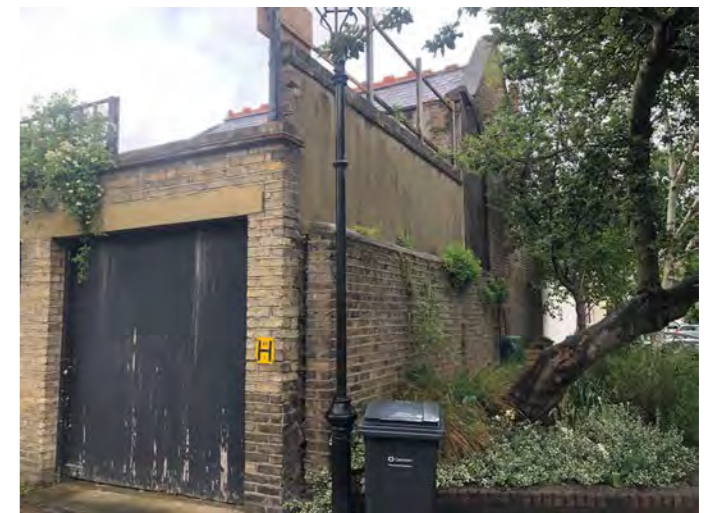
DEFECT NO	LOCATION A	LOCATION B	DEFECT TYPE	REPAIR TYPE	SIZE	UNIT	PRIORITY	IMAGE NO	SEng	NOTES
EB/01	South Wall	High Level Brickwork	B2	RB2	2	no	3	036, 037	-	I no missing brick I no spalled brick
EB/02	Central Wall	High level vegetation	V1	RV1	1	sqm	3	036	-	
EB/03	Central Roof	Coping stone	ST2	RST2	0.2	sqm	3	038, 039	-	
EB/04	North Wall	Low level brickwork	B4	RB4	1	no	4	040	-	
EB/05	North Wall	Low level brickwork	B3	RB3	6	no	5	040	-	
EB/06	North Roof	High Level Brickwork	A2	RA2C	1	no	2	041	-	Investigate brickwork once dry.
EB/07	Central Wall	Low level brickwork	B1	RBI	1	lm	3	042	-

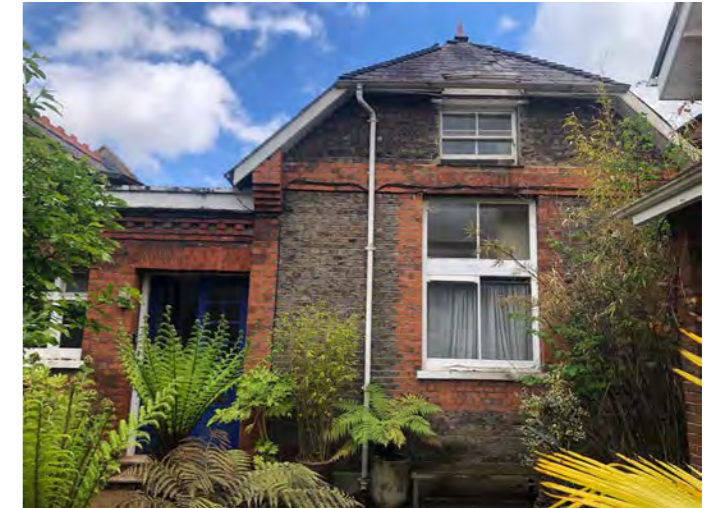
EC/29	South RVP	Pipe outlet low level	A2	RA2	1	no	3	065	-	Corroded pipe to be replaced
EC/30	North brickwork	Beneath window	B3	RB3	2	no	5	066	-	Remove redundant fixing and repoint to match adjacent
EC/31	Gabled front	Beneath top window	A1	RA1B	All (min 8)	lm	5	057, 060	-	-
EC/32	Hipped roof	East and west sides	A4	RA4	4	no	3	044	-	-

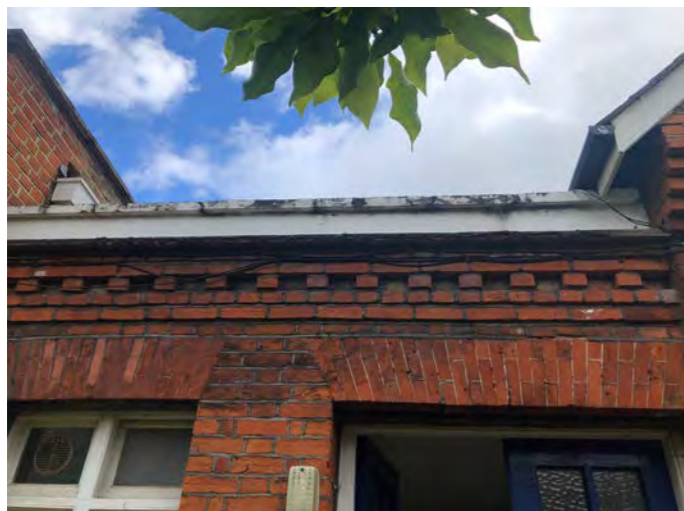
DEFECT NO	LOCATION A	LOCATION B	DEFECT TYPE	REPAIR TYPE	SIZE	UNIT	PRIORITY	IMAGE NO	SEng	NOTES
EC/01	North Parapet	Above Door and Window	ST3	RST3	4	lm	3	045	-	Painted coping stone failing, recommendation to remove paint. Redecorate front face to match existing if required.
EC/02	Electrical Cables	Ground Floor high level	A1	RA1A	14	lm	4	046	-	Remove loose cables, tidy and bunch together. Refix to mortar joints in brickwork.
EC/03	North Brickwork	Ground Floor high level	V1	RV1	4	lm	3	046	-	-
EC/04	North RWP	Hopper at high level	A2	RA2	1	no	2	047	-	Refix joints where leaks present, reline lead and repoint
EC/05	North Brickwork	High level adjacent hopper	B2	RB2	7	no	3	047	-	-
EC/06	North Brickwork	Brick headers above window	B2	RB2	14	no	3	048	-	Poor previous repairs, remove damaged bricks and replace
EC/07	North Window	Top pane cracked	G1	RG1	1	no	3	048	-	-
EC/08	North Window	Window cill and panel	IA4B	RIA4B	1	no	2	049	-	Rotten timber to be replaced - bottom stiles, rails and cill. To be decorated

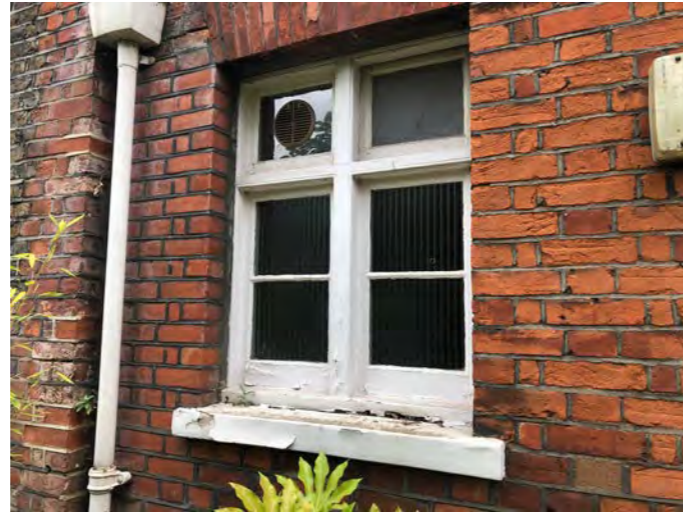
EC/09	North Window	Window cill	ST3	RST3	0.5	sqm	3	050	-	
EC/10	North RWP	Pipe outlet low level	A2	RA2	1	no	3	051	-	Corroded pipe to be replaced
EC/11	North RWP	Brickwork at low level	-	-	0.5	sqm	3	051	-	Water runoff from RWDP causing damp patch to brickwork. Remove water source and investigate brickwork once dry.
EC/12	North RWP	Gully at floor level	A2	RA2B	1	no	3	051	-	Gully filled with water to be cleared
EC/13	North brickwork	Beneath window	B3	RB3	1	no	5	052	-	Remove redundant fixing and repoint to match adjacent
EC/14	North brickwork	Low level beside door	B2	RB2	16	no	4	053	-	-
EC/15	Front door	Steps	ST1	RST1	2	no	4	054	-	
EC/16	Front door	Door jamb perimeter mortar to brickwork	M5	RM5	4	lm	4	055	-	-
EC/17	Front door	Brick headers above door	B2	RB2	2	no	3	056	-	-
EC/18	Front door	Metal strap to brick headers above door	-	-	1	no	3	056	✓	SEng to review and advise
EC/19	Gabled front	North brick quoins high level	M4	RM4	1	lm	3	057	-	-

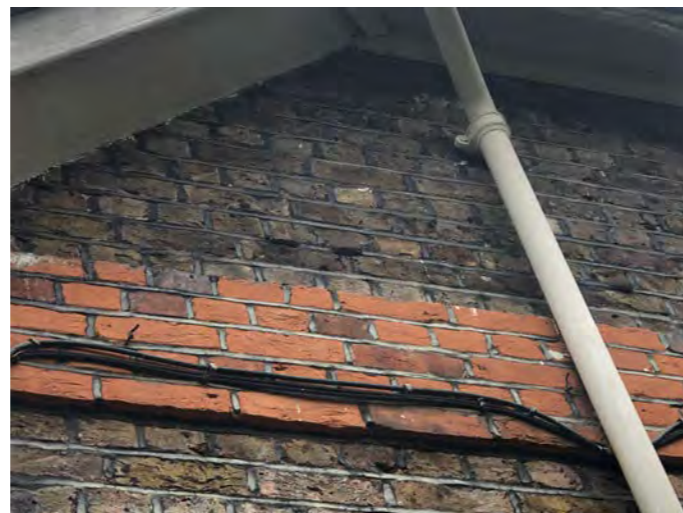
DEFECT NO	LOCATION A	LOCATION B	DEFECT TYPE	REPAIR TYPE	SIZE	UNIT	PRIORITY	IMAGE NO	SEng	NOTES
EC/20	Gabled front	Brickwork high level	M4	RM4	0.2	lm	4	058	-	-
EC/21	Gabled front	Fascia / soffit board	T1	RT1	4	sqm	3	059	-	Fascia / soffit board timber to be stripped back and redecorated. If rotten allow to replace.
EC/22	Gabled front	First floor window	G1	RG1	2	no	3	059	-	-
EC/23	Gabled front	First floor window cill creasing tiles	A5	RA5	5	no	3	059	-	-
EC/24	Front door	Brick headers above door	B1	RB1	7	no	3	060	-	-
EC/25	Gabled front	Fascia / soffit board	T1	RT1	4	sqm	3	061	-	Rotten fascia / soffit board timber to be replaced and redecorated to match existing adjacent
EC/26	Gabled front	Ground floor window cill	IA4B	RIA4B	1	no	2	062	-	Timber to stripped back and redecorated. If rotten allow to replace.
EC/27	Gabled front	Ground floor window jamb perimeter mortar to brickwork	M5	RM5	6	lm	4	063	-	-
EC/28	Gabled front	Ground floor window brickwork	B1	RB1	1	no	3	064	-	-
