## Arboricultural Appraisal Report

### Subsidence Damage Investigation at:

37 Lancaster Grove  
London  
NW3 4HB

CLIENT:	Crawford & Company
CLIENT REF:	[REDACTED]
MWA REF:	[REDACTED]
MWA CONSULTANT:	George Peters BSc. (Hons), M.Arbor.A
REPORT DATE:	18/07/2019

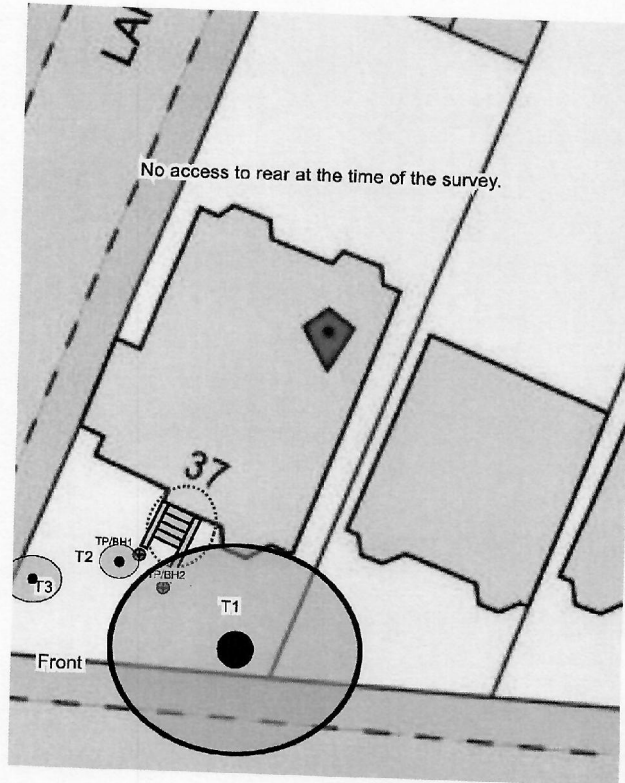
Site Plan

○ Approximate areas of damage

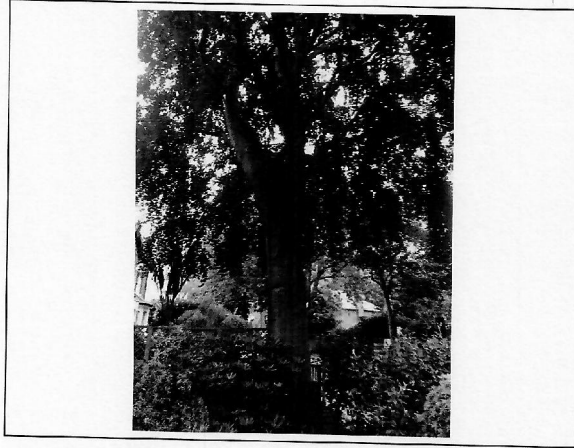
Roots were observed to a depth of 1200mm bgl in TP/BH1 and TP/BH2 and recovered samples have been positively identified (using anatomical analysis) as *Fagus spp* the origin of which will be T1 (Beech) confirming its influence on the soils below the foundations. The Monocotyledon roots originate from T2 (Cordyline) although this plant is not considered significant to the current claim.

Based on the technical reports currently available, engineering opinion and our own site assessment we conclude the damage is consistent with shrinkage of the clay subsoil related to moisture abstraction by vegetation. Having considered the information currently available, it is our opinion that T1 is the principal cause of the current subsidence damage.

View of T1 Beech, current claim.

Beech do not tolerate or respond well to heavy crown reductions and if the influence of the tree is to be mitigated removal therefore offers the most predictable solution.

Tree No.	Species	Ht (m)	Dia (mm)	Crown Spread (m)	Dist. to building (m)	Age Classification	Ownership
T1	Beech	18 *	1200 *	18	5	Younger than Property	Policy Holder
Management history		No recent management noted. Ganoderma at base.					
Recommendation		Remove (fell) to near ground level and treat stump to inhibit regrowth.

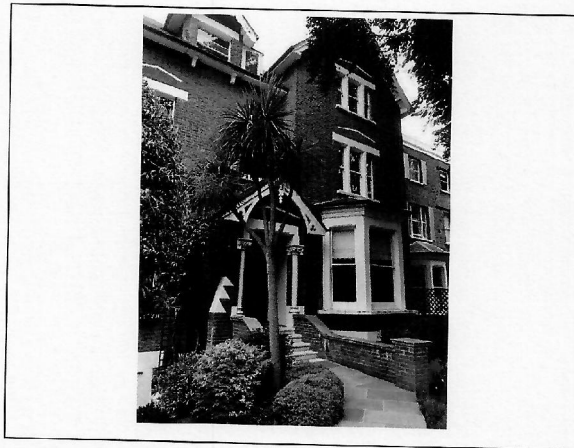
View of T2 Cordyline, future risk.

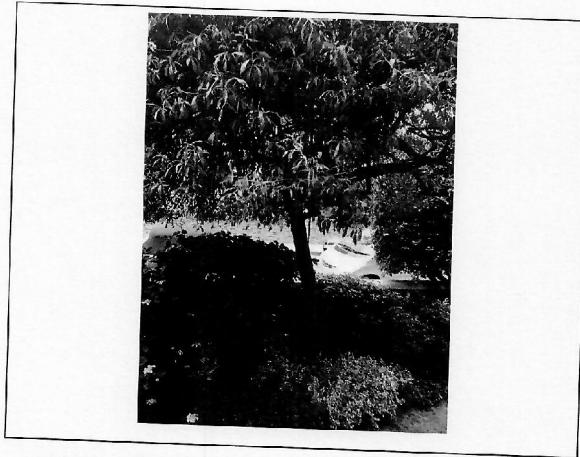
View of T2 Willow leaves pear, future risk.

Tree No.	Species	Ht (m)	Dia (mm)	Crown Spread (m)	Dist. to building (m)	Age Classification	Ownership
T2	Cordyline	4	150	2.5	1	Younger than Property	Policy Holder
Management history		No recent management noted.					
Recommendation		None.					
T3	Willow Leaved Pear	3	120 *	2.8	4.5	Younger than Property	Policy Holder
Management history		No recent management noted.					
Recommendation		Maintain broadly at no more than current dimensions by periodic pruning.
