## Arboricultural Survey & Report

10 St Mark's Crescent  
London  
NW1 7TS

August 2022

AR/MF/0128/22

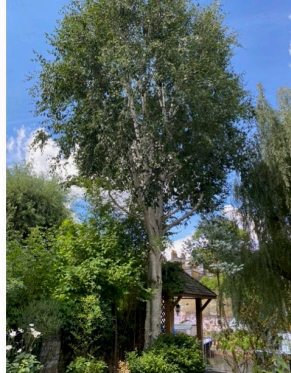
Tree T1 as viewed to the south west

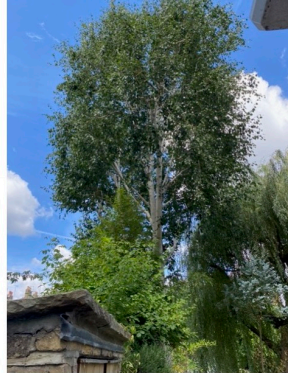
- (i) Sited at 7m distance property / 3m distance canal
- (ii) Crown lifted to 3m height with open wounds - occluding. Main union at
- (iii) 3-3.5m height is congested, gives way to columnar branch framework
- (iv) Crown reduced to established reduction points at 5-9m; currently lapsed 2 years

Tree T1 as viewed to the west showing reduced form of crown

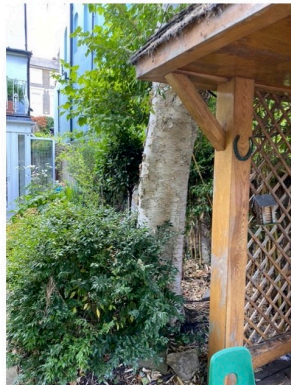
Main stem of tree T1 viewed to the south east

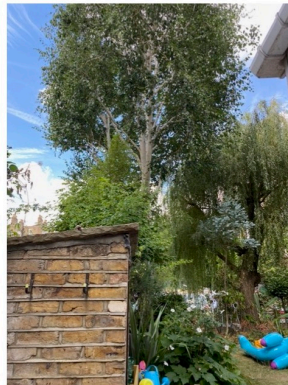
6.1 Tree T1 provides canopy cover and amenity value within the borough but with current form and over-extended scale for the rear garden and in relation to adjacent Willow is incongruous within the landscape. The tree requires cyclical pruning and is a medium to large sized tree for a small rear garden where the important canal bank Willow tree's form to the north shall be improved further to removal and replacement of a smaller tree.

Tree T1 as viewed to the west showing suppressed form of adjacent Willow

5.6 Tree T1 is proposed for removal and replacement for the following reasons:

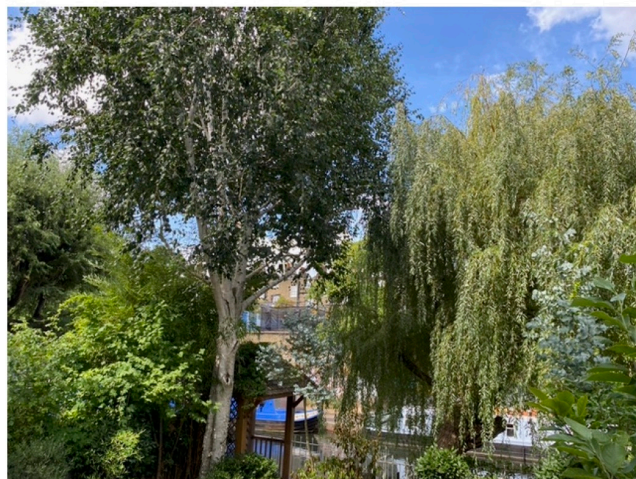
Overview of rear garden - 10 St Mark's Crescent tree T1 as viewed to the south west showing suppressed form of adjacent Willow
