REPORT FOR LBC - ROOF STRUCTURE

Project name	4-6 Bedford Place, London		
Design note title	Structural Statement in Support of Listed Building Consent – Existing Roof		
Document reference	24973_BP_HYD_XX_RP_S_001		
Author	Jerry King (Director) MStructE, B.Eng (Hons) C.Eng		
Revision	P3		
Checked	Roger Bareham MICE MStructE, B.Eng (Hons) C.Eng (CARES registered engineer)		
Date	27th September 2022	Approved	✓

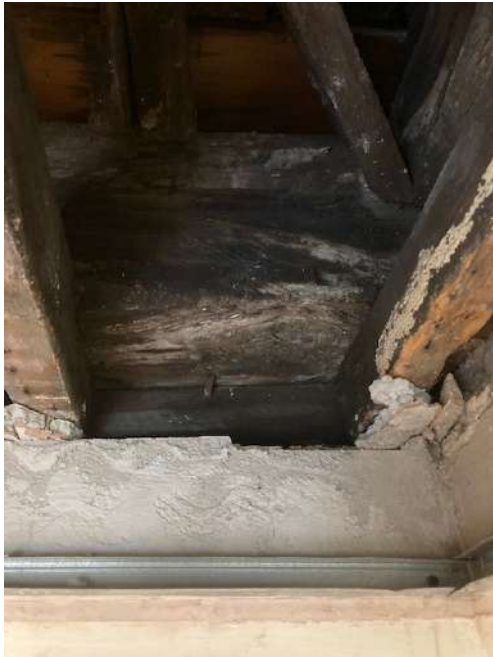
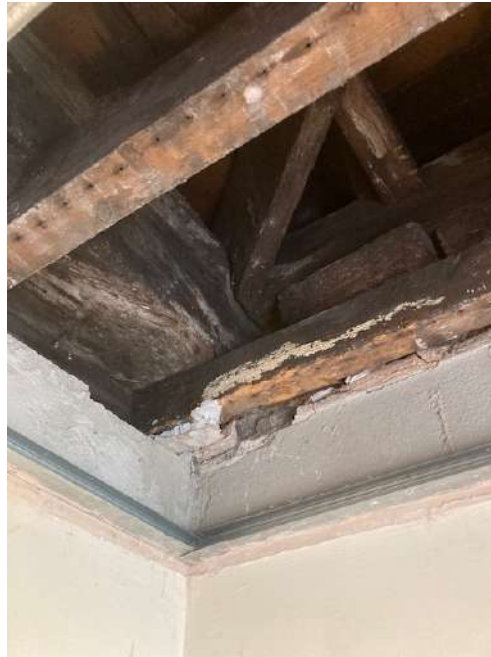
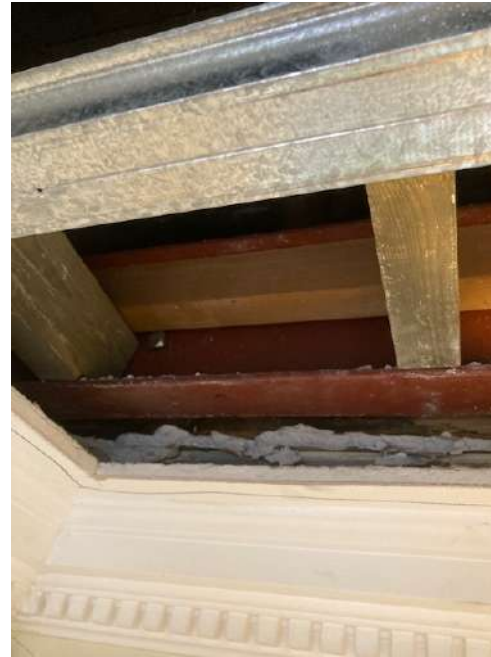
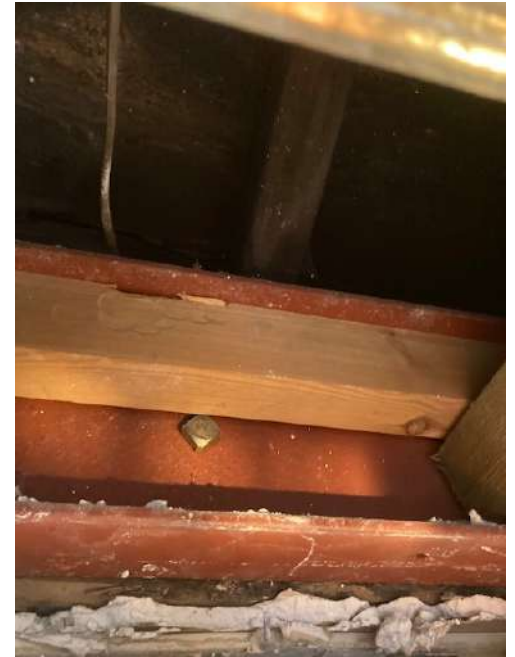
- We have assumed the valley beam is of good grade softwood for the purposes of this report and would highlight that it is suffering from wet rot in at least 2 locations above number 4 Bedford Place. In addition, the beam above 6 Bedford Place has been strengthened for part of its length with a modern 180x75PFC which possibly infers further decay somewhere along that particular member.

Photos 1- 4; No.6 Bedford Place – showing valley-beam and localised valley beam strengthening

- Install temporary roof and complete soft strip works to expose full length of valley-beams
- Temporary prop valley beam to enable strengthening works
- Carefully remove asphalt, slates and sarking boards (safely storing any slates that can be reclaimed)
- Repair sections of decayed valley beam using a Rotafix based detail, refer to enclosed sketch SK-S-106, with the following method tbc by manufacturer and full extent of timber decay following soft strip works:
 - » Remove section of decayed timber
 - » Splice with new timber section
 - » Form slot to allow for Rotafix TRS stainless steel rebar rods and apply Rotafix P8 paste for the full extent of the new timber section and existing timber section either side to suit actual site conditions.

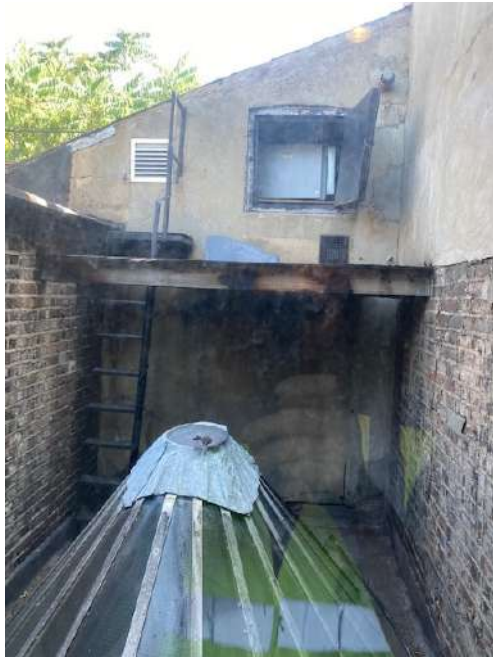
Photos 5; typical flat roof and roof-light feature at 3rd floor level
Photo 6; typical sagging roof due to overstress of original rafters
Photos 7 and 8; asphalt covering across slates

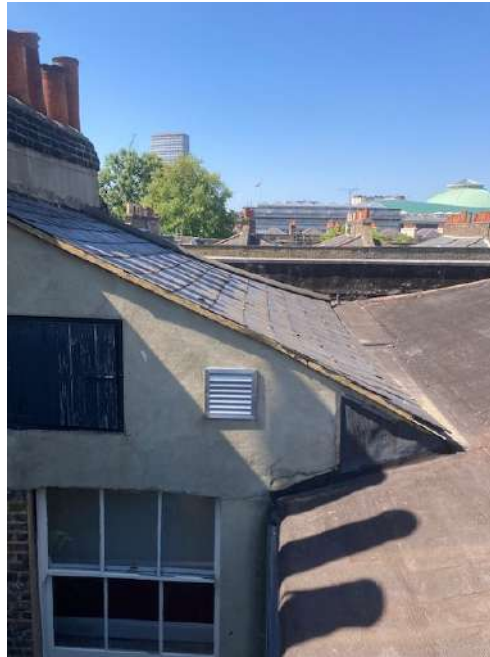
- The rafters are undersized for the current loading condition and are showing signs of significant deflection on a number of the roof planes. This potentially compromises the safety of the roof and the existing heritage features immediately below.
- Even with the asphalt removed the calculated deflection is 24mm which is greater than 2x the acceptable deflection according to modern building standards (and hence could cause disturbance of heritage features at lower levels).
- The valley beams are undersized for the larger span for both the current and original load condition. This manifests as further deflection onto the both new and original partitions below creating unintended load paths down through the rest of the building

- Cut existing valley beam to enable insertion of new trimming beam
- Install padstones as per enclosed sketch SK-S-106 to take strengthened valley beams and trimmer beams
- Install trimming beams to relieve load from unintended load-paths as per enclosed sketches SK-S-105 and SK-S-106.
- Install strengthening channels either side of valley beams as shown on enclosed sketches SK-S-105 and SK-S-106.
- Remove temporary propping
- Install new rafters and ceiling joists alongside existing rafters
- Replace roof build-up as per architectural proposals
- Remove temporary roof

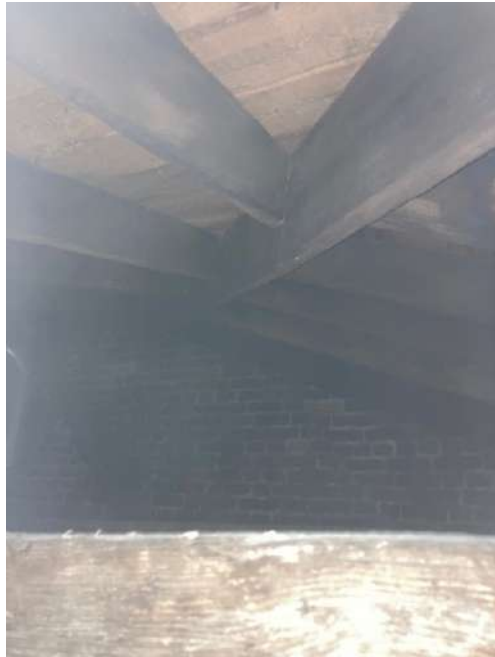
Photos 9; hip beam and rafter arrangement

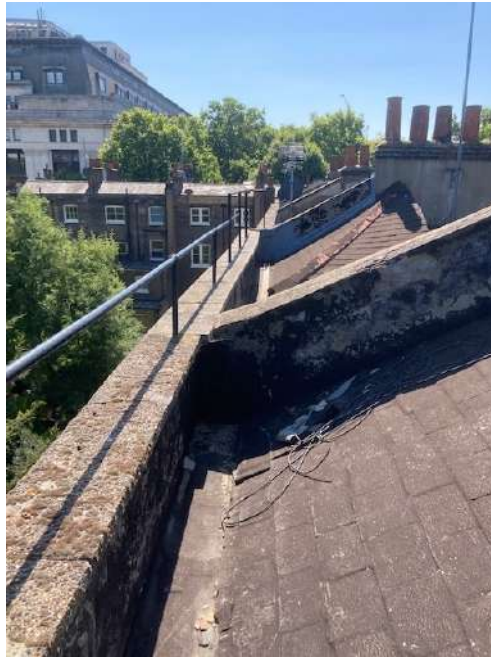
Photo 10; rear gutter showing hip on adjacent roof

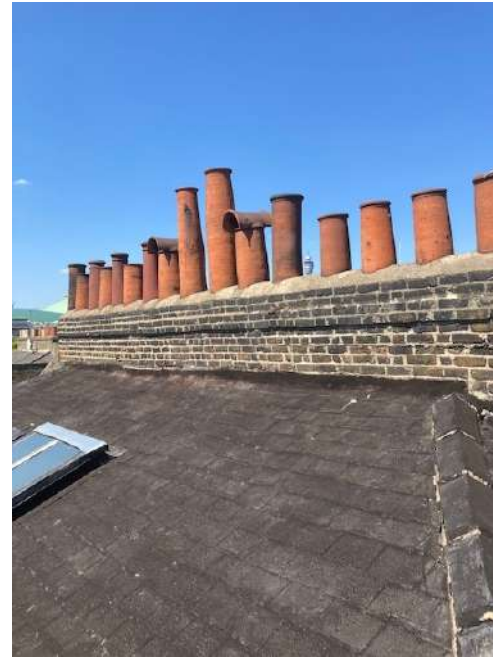
Photo 11; party wall chimneys - typical arrangement

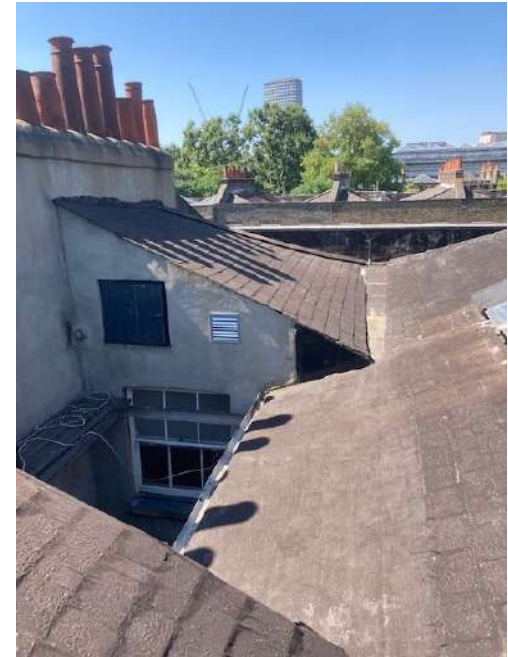
Photo 12; view showing cut-out for 3rd floor flat roof (note all rainwater drains into this section of roof)

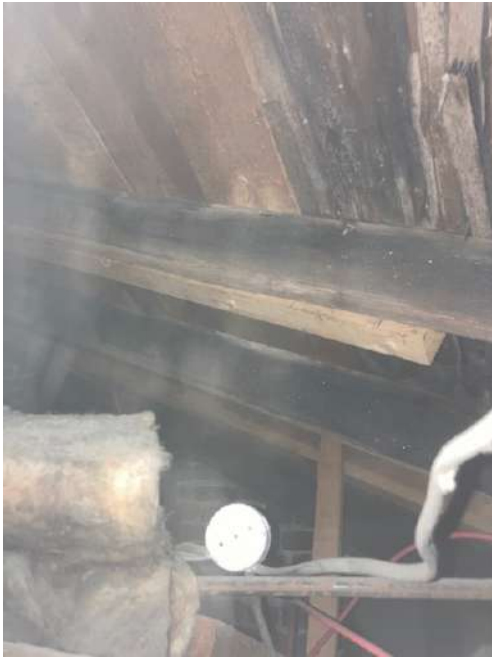
Photos 13; modern (inadequate) sw rafter strengthening and ceiling hanger
Photo 14; wet-rot decay of valley beam above number 4 Bedford Place
Photo 15 and 16; adjacent roof-light showing source of water ingress

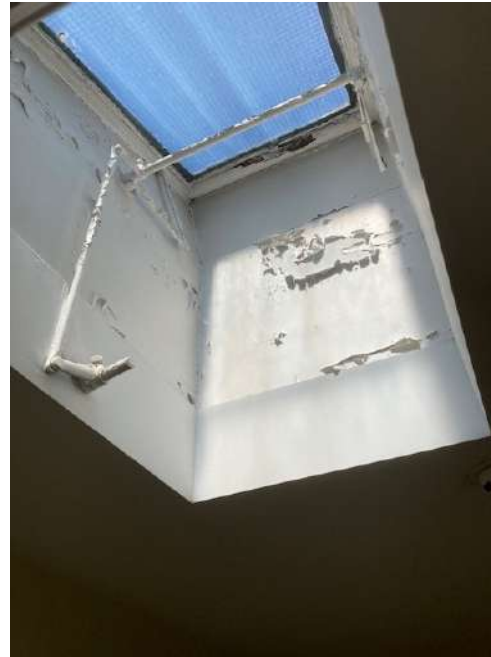
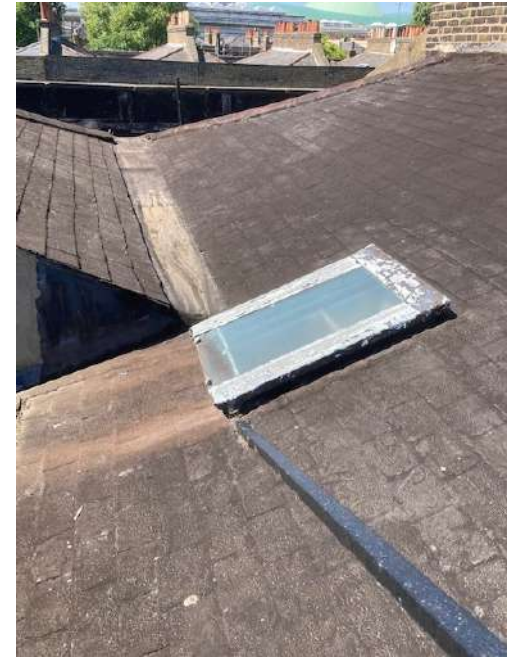
- The valleys collect all of the rainwater from the roofs before discharging down onto the flat roof above the main staircases. Both areas are prone to water ingress and we anticipate further extent of wet rot to the existing valley beams when fully opened-up.
- The valley-beams are partially aligned with timber stud partitions for part of their length although the head detail does not infer that continuous support is provided.
- The valley beam takes support at the stair walls but also appears to bear onto the modern stud corridor wall within number 6.
- A 15mm-20mm thick asphalt layer has been laid across the slate roof which represents a significant additional roof load that has been in place for a number of years across all three roofs
- There is localised strengthening to the rafters at the rear of number 4 with modern softwood rafters installed alongside the original timbers

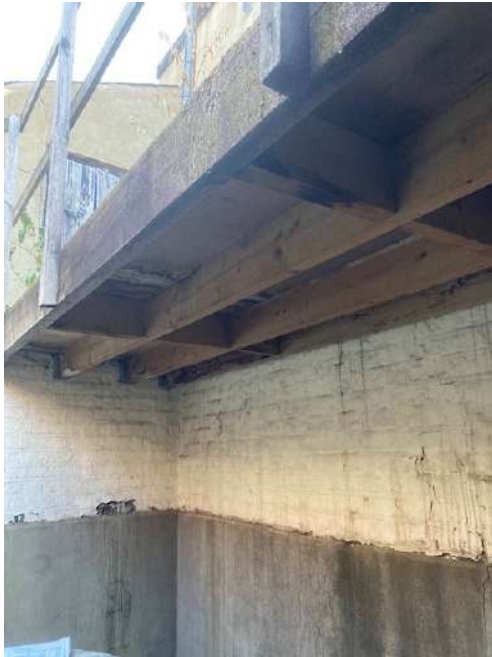
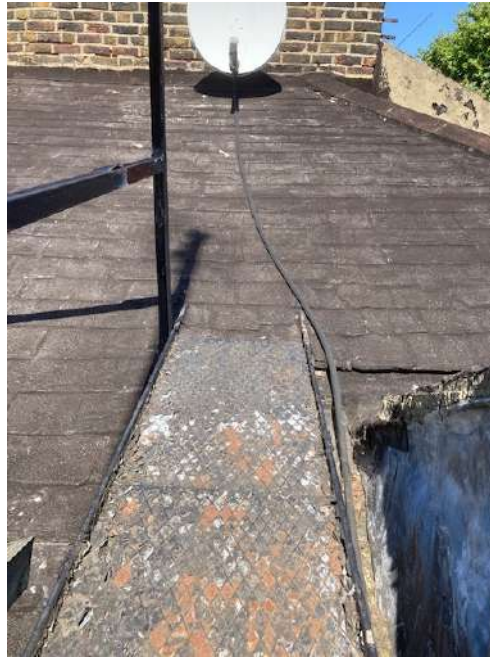
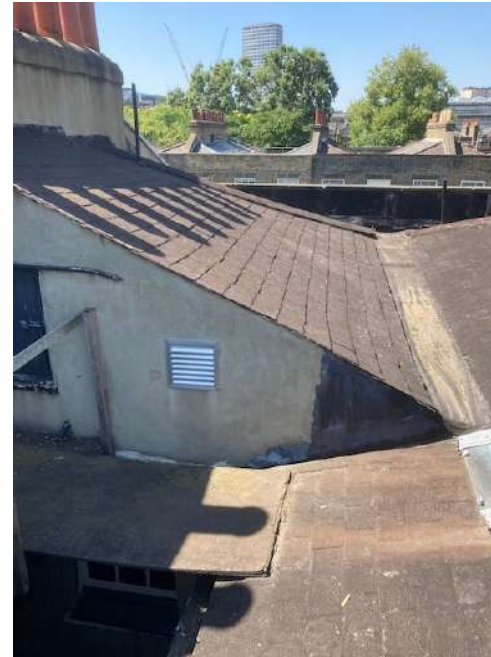
Photos 17-19; various additions typical of all 3 flat-roof areas
Photo 20; 4 Bedford Place valley beam showing rafter relationship

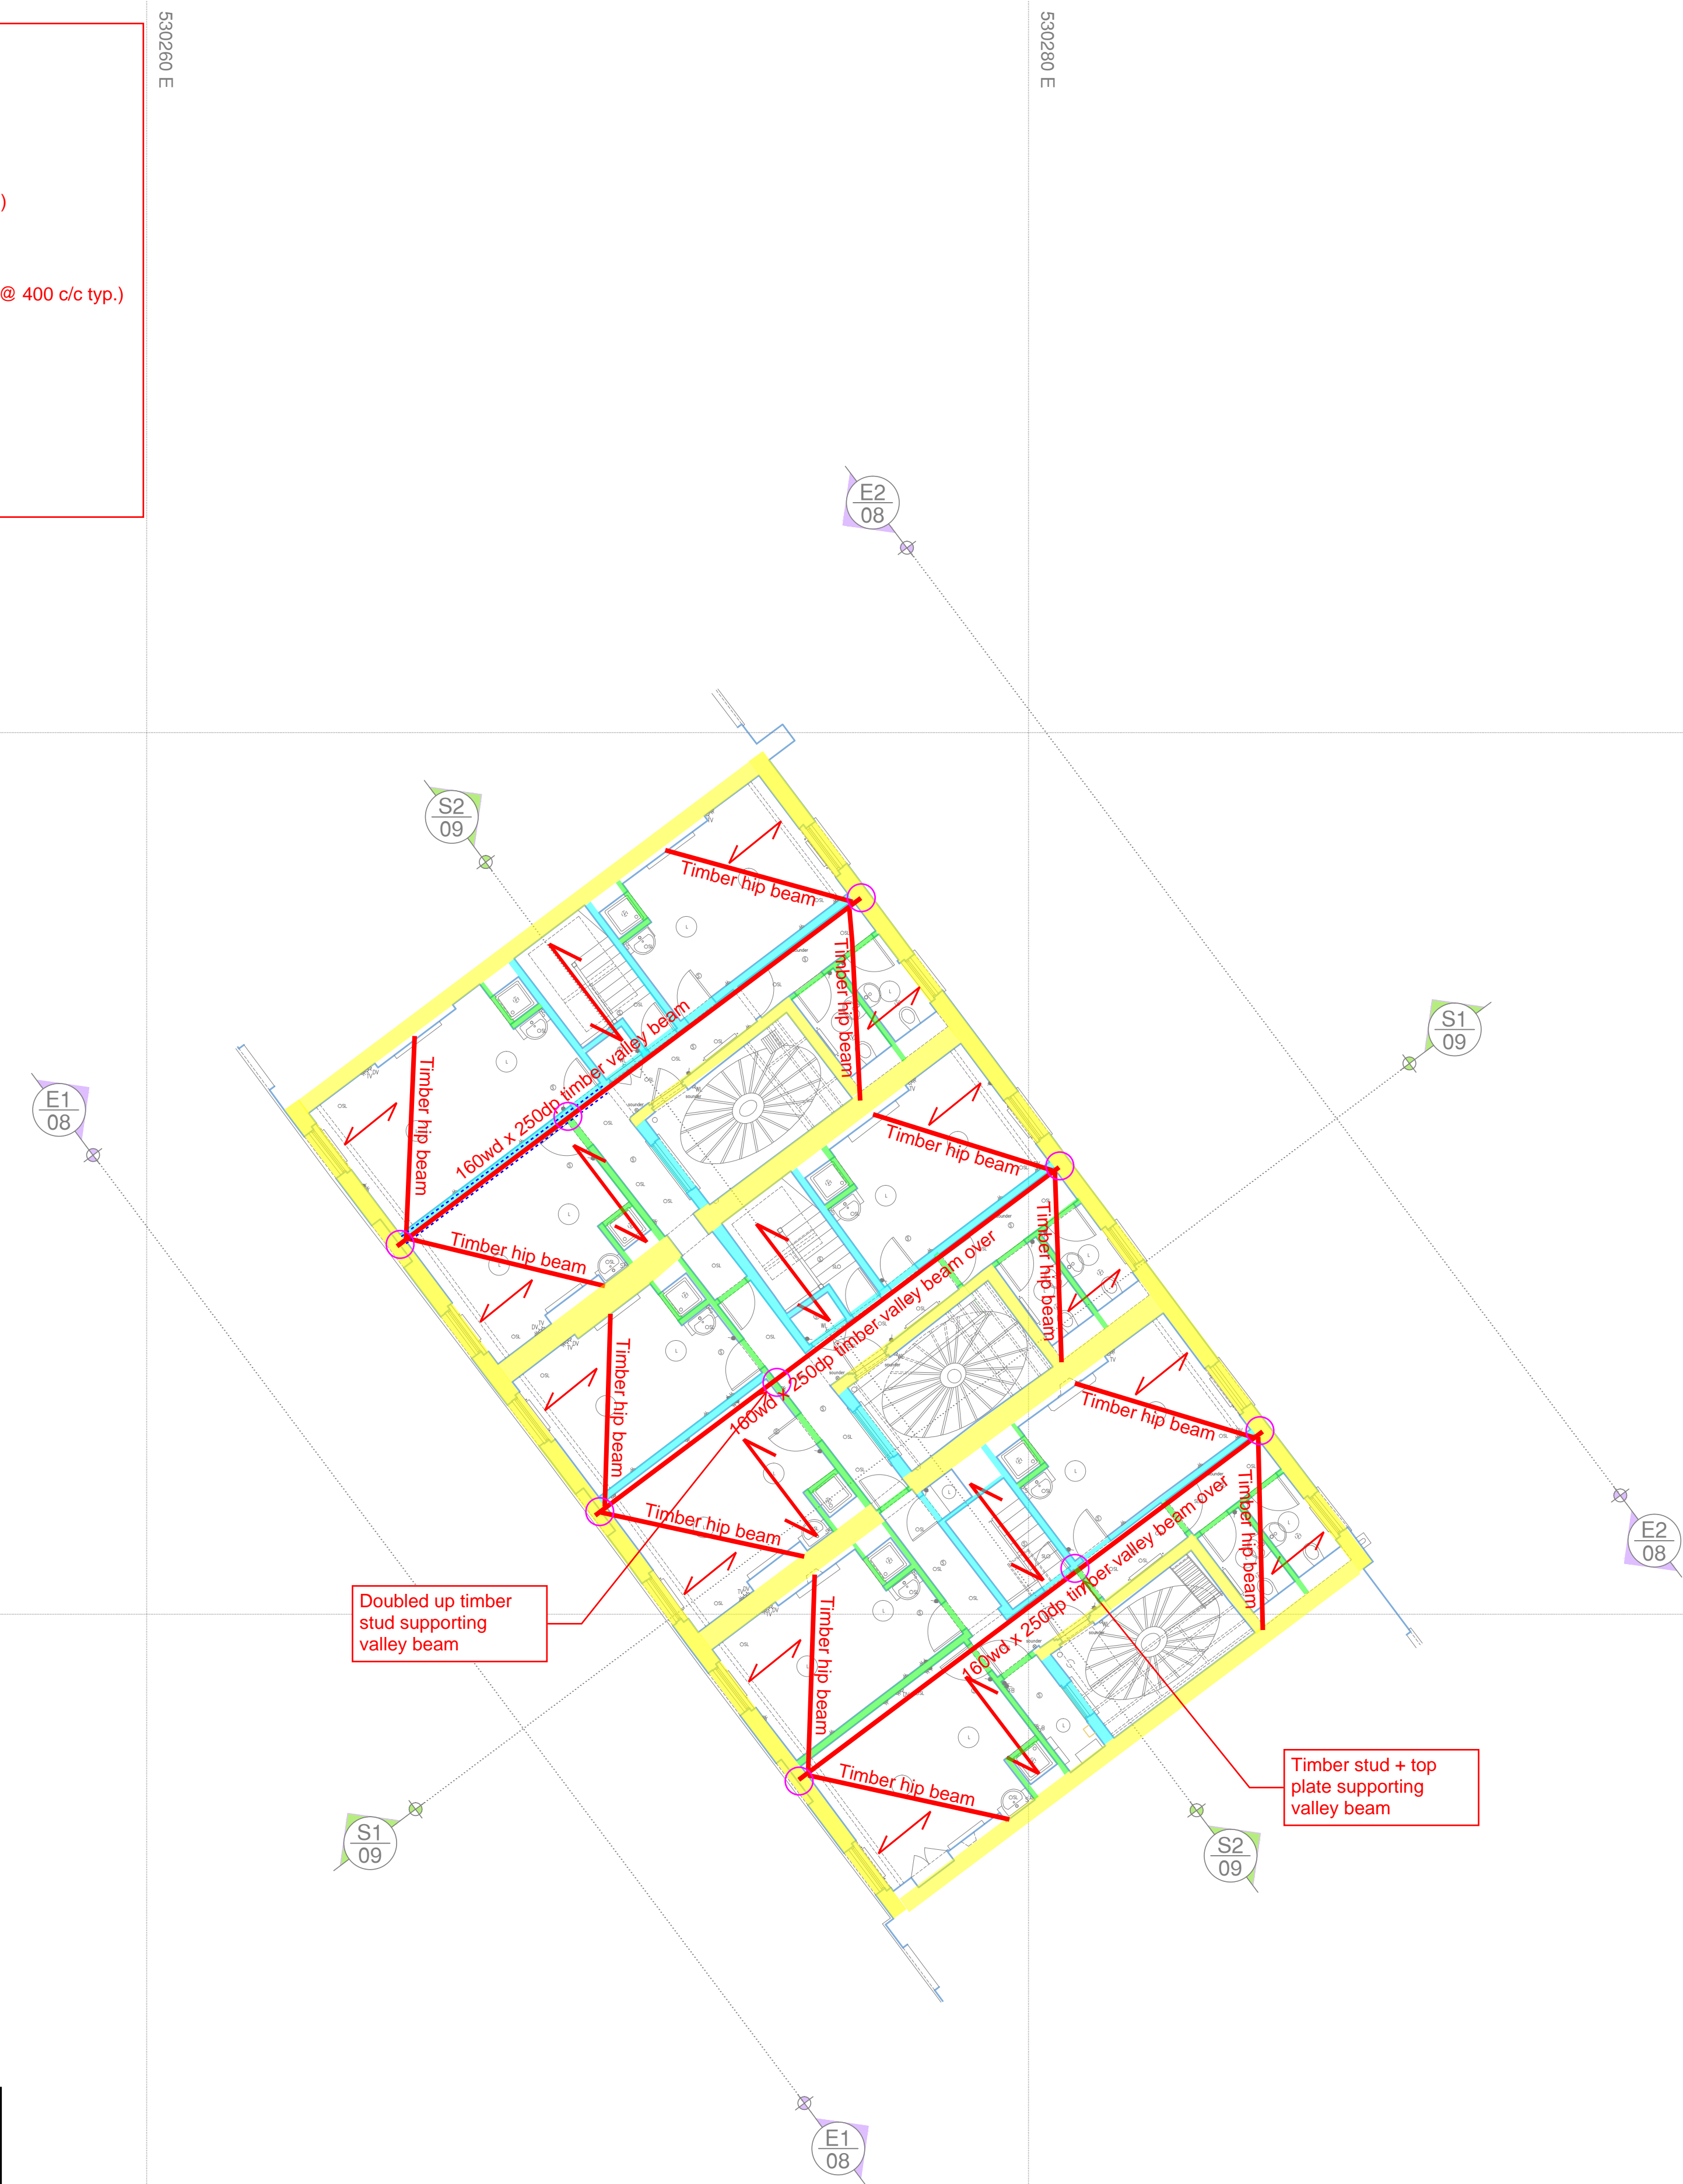
Drawn: ML
Job: 4-6 Bedford Place
Title: Roof Mark-up
Sketch No.: SK-S-104-P1
Date: 18/08/22

- 100*50 Softwood rafters (at varying centres but typically 350mm average) spanning approximately 3.5m from the party walls onto a central valley beam
- Hip members to form the roof fall down to the front and rear gutter lines
- 160 wide x 250 deep valley beams located on the centre-line of each building - probably intended to span from front/rear walls onto the stair walls

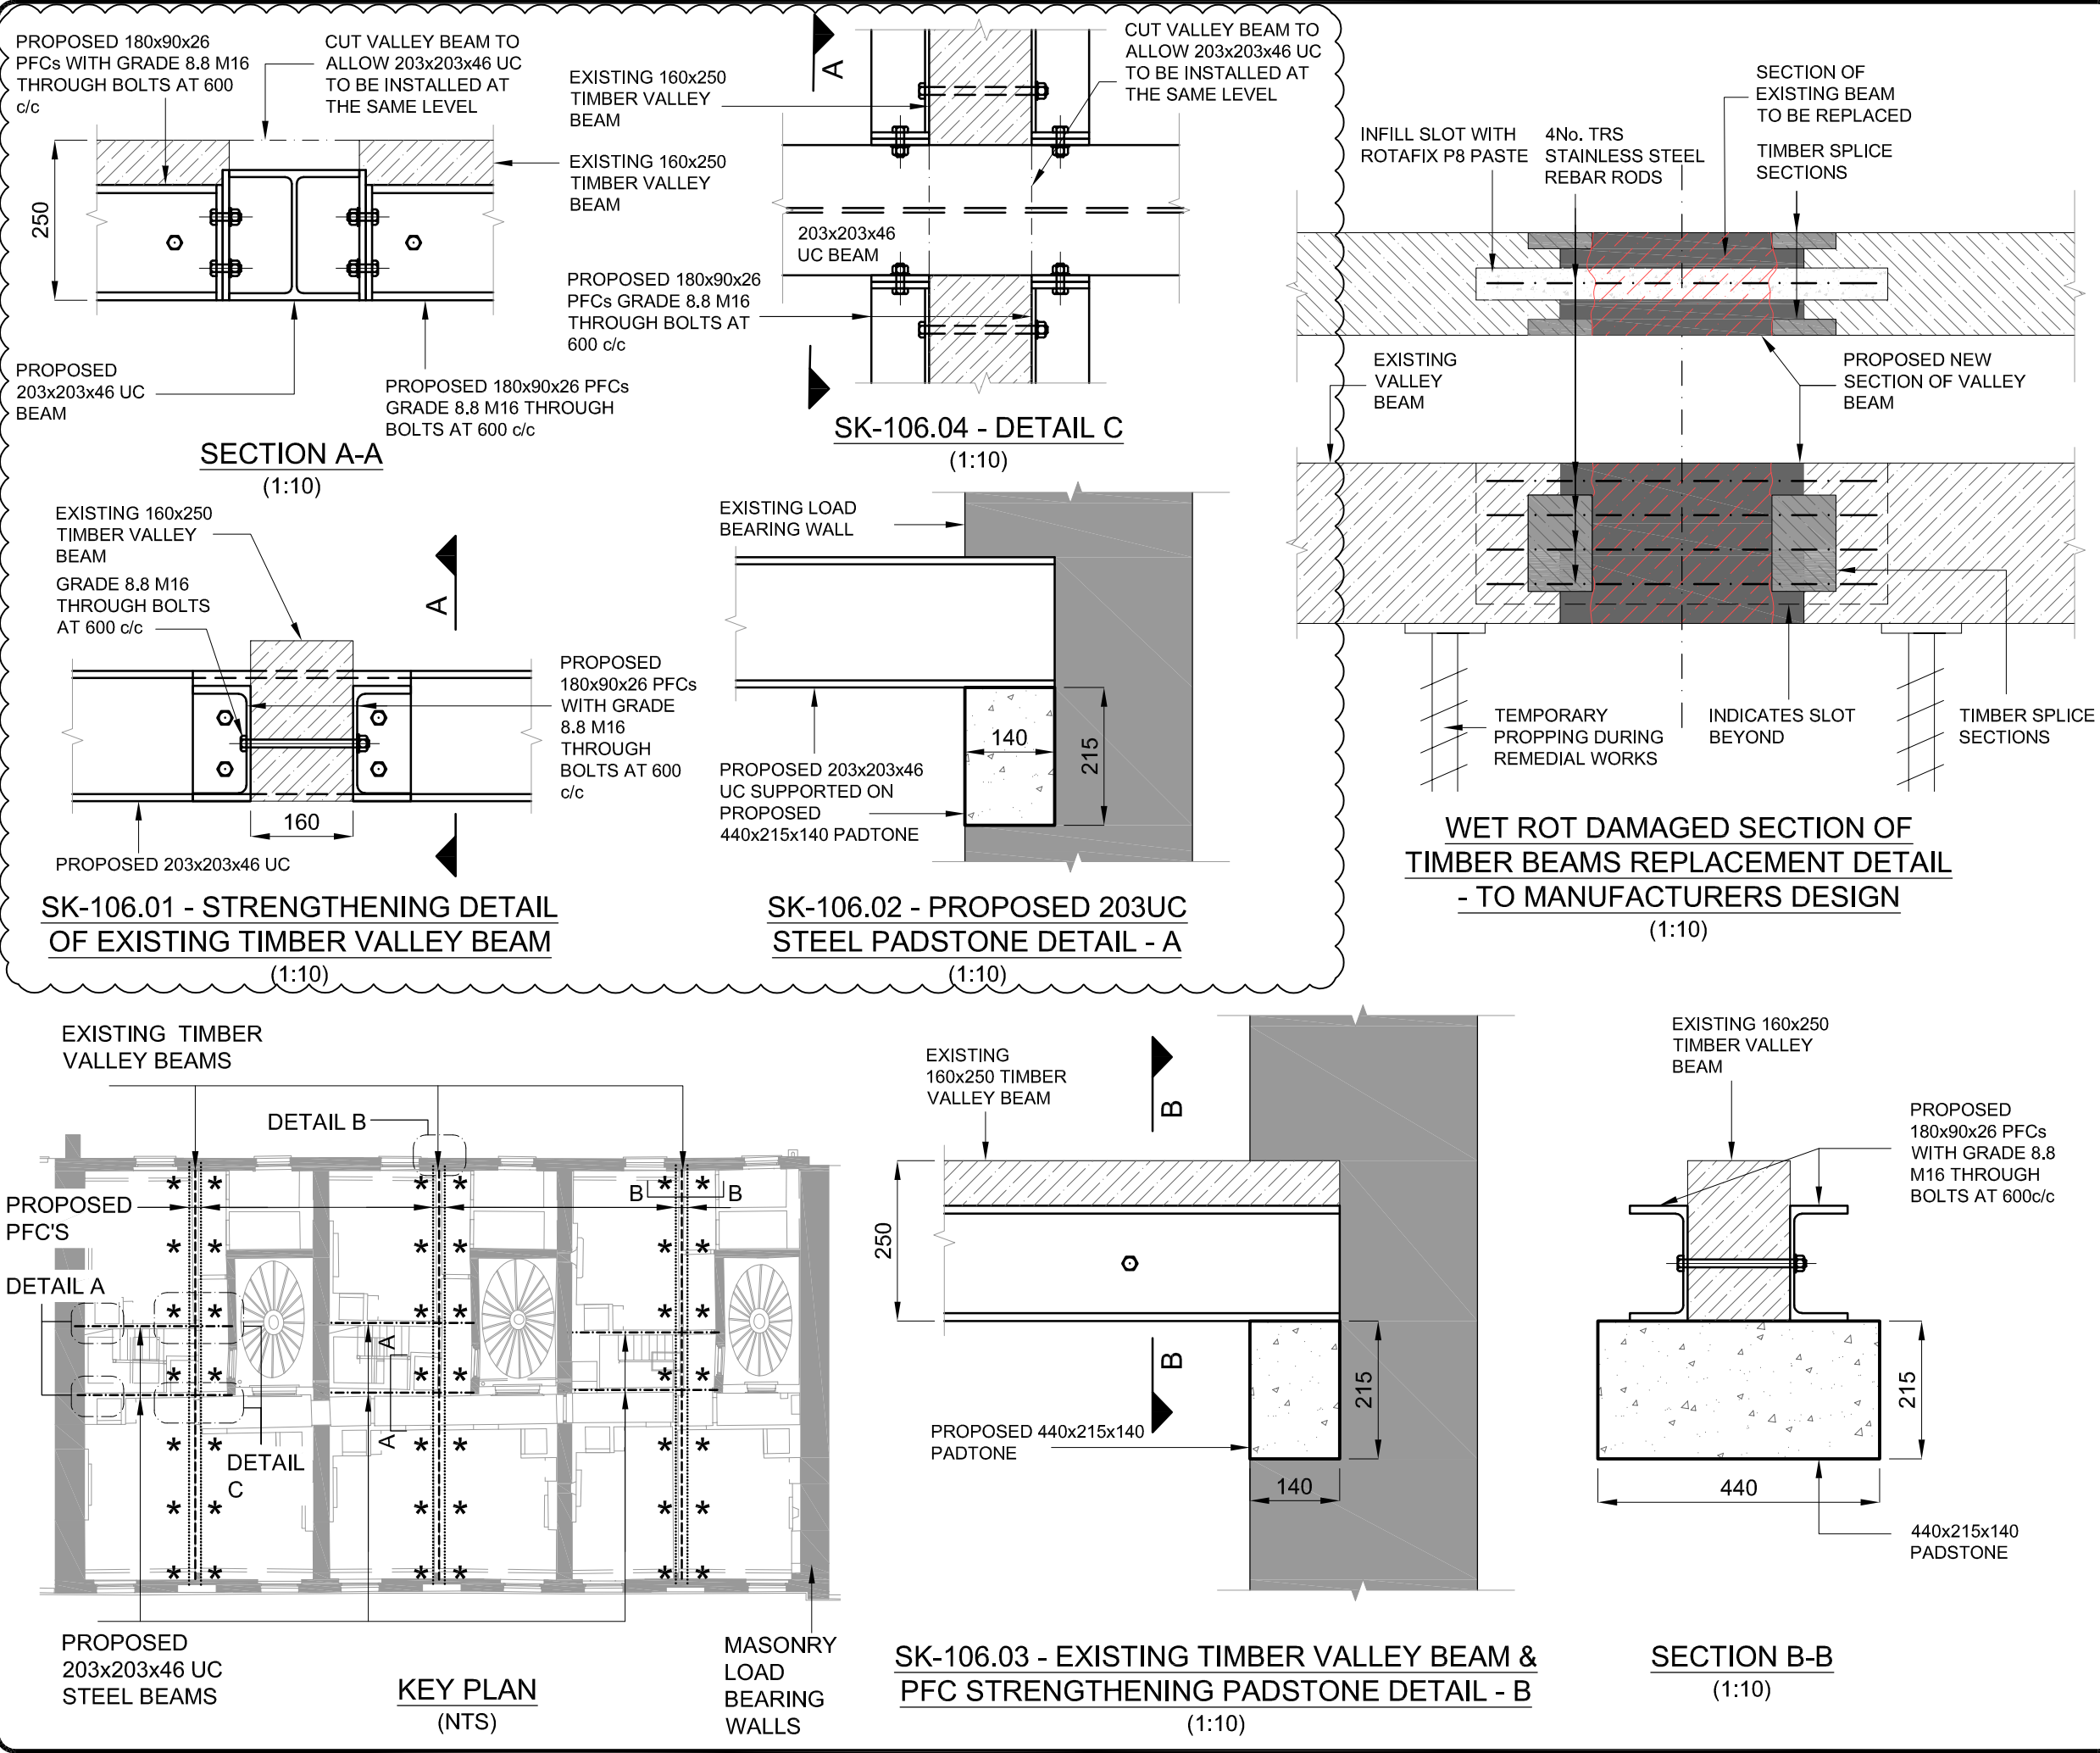
BPL-HYD-XX-03-SK-S-106

- DENOTES AREA AFFECTED BY WET ROT, SHOWN INDICATIVELY

***** - INDICATES TEMPORARY PROPPING REQUIRED TO SUPPORT EXISTING ROOF STRUCTURES DURING VALLEY BEAM STRENGTHENING WORKS TO CONTRACTOR DESIGN
