Title:	
200944 - Crown Estate Paving Commission (MASTER)	
Client:	
CEPC	
Project:	
Chester Close North	
Date:	Drawn by:
3/10/2022	EB
Drawing No:	Scale:
200944	1:500@A4

TIM MOYA ASSOCIATES

Chester Close North

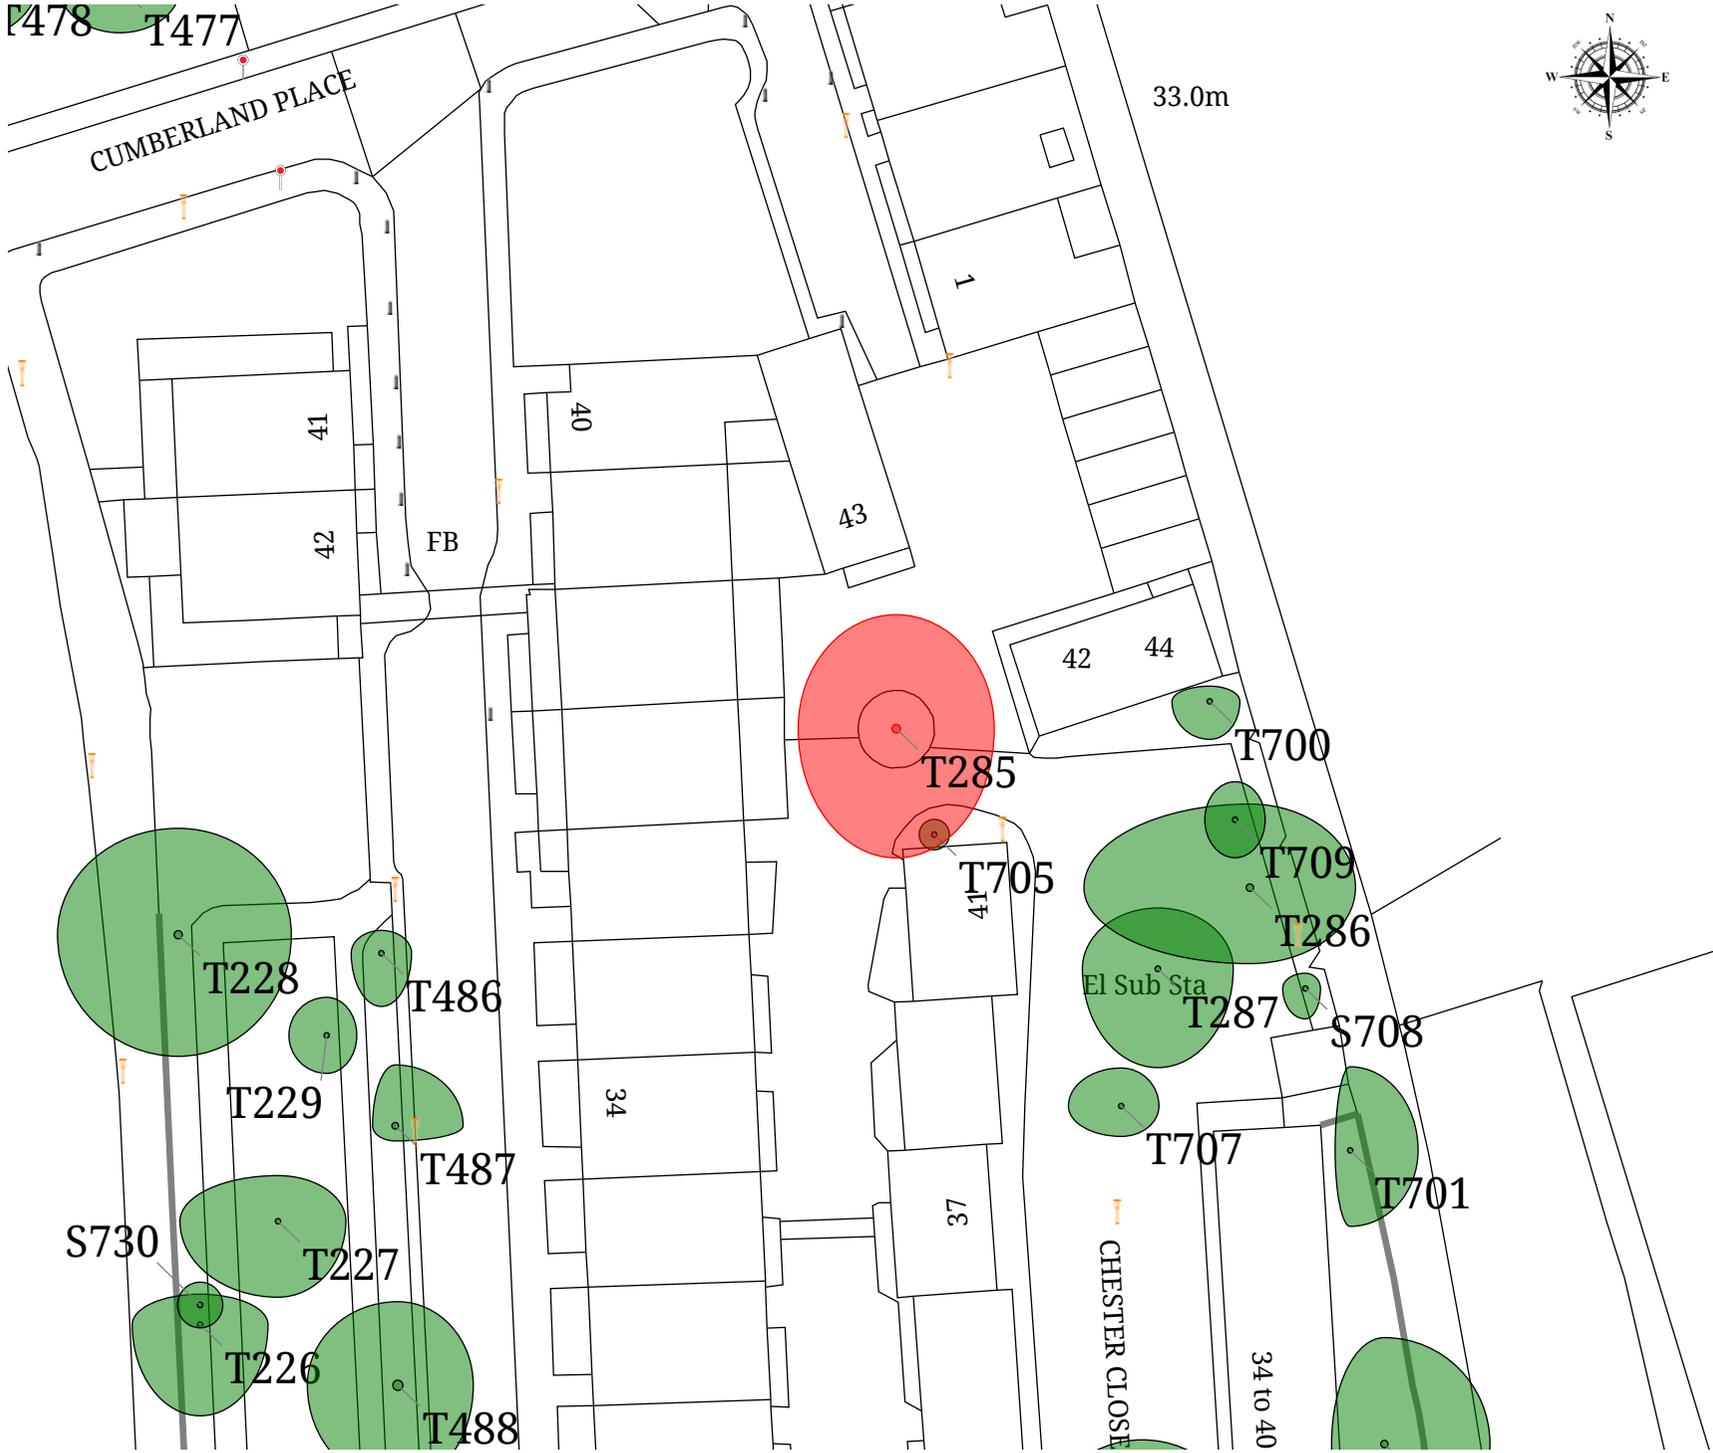
Tree No (old tag)	Vegetation type	Species	No. of stems	Height (m)	Crown spread	DBH (cm)	Life stage	Vitality	Physiological Condition	Structural Condition	Safe Life Expectancy	Access	CAVAT value (£)/ Crown area (m2)
T285 (n/a)	Tree	1 Acer platanoides 'Crimson King' Red Norway Maple	1	16.0	17.0	57	Mature	Low	Poor	Fair	5-10 yrs	Good	£17645.40 / 226.98m2
Site Features	Targets	Conditions	Notes										Survey date/ Surveyor
Tree in hard surface or tree pit. Underground services within crown spread.	Building within falling distance of tree. Main drive within or adjacent to canopy.	Buttresses / buttress roots - Minor adaptive growth / moderate development. Bark wound - Physical damage or vandalism. Die-back - Throughout crown. Decline - Suspected. Decay / structural defect in crown limb / limbs - Localised. Deadwood - Major. Girdling roots - Minor. Pruning wounds - Suspected compartmentalised. Root environment - Compacted. Stems - Co-dominant.	Decline possibly associated with compacted root plate on eastern side, traffic driving over island bed. Traffic collisions on low branches.										2022-09-12. /Dean Meadows.

Site Features	Targets	Conditions	Notes			Survey date/ Surveyor
Tree in hard surface or tree pit. Underground services within crown spread.	Building within falling distance of tree. Main drive within or adjacent to canopy.	Buttresses / buttress roots - Minor adaptive growth / moderate development. Bark wound - Physical damage or vandalism. Die-back - Throughout crown. Decline - Suspected. Decay / structural defect in crown limb / limbs - Localised. Deadwood - Major. Girdling roots - Minor. Pruning wounds - Suspected compartmentalised. Root environment - Compacted. Stems - Co-dominant.	Decline possibly associated with compacted root plate on eastern side, traffic driving over island bed. Traffic collisions on low branches.			2022-09-12. /Dean Meadows.
Recommendation	- Reduce crown by - Specified extent height and branch length by approximately 2 m to stimulate renewed growth due to decline-induced retrenchment.		Purpose of works	- Appropriate	Safety Action Date	n/a

Risk assessed	Branch failure on to road		Risk of harm range	<1/1 000 000	Risk category	1

Recommendation	- Reduce crown by - Specified extent height and branch length by approximately 2 m to stimulate renewed growth due to decline-induced retrenchment.						Purpose of works	- Appropriate			Safety Action Date	n/a	
Risk assessed	Branch failure on to road						Risk of harm range	<1/1 000 000			Risk category	1	
Tree No (old tag)	Vegetation type	Species	No. of stems	Height (m)	Crown spread	DBH (cm)	Life stage	Vitality	Physiological Condition	Structural Condition	Safe Life Expectancy	Access	CAVAT value (£)/ Crown area (m2)
T285 (n/a)	Tree	1 Acer platanoides 'Crimson King' Red Norway Maple	1	16.0	17.0	57	Mature	Low	Poor	Fair	5-10 yrs	Good	£17645.40 / 226.98m2
