## Arboricultural Appraisal Report

### Subsidence Damage Investigation at:

Flats 1 - 9  
8 Compayne Gardens  
London  
NW6 3DH

CLIENT: Crawford & Company  
 CLIENT REF: [REDACTED]  
 MWA REF: [REDACTED]  
 MWA CONSULTANT: Andy Clark  
 REPORT DATE: 15/09/2021

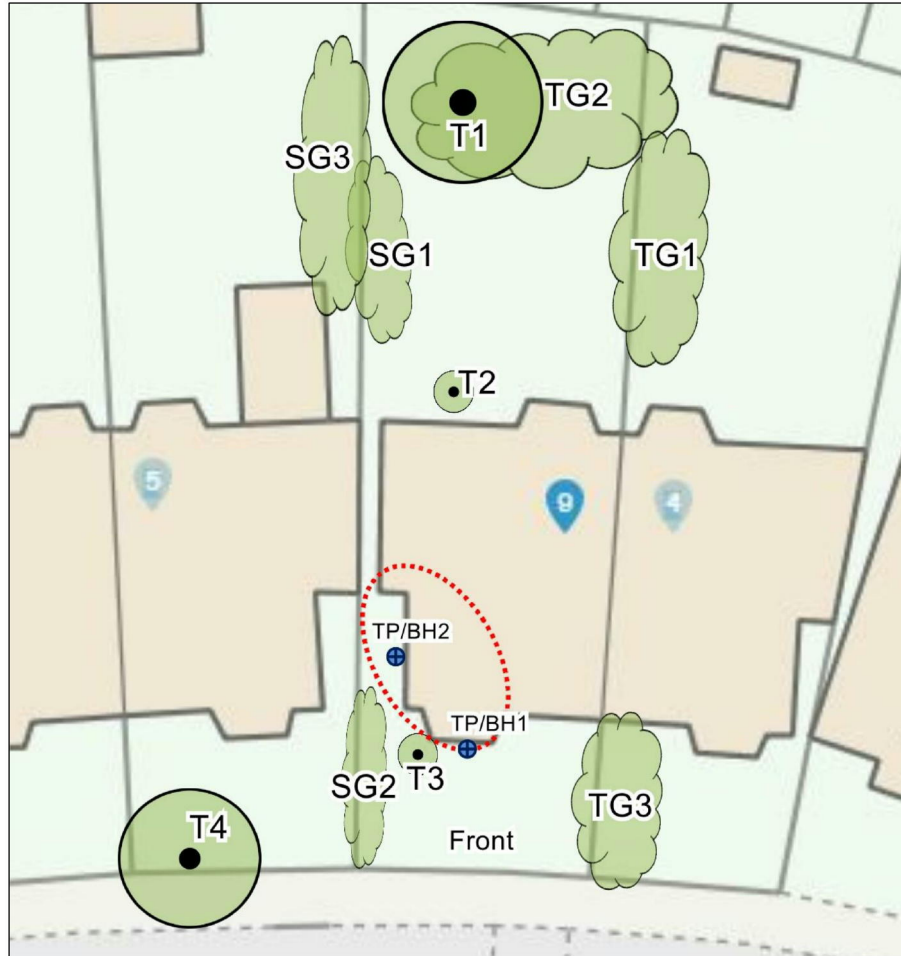
Site Plan

Approximate areas of damage

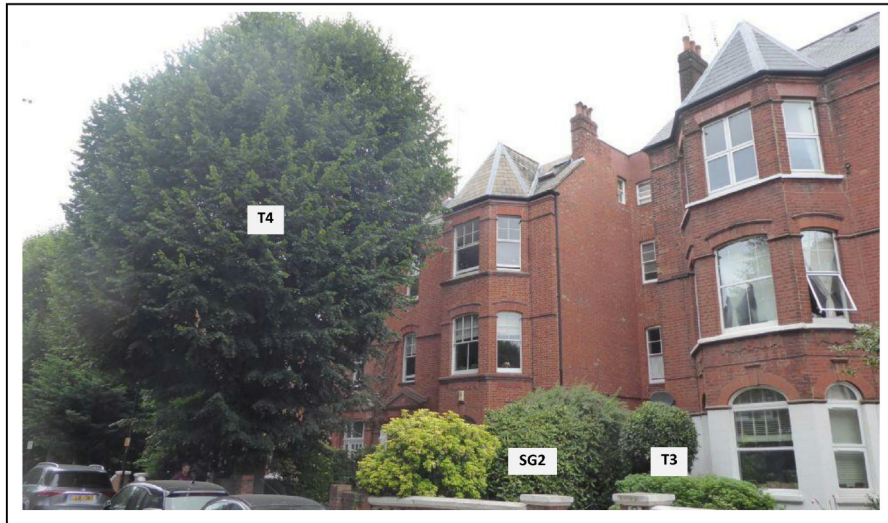
Based on the technical reports currently available, engineering opinion and our own site assessment we conclude the damage is consistent with shrinkage of the clay subsoil related to moisture abstraction by vegetation. Having considered the information currently available, it is our opinion that T4 Lime is the principal cause of the current subsidence damage, combined with a localised contributory influence from SG2 group and T3 Bay.

Overview of T4 Lime, SG2 group and T3 Bay

If an arboricultural solution is to be implemented to mitigate the influence of the implicated trees/vegetation we recommend that T4 and T3 are removed and that SG2 group is subject to significant crown reduction works in order to reduce the groups collective moisture uptake.

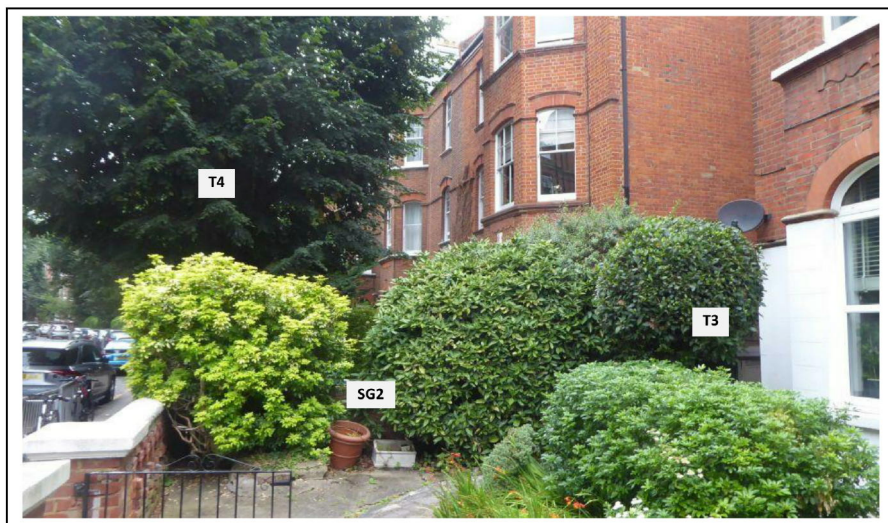
Damage relates to the front left-hand corner of the building, with cracking noted over several floors. Damage is reported to have first been observed during 2018/19 which worsened becoming a concern during 2020.

View of T4 Lime, SG2 group and T3 Bay adjacent to front left corner of the building

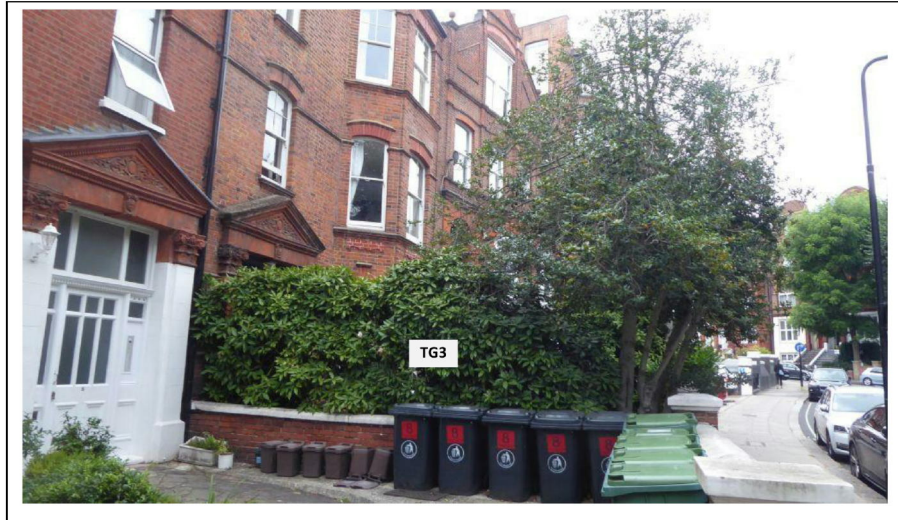
View of TG3 group

Management history		No significant past management noted.					
Recommendation		None at present.					
TG3	Aucuba, and Holly group	6.5	220	3.0	0.6	Younger than Property	Third Party 6 Compayne Gardens NW6 3DH
Management history		Subject to past management/pruning - appears regularly pruned.					
Recommendation		Reduce height of group to 2.0m and cut back sides to leave crown spread of no more than 1.0m. Trim thereafter on an annual cycle to maintain at broadly reduced dimensions.
