Site Investigation Report

Job Information	
Client	Crawford & Co
Client ref	[Redacted]
Visit date	05/07/2021
Report date	07/07/2021

Auger were commissioned by Crawford & Co to undertake a site investigation and CCTV inspection of the underground drainage within the area of concern at the property.

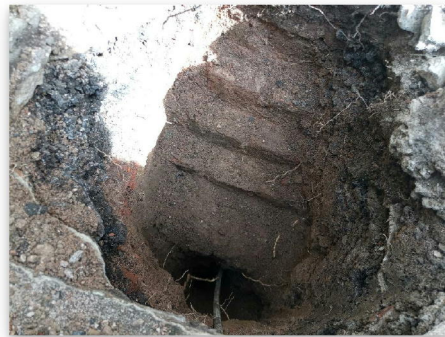
Fig 1.2: Trial Hole 1 Footing

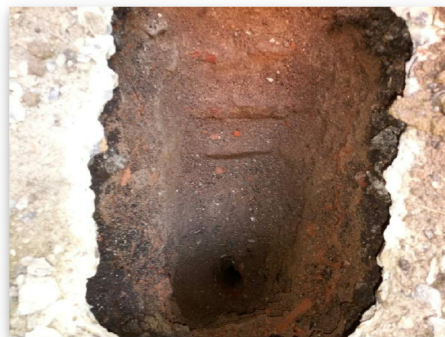
Fig 2.2: Trial Hole 2 Footing

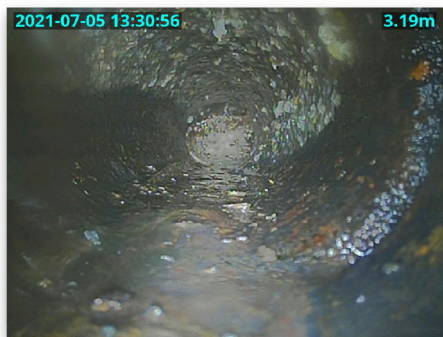
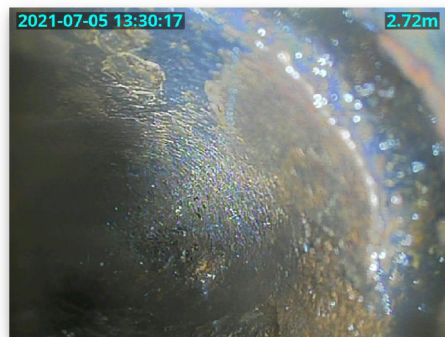
Our CCTV survey revealed joint displacements to the SVP rest bend and the pipework downstream from this point, this will be resulting in an escape of water. The SVP was found to extend below the ground to the level of the manhole before reaching the rest bend and then extending into the manhole.

The above mentioned defects to the below ground drainage system have been caused by ground movement.

Fig 3.1: Line 4, joint displacement

Fig 3.2: Line 4, joint displacement

Line 2 - Auger recommend to install 1.5m of 100mm flexi liner from MH1 upstream then install a 100mm radial patch on the rest bend from MH1.

Please Note: Deep MH entry will be required.

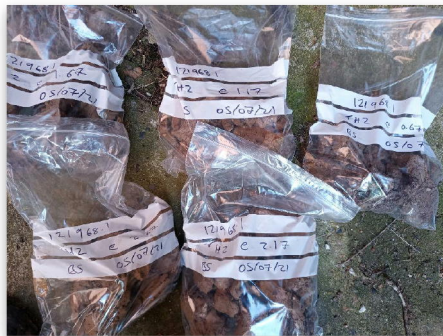
Fig 4.5: Soil samples collected

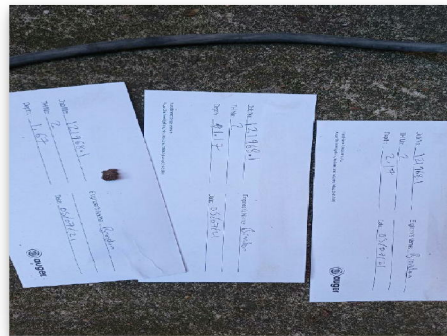
Fig 4.6: Root samples collected
