26 Fitzroy Square

Visual Structural Inspection Report
for
Avery Real Estate Limited

20th May 2022

Project No. 99657

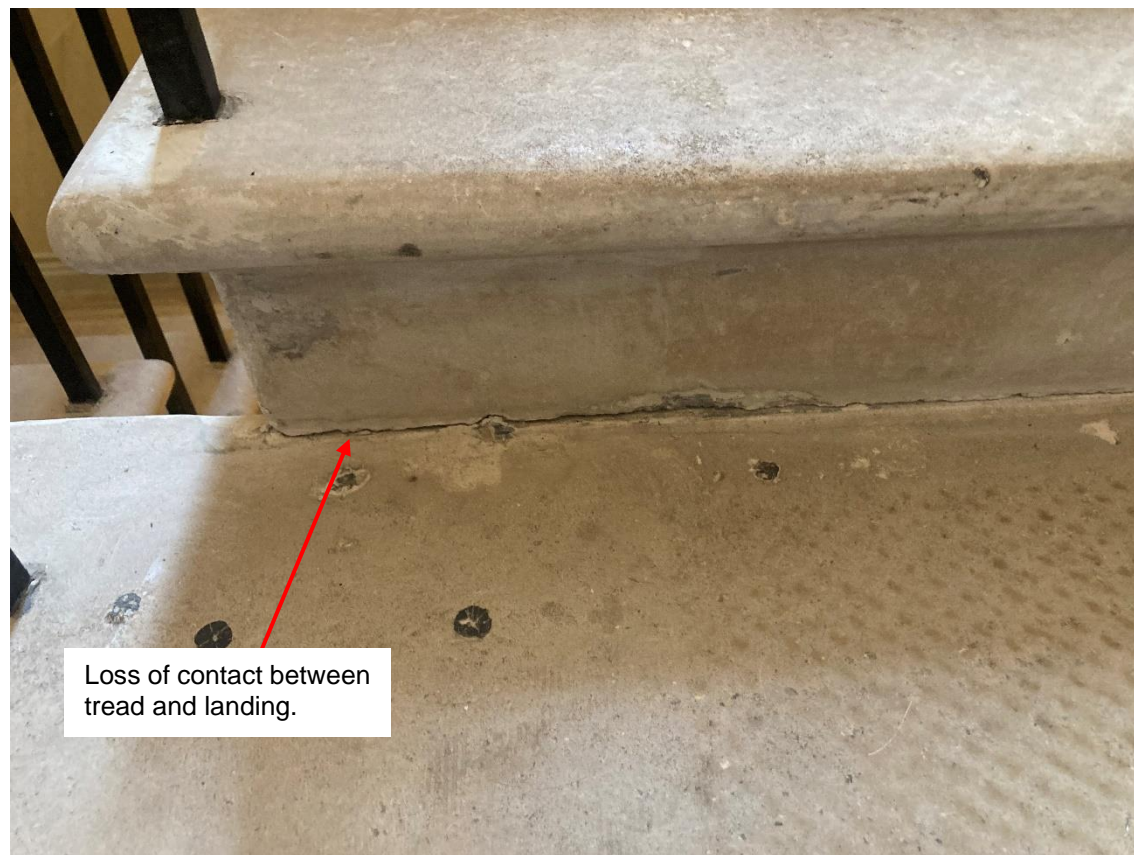
Photos of cracking at the construction joint that had occurred around the first tread above the first-floor landing are shown in Figures 1 & 2. Upon inspection it was evident that the cracking had been caused by a lack of contact between the tread and the landing, thus resulting in a reduction of the transfer of compressive forces between the two. Overall, this means that more reliance is placed upon the embedment of the tread into the wall.

Figure 1: Cracking between first floor landing and first tread above.

Following the site inspection, DCL suspects that the looseness and observed movement of the treads was likely caused by the first floor landing dropping slightly, thus resulting in a loss of contact between the landing and the tread above.

In order to confirm that this is the case, DCL advises that the coving and ceiling beneath the first floor landing are opened up locally for the inspection of the bearing/embedment of the landing. Since the building is Grade II* listed, it is possible that approval will be needed from the Westminster Conservation team before the coving is removed.

DCL forecasts that the repair to the stairs will likely consist of reinstating good contact between the landing and the tread above by jacking up the landing. This can be achieved either by rebricking and repacking the area beneath the slab or by providing a new bracket support to the landing. The required repairs to the landing and treads will be subject to change following the results of the additional opening up works.

Once solid contact is reinstated between the treads, the construction joints in the stairs can be reinstated by raking out the existing resin and injecting new resin at any treads that were previously loose.

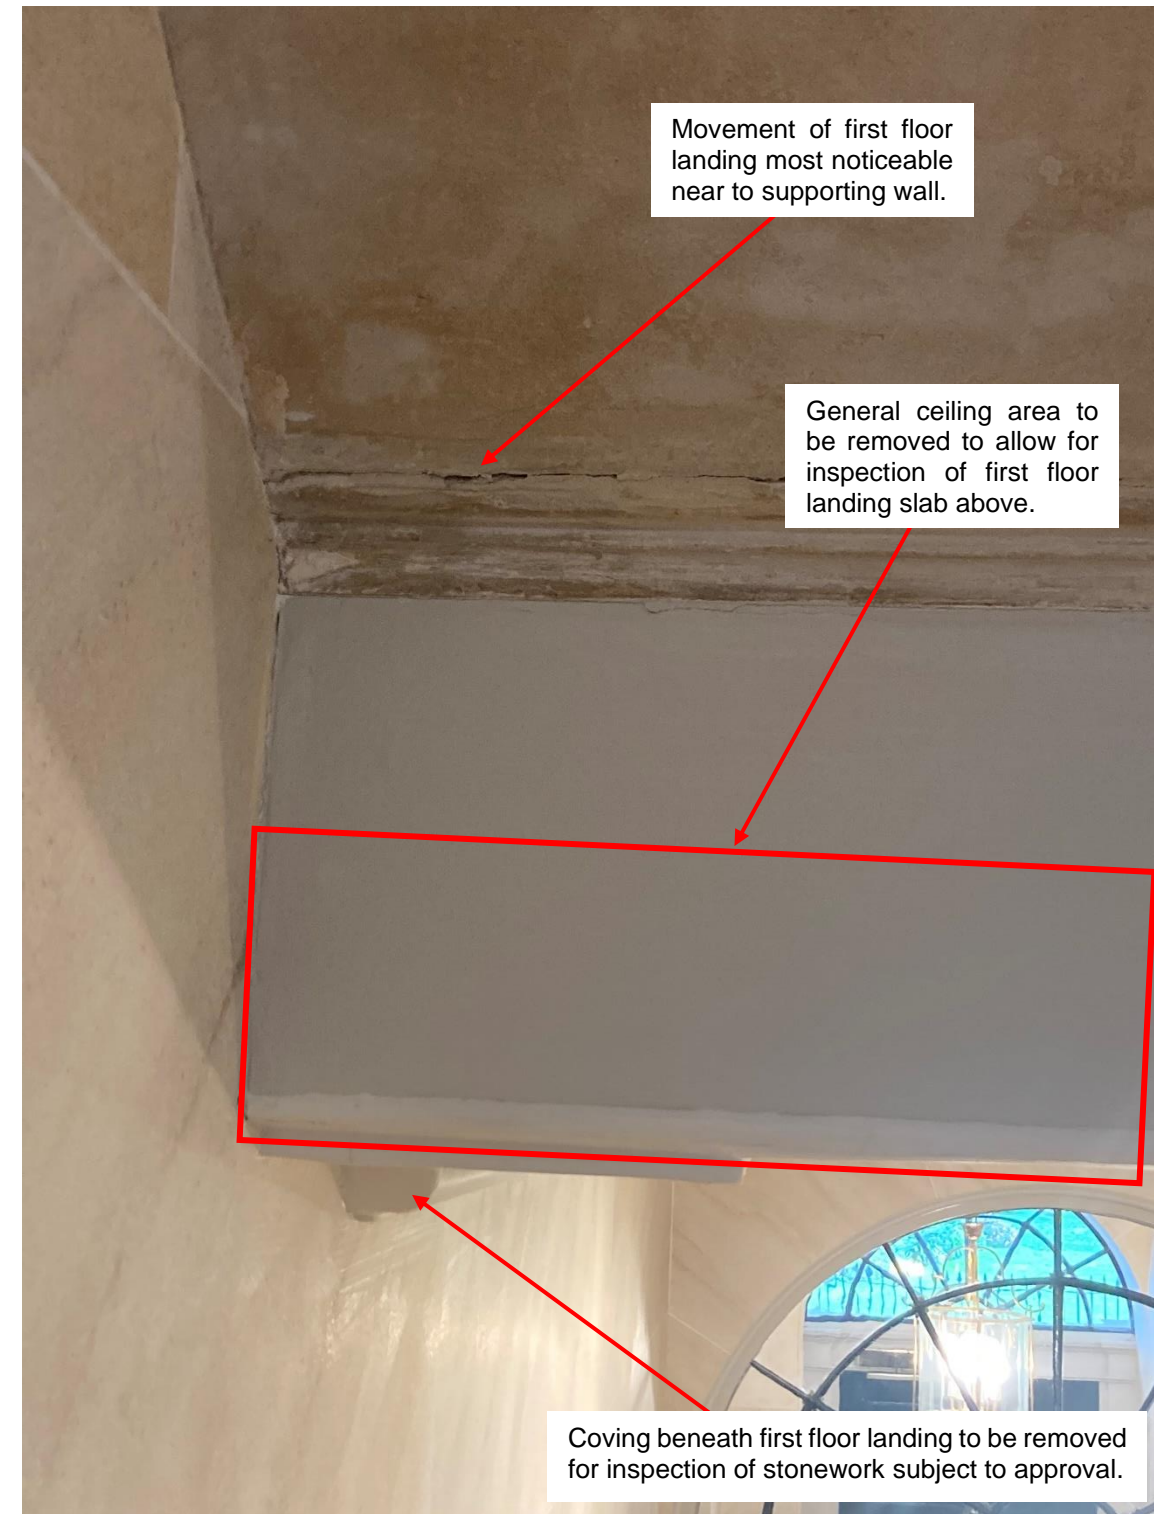
When the landing was jumped upon from above, noticeable movement of the stonework could be seen. The movement that occurred in the landing was most noticeable near to the supporting wall as shown by the cracking in Figure 2. This indicated that there could have been insufficient embedment of the landing into the wall as a result of small movements over time.

Figure 2: Cracking around rebate between first floor landing and first tread above.

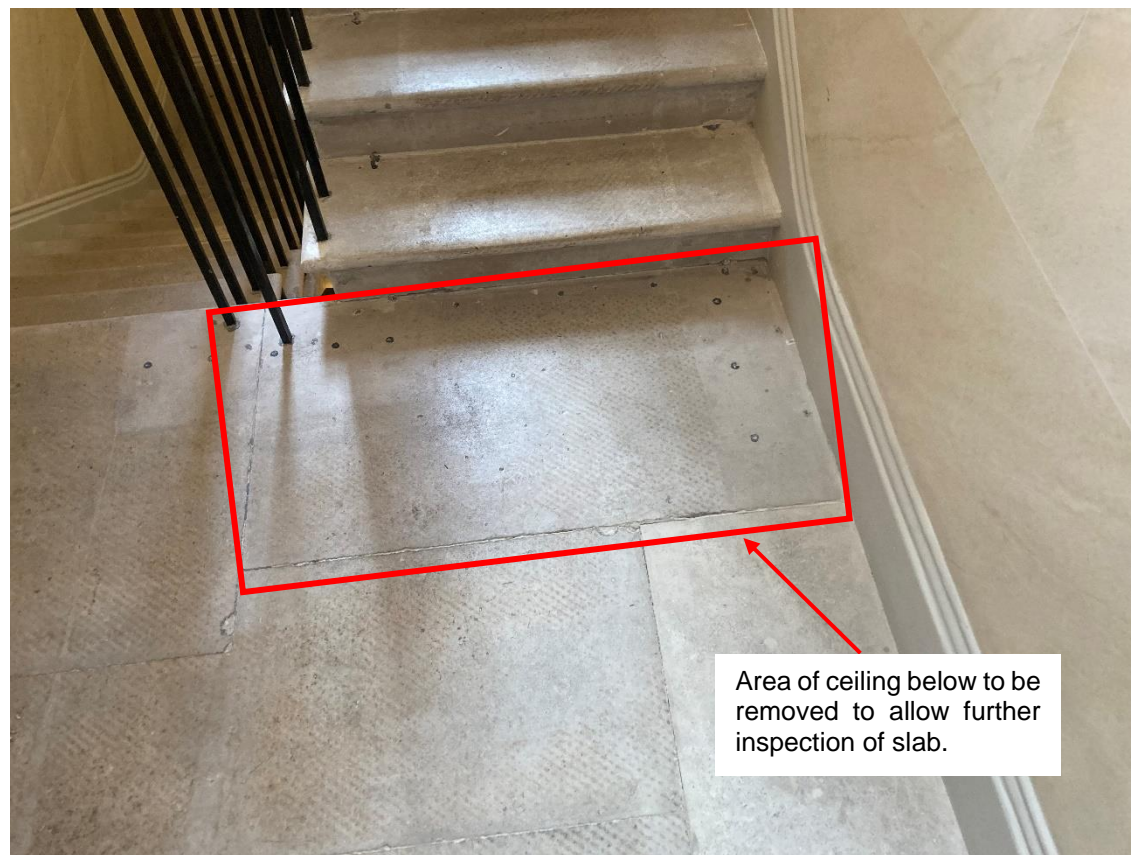
As can be seen in Figure 3, the first floor landing comprised of several stone slabs which had been joined together.

Figure 3: View of first floor landing.

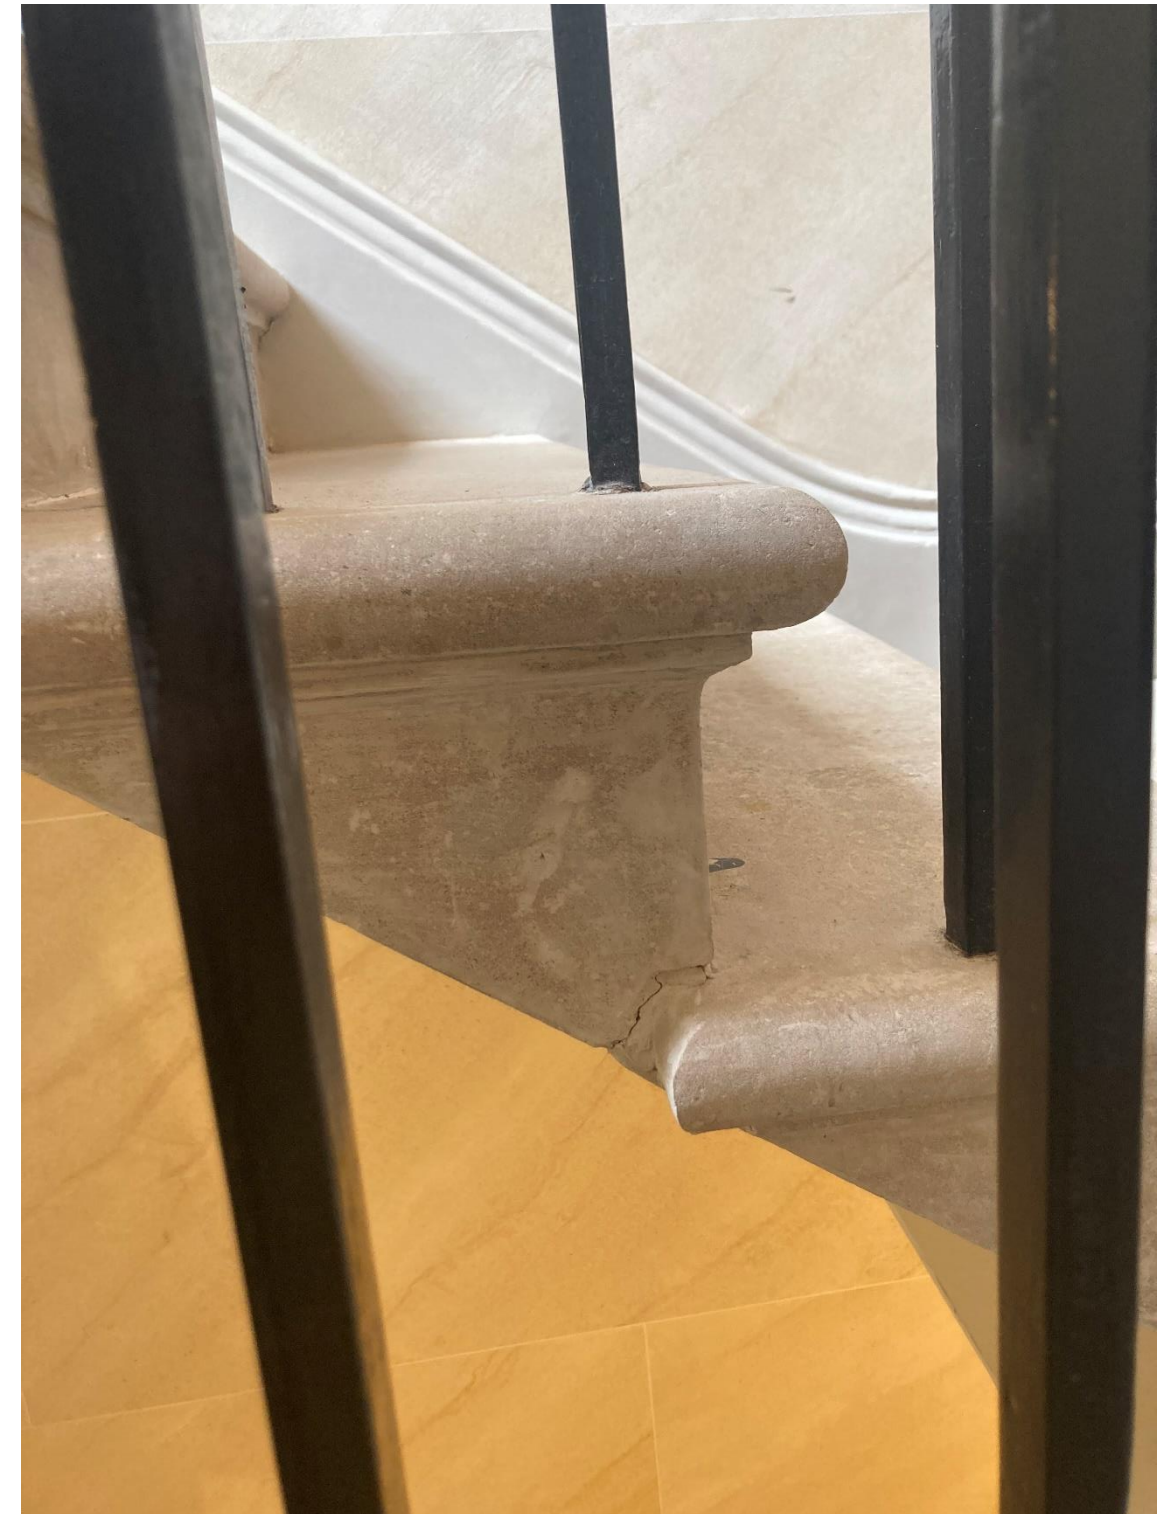
Figures 4 & 5 show some cracking of the stone at the rebate joints of the second and third treads respectively. Both these treads as well as the first tread showed some movements when jumped on from above. The most noticeable movement occurred in the first tread and decreased with each tread. The fourth tread and the treads above did not show any signs of movement.

Figure 4: Cracking of stone at rebate construction joint of second tread.

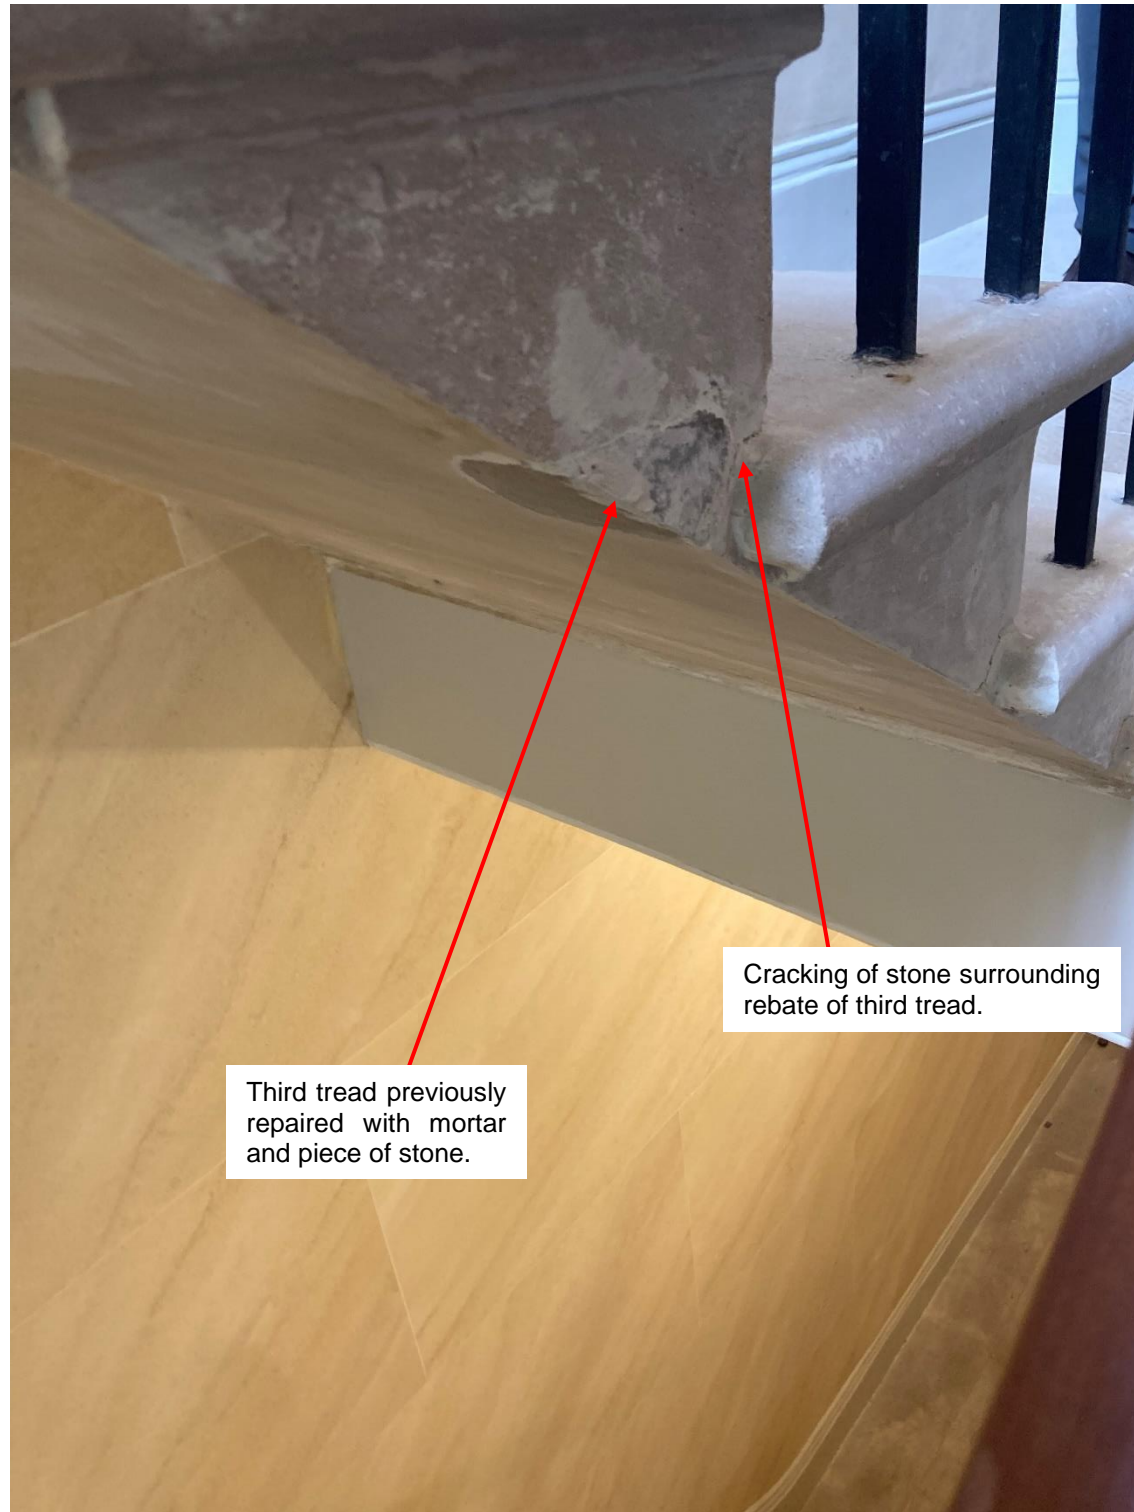
Figure 5: View of third tread above first floor landing showing previous repair and cracking.
