STRUCTURAL INSPECTION REPORT

Retaining Party Fence Wall between
28 & 30 Redington Road
London
NW3 7RB

19117-SYM-RP-S-002

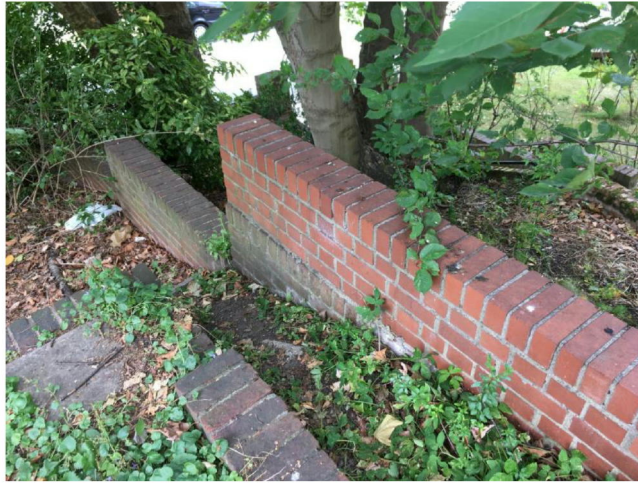
Figure 2 - Retaining party fence wall to front of property taken from No.28 facing Redington Road

- 5.1 The proposals include extensive excavation works to the front of the property to install a new attenuation tank and re-landscape the driveway.
- 5.2 The existing front party fence retaining wall should be demolished and rebuilt as part of these works, utilising the space on the side of No. 28 Redington Road for the new foundation as required.

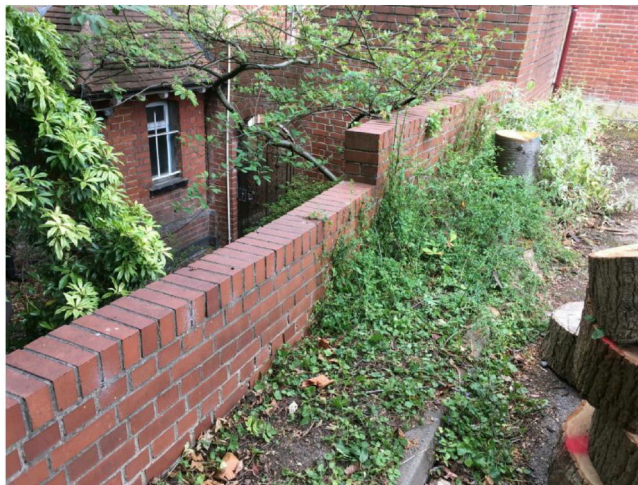
Figure 3 - Retaining party fence wall to front of property taken from No.28 facing the property

- 3.8 At some point in the past the masonry to the walls to the front had been extended vertically.
- 3.9 The retained heights varied to the front as the land sloped down towards the road, but closest to the property the level difference was approximately 1.5m
- 3.10 The party fence wall to the rear of the property was of the same construction as the front, albeit covered in foliage on the side of No. 30 Redington road, as shown in Figure 4.

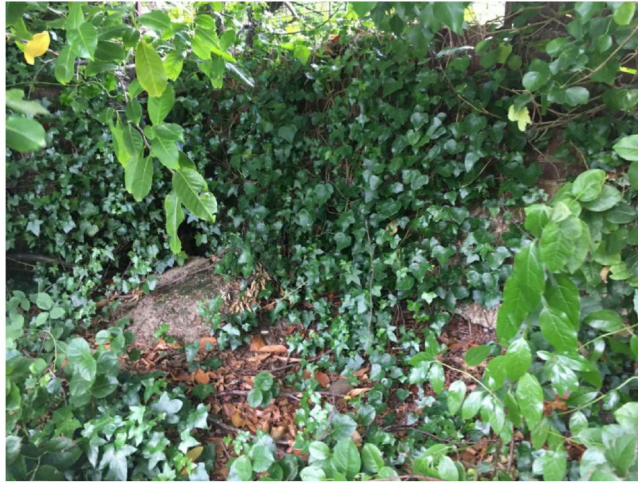
Figure 4 - Retaining party fence wall to rear of property taken from No.30 facing the garden

- 3.11 To the rear the retained height was approximately 0.8m.
- 3.12 There were a number of trees present to front and the rear of the property in close proximity to the retaining walls.

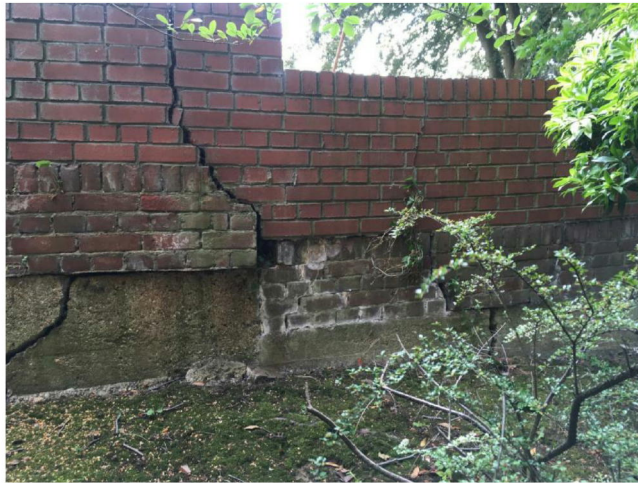
4.1 The retaining wall to the front of the property had failed in a number of locations.

4.2 This failure was evident from the large cracks which could be seen along the wall's elevation, as seen in Figures 5 and 6.

Figure 5 - Cracking to the front party fence retaining wall taken from No. 30

- 6.1 The party fence retaining wall to the front of the properties shows signs of failure and should be replaced.
- 6.2 The distress to the wall is most likely caused by a number of factors including:
 - The trees nearby increasing earth pressure on the wall from the side of No. 28 Redington Road.
 - The wall has been extended in the past, presumably to allow for the raising of the ground level on the side of No. 28 Redington – increasing the earth pressure on the wall.
 - Shallow foundations.
- 6.3 The party fence retaining wall to the rear of the property showed little sign of distress and therefore can remain in its current form.

- 5.3 The wall will be designed to the latest building codes, in a material to be determined, but would be faced in brickwork to maintain the same appearance as the existing.

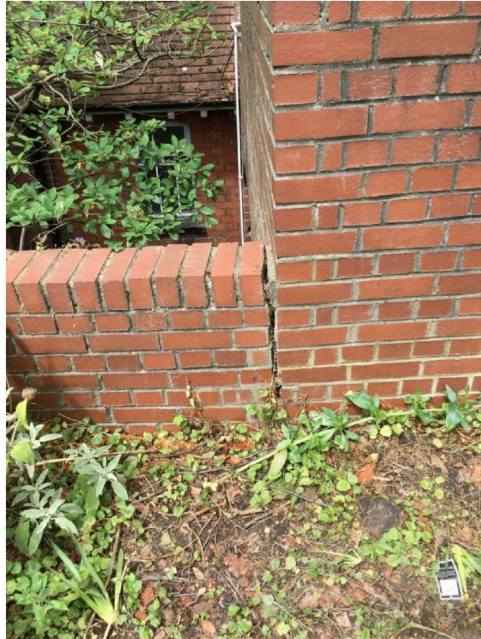
Figure 6 - Cracking at the junction between the party fence wall and party wall to the front of the property taken from No. 28

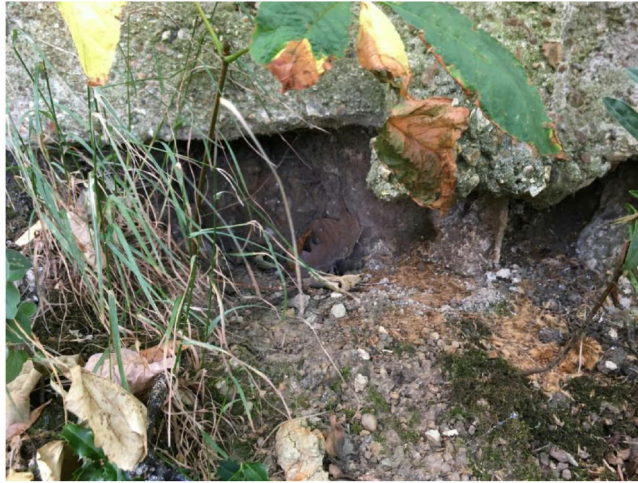
- 4.3 The existing wall foundations were very shallow.
- 4.4 The base of the foundation was at around the same level as the ground level on the side of No.30 Redington Road.
- 4.5 It could be seen in two locations that animals had burrowed beneath the wall, as seen in Figure 7, which confirms the shallow profile of the foundation.

Figure 7 - Evidence of burrowing beneath the shallow foundations of the party fence retaining wall taken from No. 30

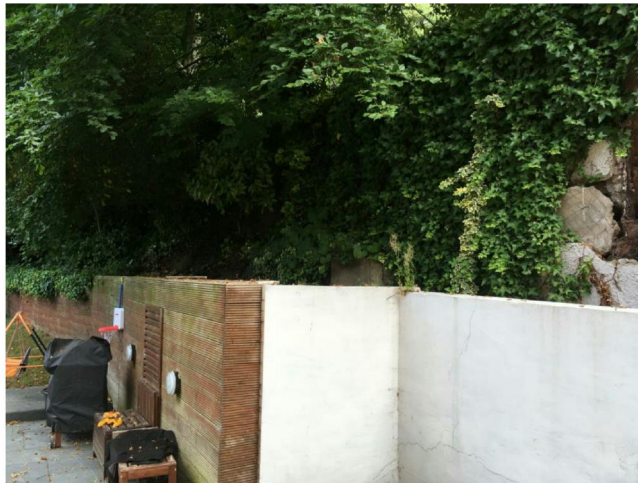
- 4.6 To the rear of the property, the retaining party fence wall between No. 28 and No.30 was masonry founded on mass concrete shallow footings.
- 4.7 There was a second retaining wall inset approximately two meters from the boundary on the side of No. 30 Redington Road – Refer to Figure 9 for sectional profile.

Figure 8 - Garden retaining wall inset from the party fence retaining wall taken from No. 30 facing the garden

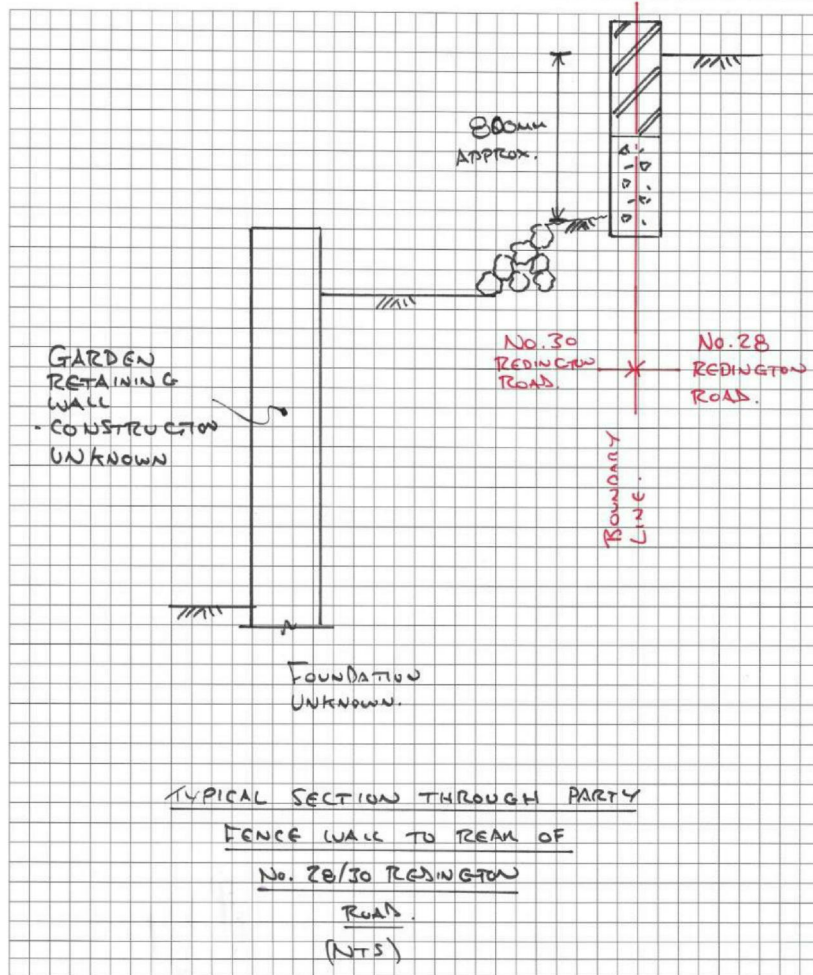
Figure 9 - Typical section through party fence retaining wall to rear of No. 28/30 Redington Road

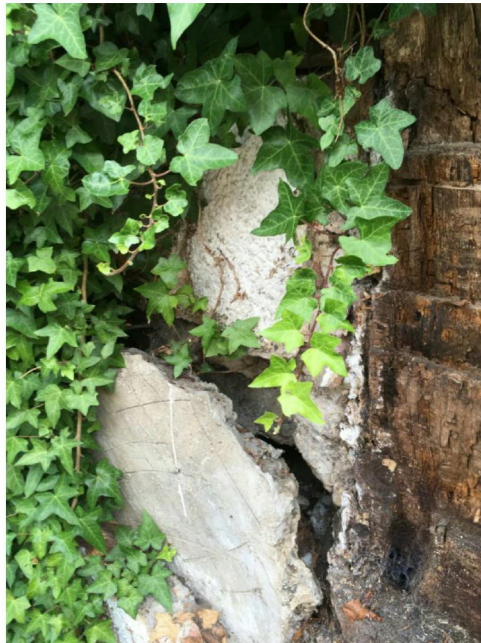
- 4.8 The party fence retaining wall showed little sign of movement.
- 4.9 An existing tree stump remained within the line of the wall, and this was where some movement has taken place.

Figure 10 - Cracking at junction between rear party fence retaining wall and tree stub taken from No.30

- 5.5 The proposed ground levels to No. 28 are broadly unchanged adjacent to the wall.
- 5.6 This wall could remain as there is no concern regarding the safety of the occupiers in relation to this wall in its current condition.

- 5.7 If there is a desire to replace the wall for aesthetic reasons, care would need to be taken to not destabilise the trees in close proximity to the wall during construction.

- 5.8 This could be undertaken utilising a post and beam solution – minimising excavations.

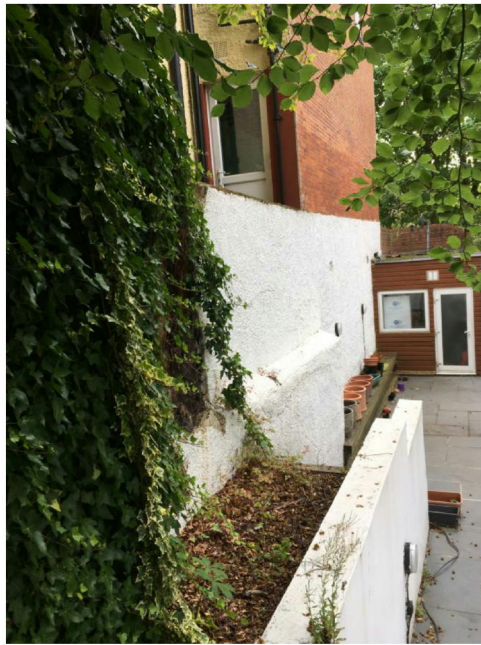
- 4.10 There was a large stepped retaining wall adjacent the rear of the property which retains approximately 3m of earth and shows no sign of distress.

Figure 11 - Photo taken from rear of No.30 facing south west showing party wall/stepped party fence wall and inset garden retaining wall
