Dead Dog Basin Footbridge

Inspection and Assessment Report

Document Ref: 10049461-ARC-SBR-01-RP-SE-0001

DECEMBER 2021

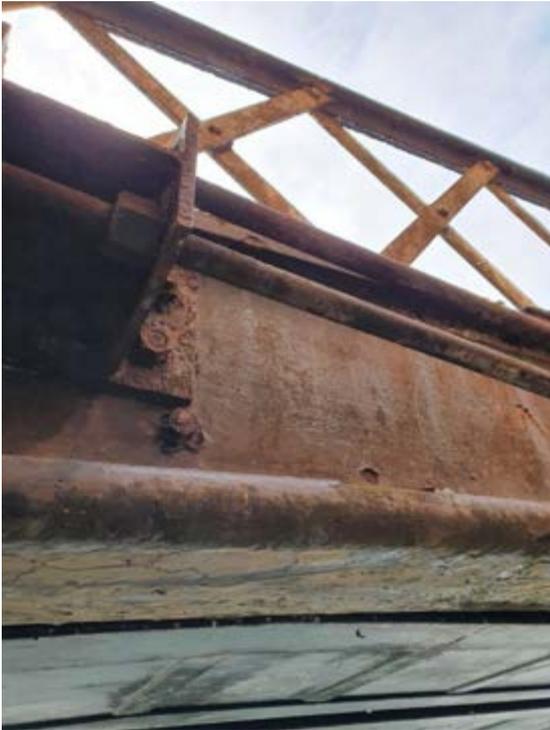
- Delamination caused by general surface corrosion is noted along the entire length of both the canal side and basin side edge I girders. (See Photos 1 – 3).
- Full thickness section loss in the lower flange to the canal side edge I girder measured approximately 65mm in width at the midspan. (See Photos 4 – 5).
- Full thickness section loss in the lower flange to the canal side edge I girder toward the west abutment measured approximately 70mm in width and 30mm into the flange. (See photos 6 – 7)
- Pitting to the web on the basin side edge I girder toward the west abutment. (See photo 12)

Photo 1: Corrosion of north side edge I girder

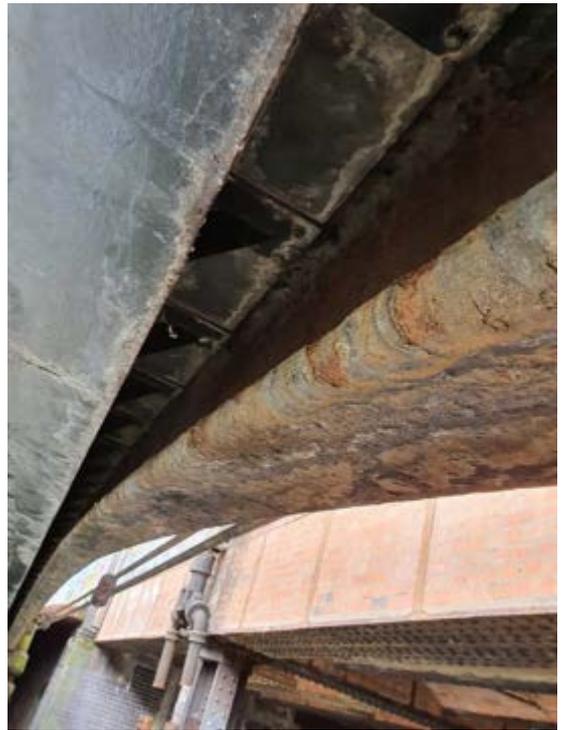
Photo 2: Delamination of northside edge I girder

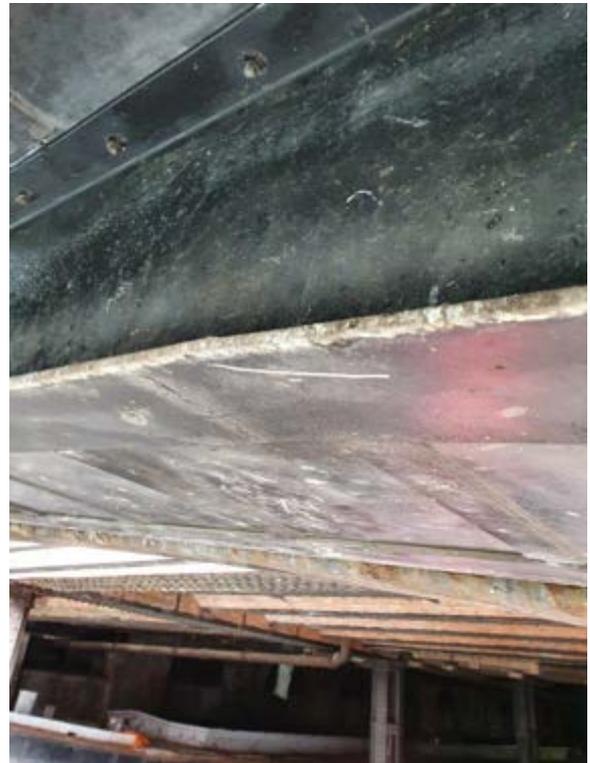
- The steel beams have minor corrosion on the edges of the flanges and minor deterioration of paintwork throughout. (See Photos 8 – 9).
- The shallow, steel deck trays between the steel beams have deteriorating coating possibly caused by damp conditions when the coating was applied. (See Photo 10)
- Pigeon guano at the top of the flanges of the steel beams.
- Corrosion to the base plates of the support brackets, in some cases causing minor section loss of base plate. (See photo 11)

Photo 8: Edge of flange corrosion of central beams

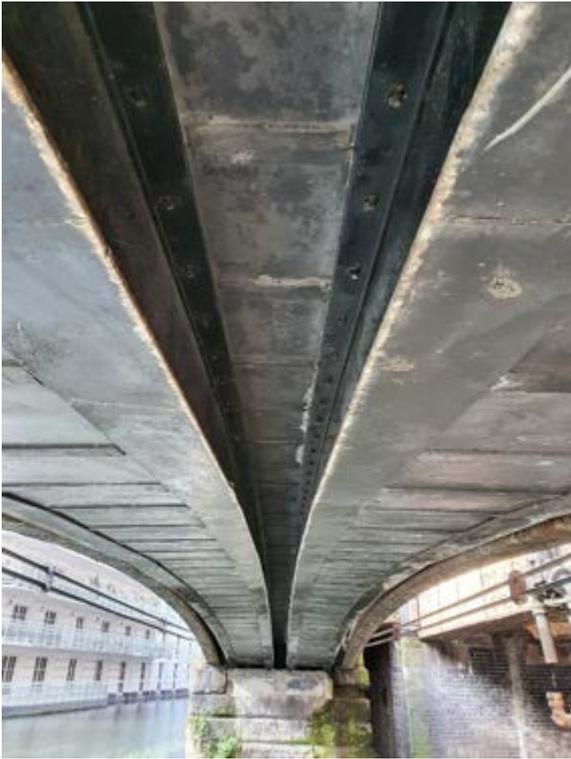
Photo 9: Deterioration of paintwork to central beams and cable trough trays

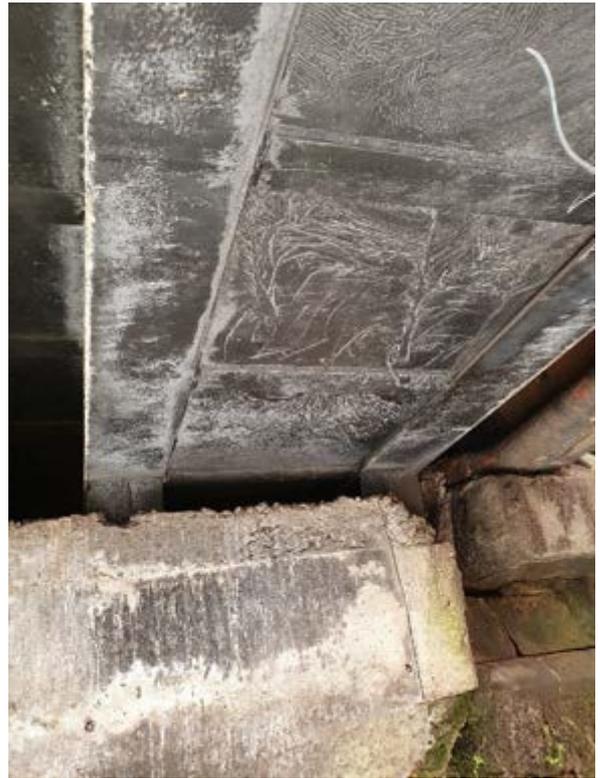
Photo 10: Deterioration of paintwork to cable trough trays

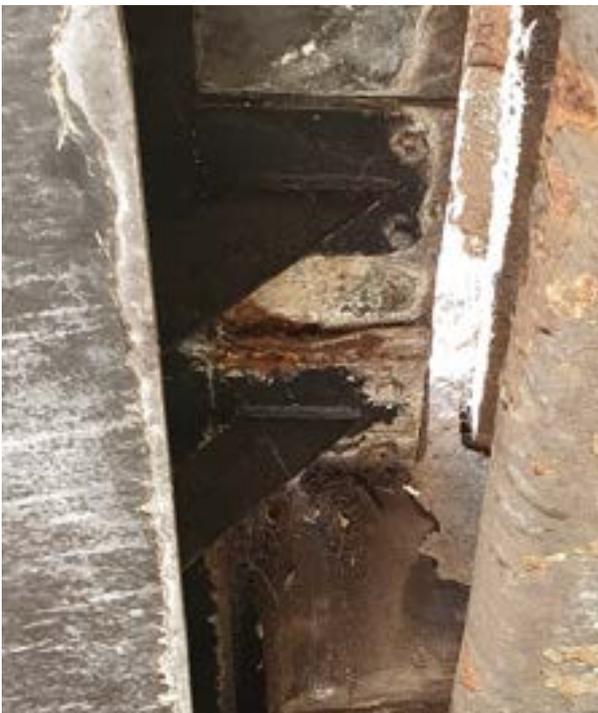
Photo 11: Corrosion to the base plate of the support brackets

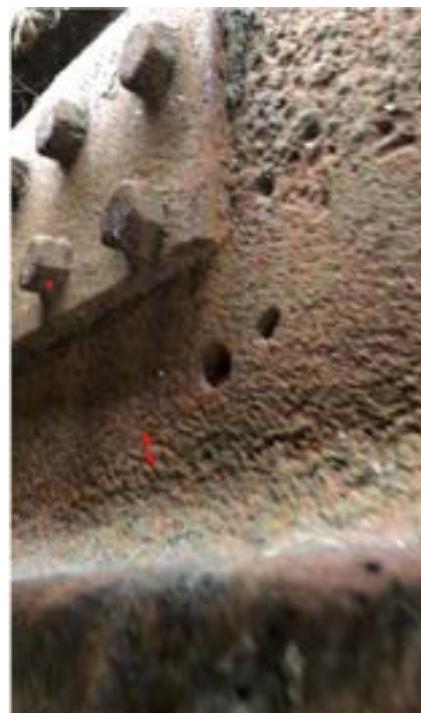
Photo 12: Pitting to the web on the basin side edge I girder

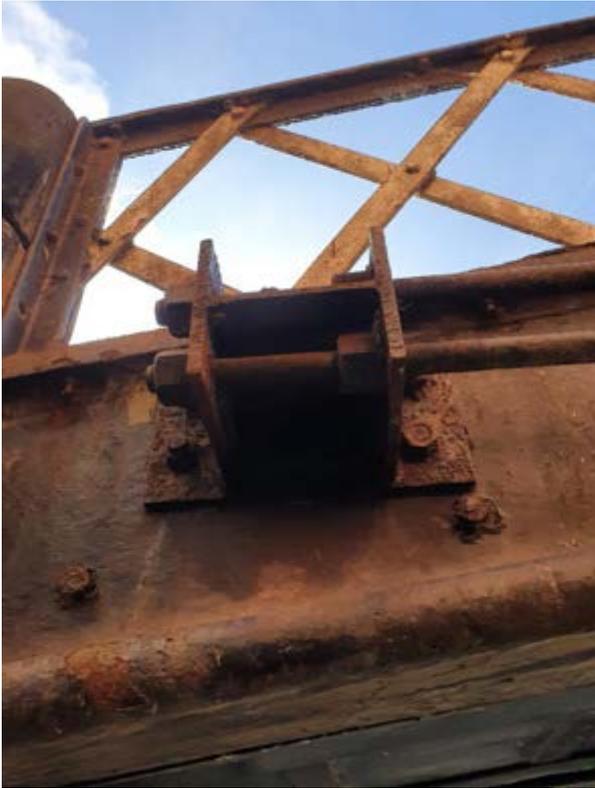
- Surface corrosion to the tie rod clamp I sections and bolts on the basin side I girder. (See photo 13).
- The tie rod on the basin side I girder is providing no structural support to the deck and moves side to side with little applied force.

Photo 13: Corrosion to tie rod clamp and bolts

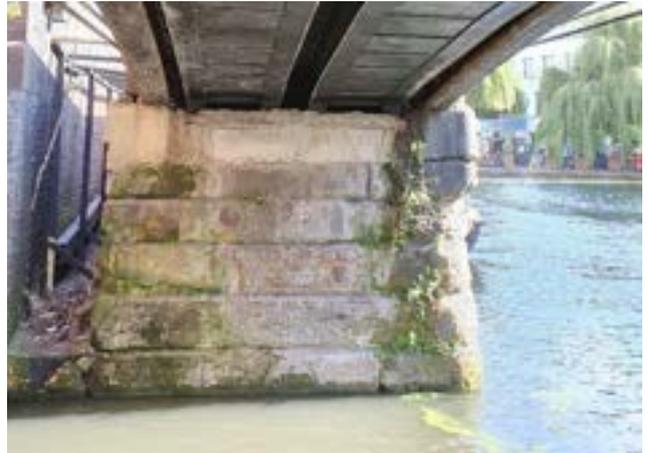
- Corner sections have been broken away by possible boat impact on both abutments. (See photo 14 – 15).
- Vegetation and moss are growing from the brickwork. This can also be seen in photos 14 – 15

Photo 14: Damaged brickwork to east abutment

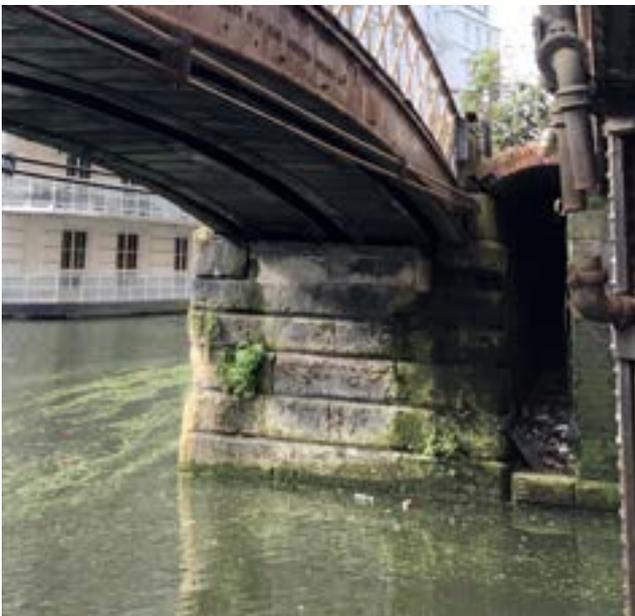
Photo 15: Damaged brickwork to west abutment

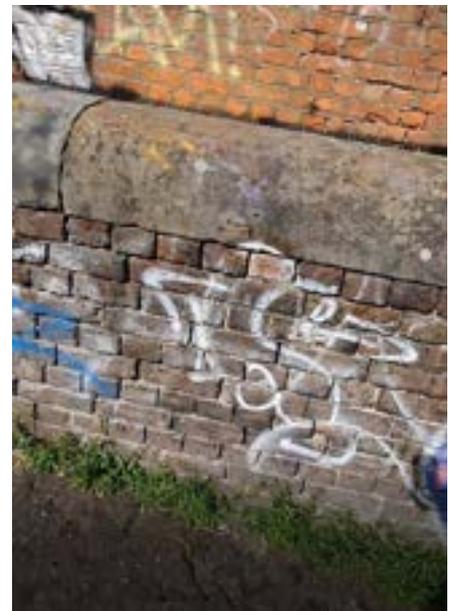
- Minor vegetation growth along the footpath at the base of the wall on the basin side of the ramps. (See photo 16-17).
- Loss of tarmac surfacing to the east ramp. (See photo 18)
- Areas of graffiti to both ramps. (See photos 19-20).
- Approximately 250mm wide hole to the east ramp where it meets with the bridge deck at the base of the canal side ramp parapet. Light is visible through this hole and has accumulated minor debris and detritus. (See photo 21)
- Approximately 150mm wide hole with cracking to the surfacing of the east ramp where it meets with the bridge deck at the base of basin side ramp parapet. Light is visible through this hole and has accumulated minor debris and detritus. (See photo 22).
- A lateral crack in the east ramp approximately 1m away from the bridge deck

Photo 16: Vegetation growth on the east ramp

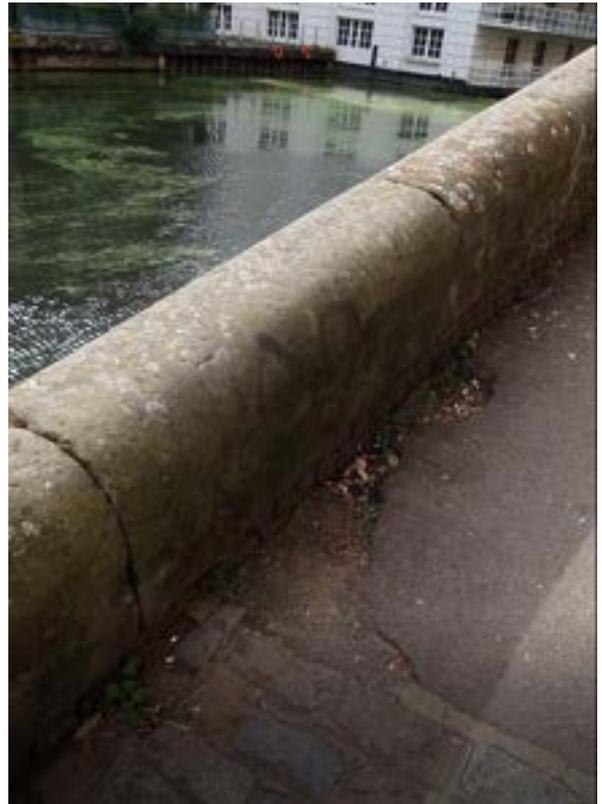
Photo 18: Loss of tarmac surfacing on the east ramp

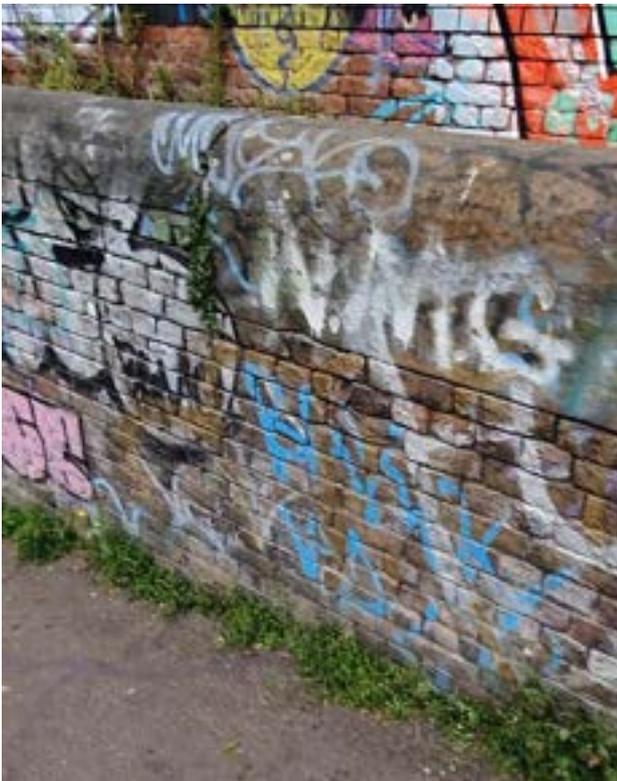
- Extensive graffiti to the boundary wall. (See photo 27)
- Loss of mortar and brick to the boundary wall. (See photo 28).
- Vegetation growth to the boundary wall. (See photo 29).
- Algae staining to the ramp parapet. (See photo 30).

Photo 27: Graffiti to the boundary wall on the west ramp.

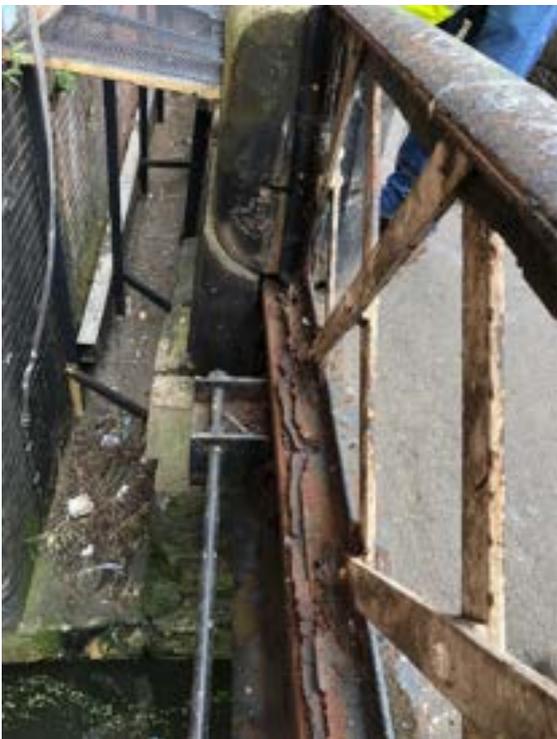
- Significant rusting and delamination of the base T-section at the basin side leading to some section loss and missing bolts that should connect to the edge I girder. (See photo 31 – 33).

The north parapet is noticeably unstable. The primary defects contributing to this instability is the corrosion of the base T section and the loss of connection to the masonry walls at either end. There is a significant difference in condition between the two parapets. The difference being that it appears that the T section at the base of the lattice members on the south side has been replaced more recently as there is very minimal corrosion, however, the corrosion on the same element on the north parapet is extensive and connection has been almost lost between the cast iron beam and the parapet. Our assessment is that the north and south T sections have a condition factor of 0.2 and 0.9 respectively.

Photo 31: Rusting of the base T-section on the basin side parapet.

- Replacement of the lower 'T' section on the north parapet
- Reinstatement of the bolted masonry connections on the north and south parapet.
- Removal of all corroded material and failed paint systems across the entire bridge
- Repainting of all elements on the bridge
- Repointing and replacement of missing masonry on approaches
- Laser scanning of the bridge prior to removal of any elements

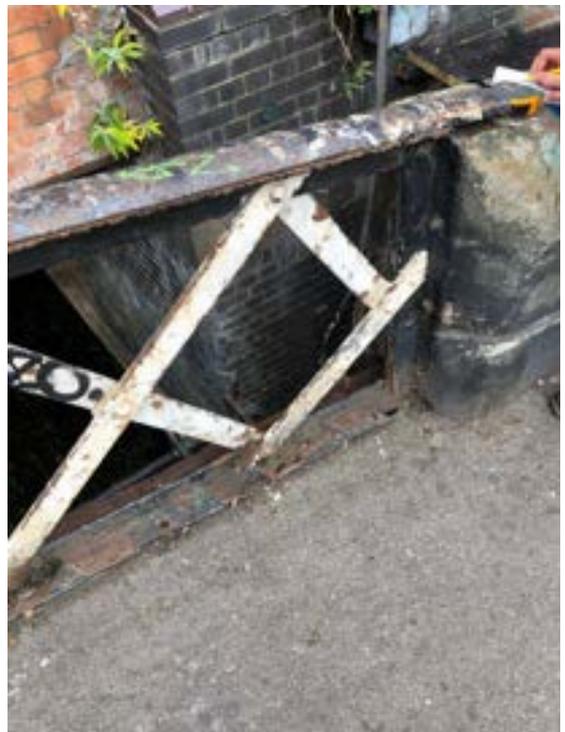
Photo 32: Rusting of the base T-section on the basin side parapet.

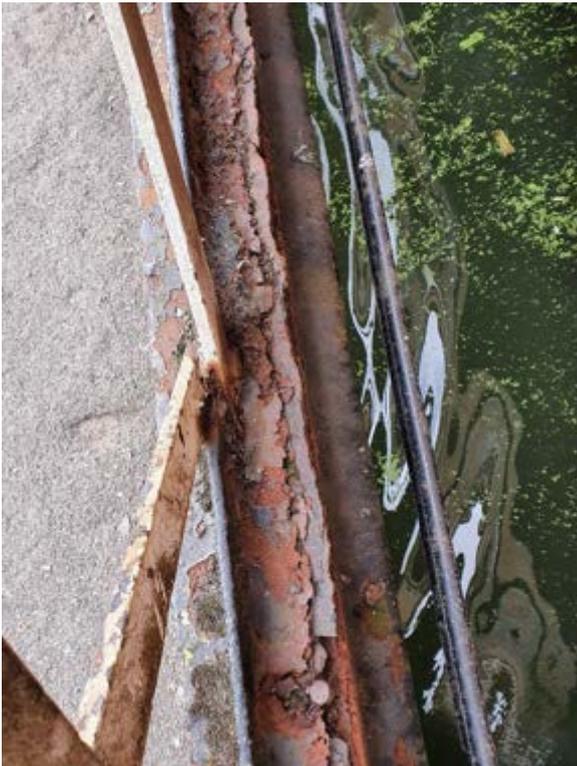
Photo 33: Rusting of the base T-section on the basin side parapet.

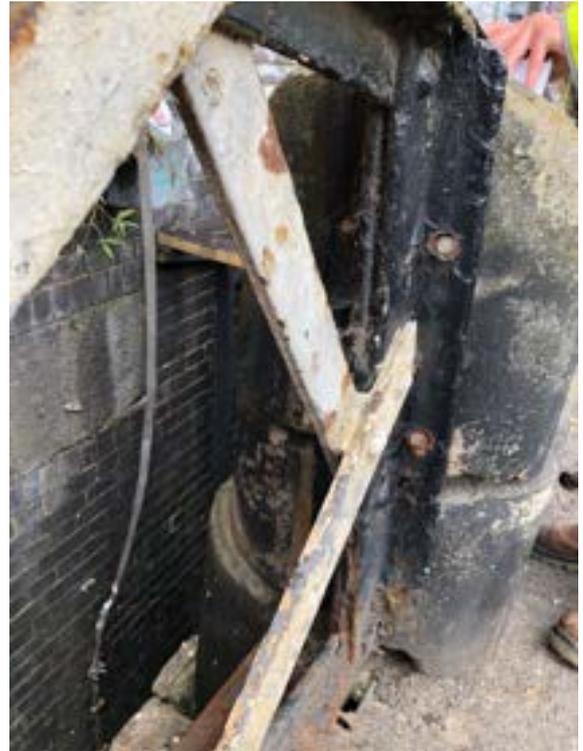
- At the east end, basin side parapet, replacement bolts have been used to secure the end L – plates to the parapet but are now loose making the end of the parapet unsecured and loose. (See photo 34).

Photo 34: Replacement bolts on the L plate of the basin side parapet east side.

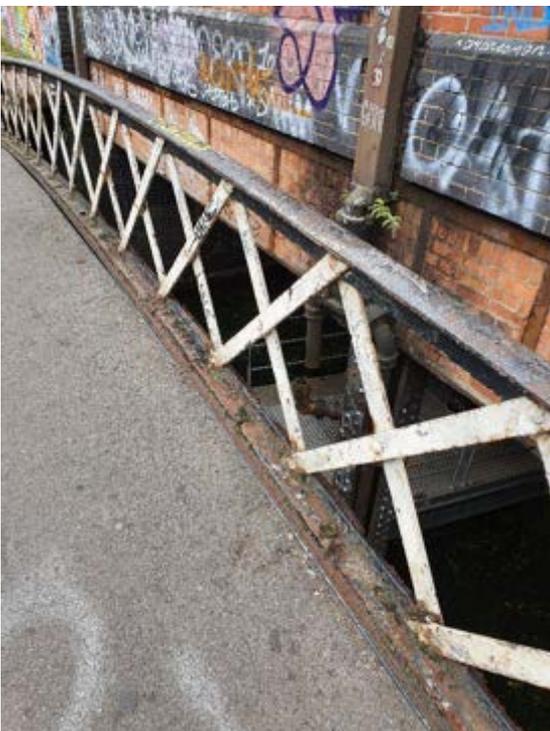
- Lattice work is generally in reasonable condition on both sides of the bridge with deterioration of paintwork and rusting at the bolted connections. (See photo 35).

Photo 35: Lattice work on basin side parapet

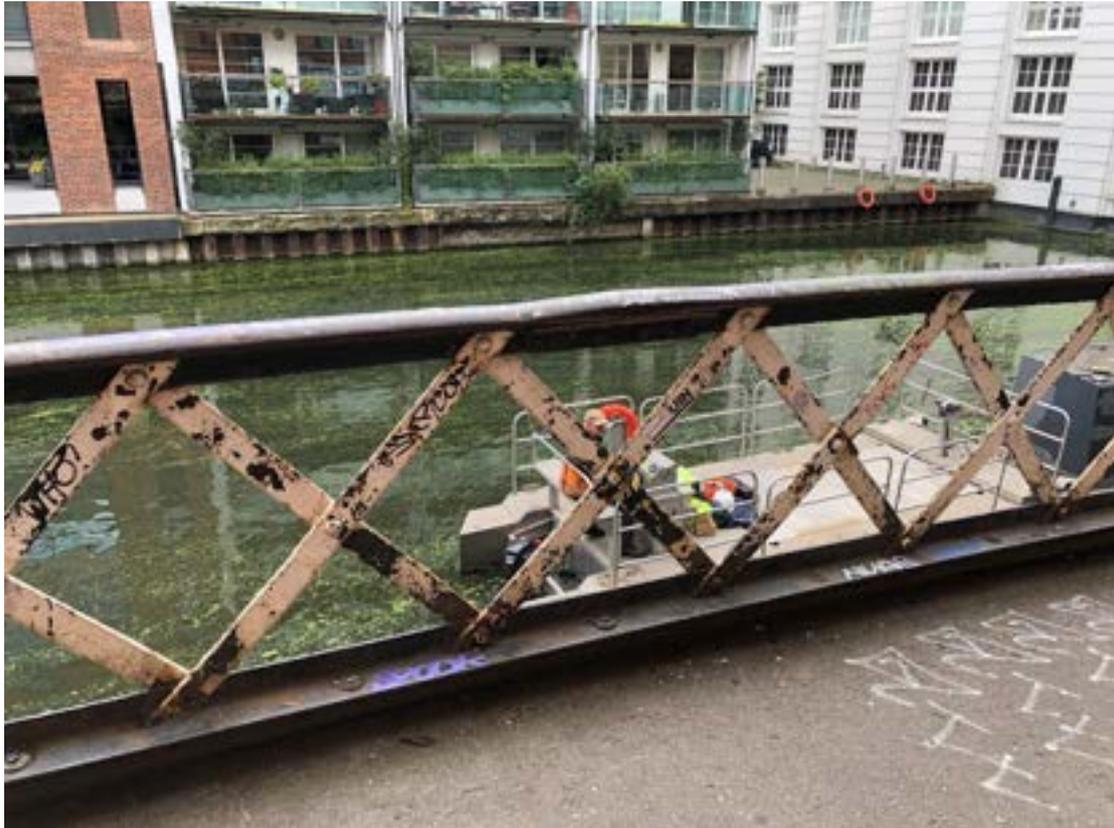
- Top rails are in reasonable condition with minor deterioration of paintwork. There are signs of delamination on the canal side edge, however, the canal side edge parapet is generally in better condition than the basin side parapet. (See photo 36 - 37).

Photo 36: Delamination of top rail on canal side parapet

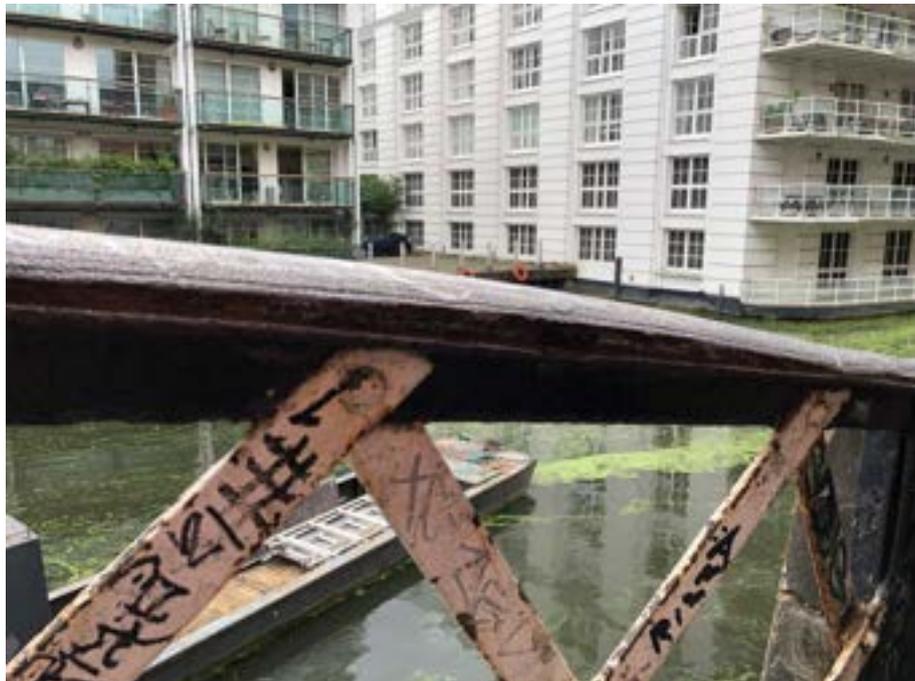
Photo 37: Delamination of top rail on canal side parapet

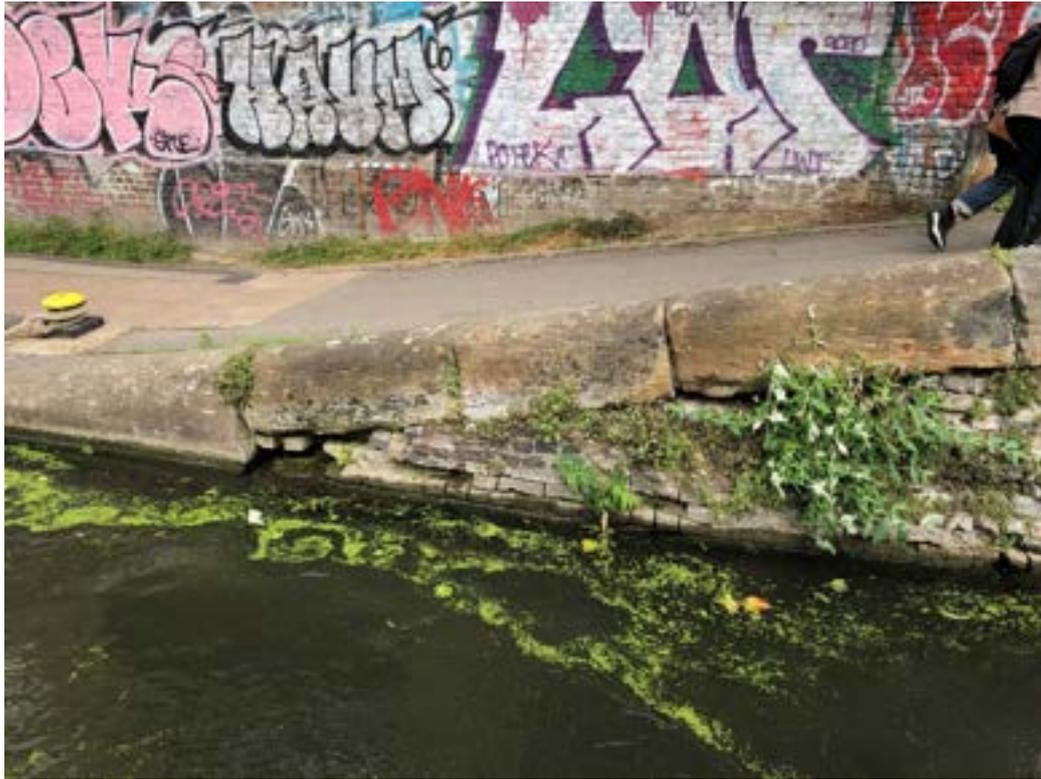
Photo 39: Loss of brick and mortar on west wing wall

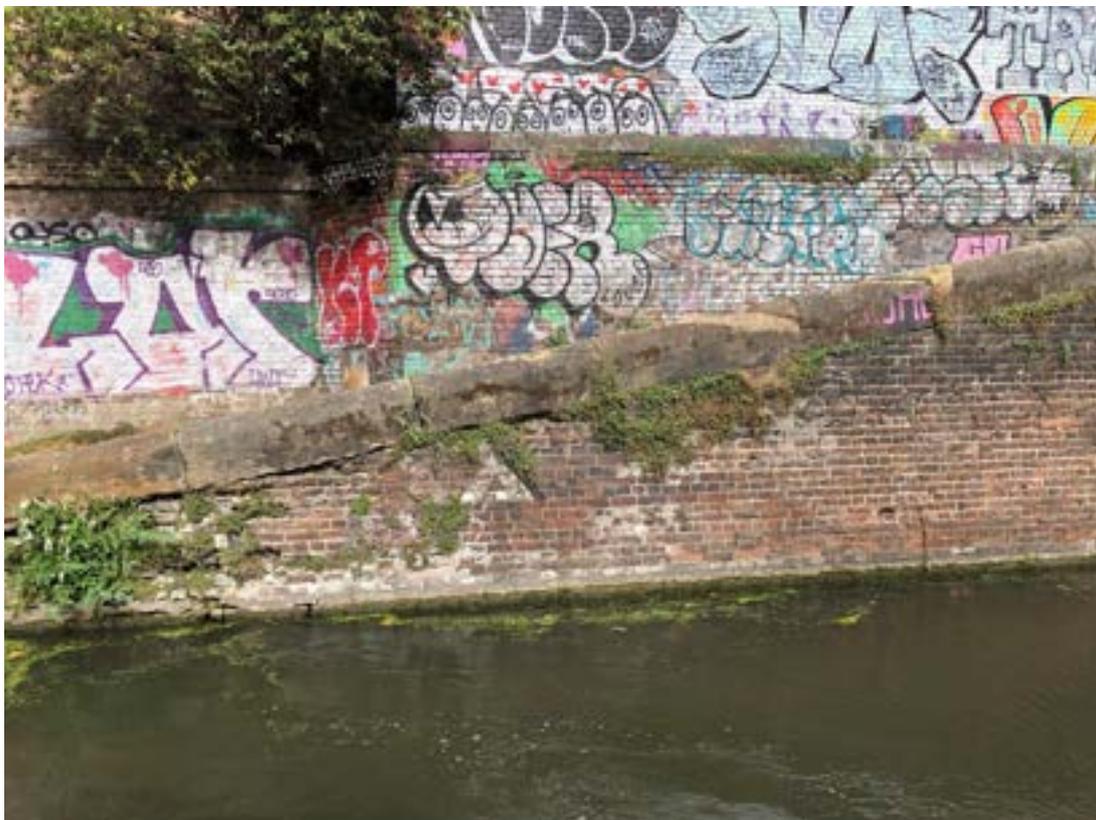
Photo 40: Vegetation and algae growth on the west wingwall

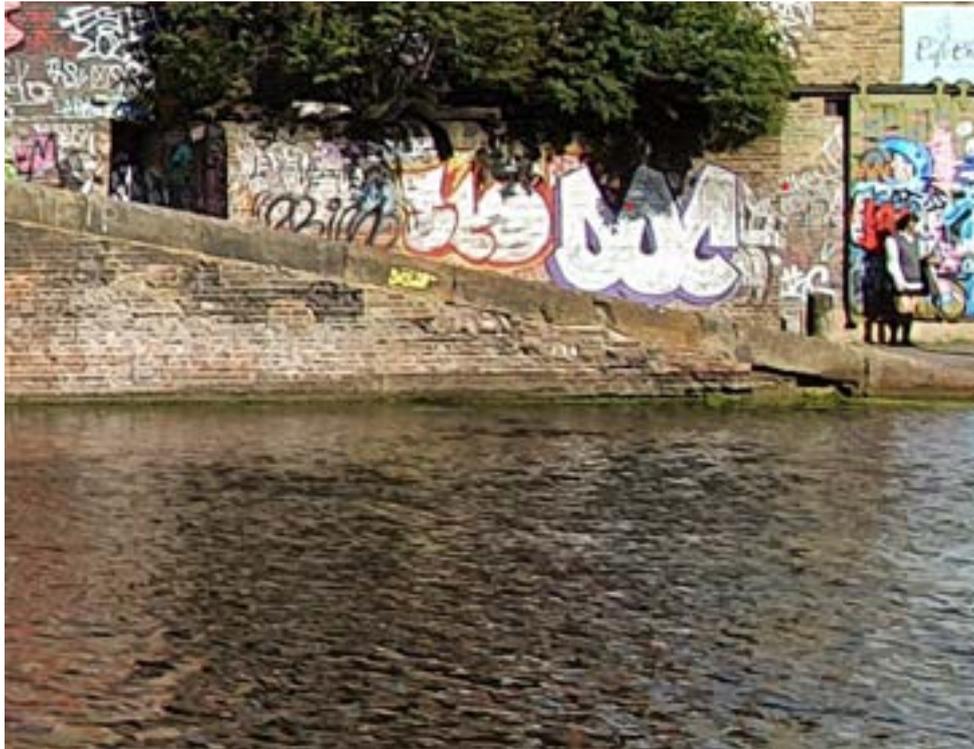
Photo 41: Loss of brick and mortar to the east wingwall

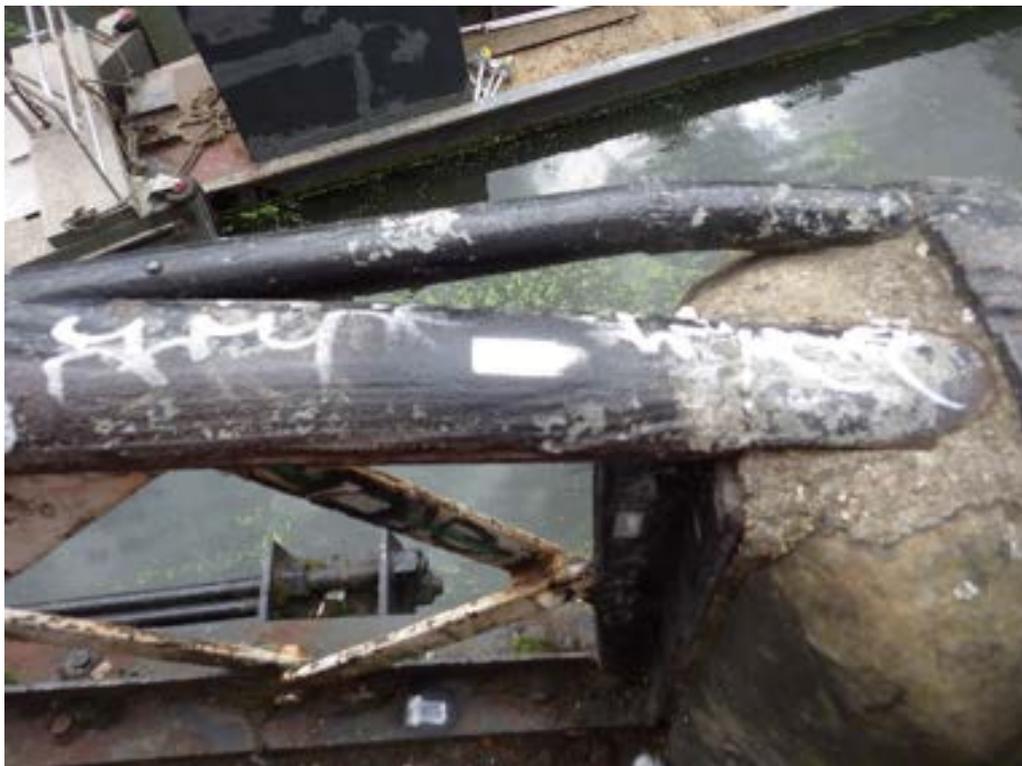
Area 1 comprised of the top horizontal domed handrail, shown in Figure 4. The general appearance of the handrail was degraded. The top surface was very smooth and dimpled, typical of a high touch-traffic area. The top surface of the handrail had bowed upwards, caused by the gross general corrosion between the top and bottom sections of the handrail, highlighted in Figure 5.

Figure 4: Overview of Area 1.

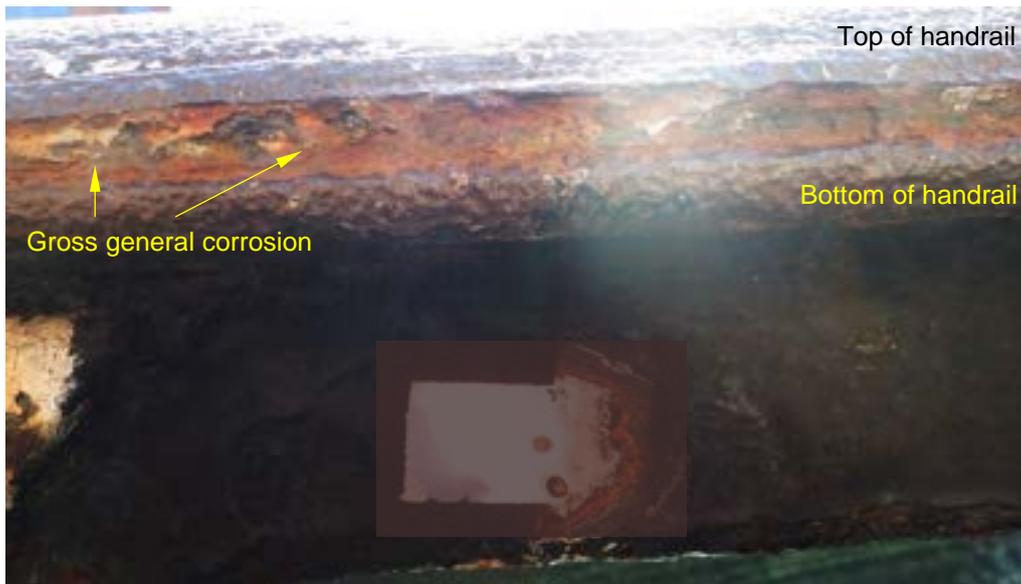
Figure 5: Detail of Area 1 – Handrail showing oxide jacking of top of handrail due to gross general corrosion.

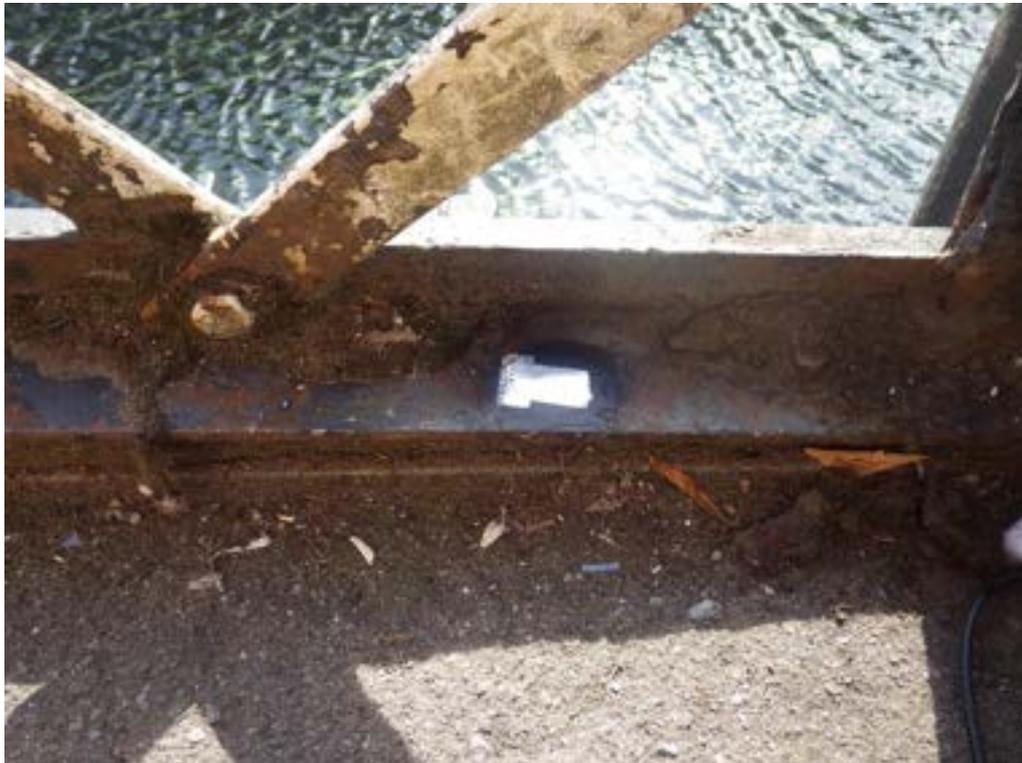
Area 3 comprised of the bottom horizontal bracketed steelwork, shown in Figure 7. Similar to other areas of painted steelwork, the paint condition in this location was poor. Greater areas of exposed corroded steelwork were visible, indicating a greater degradation of the paint. This was likely aided by the fact this area was located horizontally and at the bottom of the structure creating a flat area to hold water and contain mosses and plant life which will in turn contain and hold moisture increasing corrosion.

Figure 7: Overview of Area 3.
