## Tree Survey & Hazard Assessment Report

13th October 2022

Athlone House  
Hampstead Lane  
London  
N6 4RU

AS/MF/0161/22

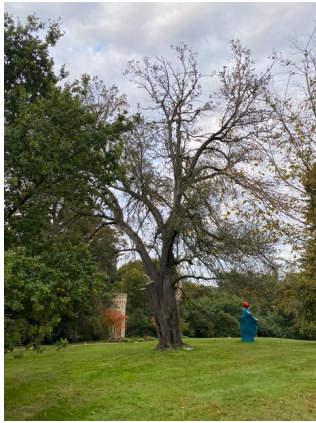
- Fracture in main stem from ground level to 1.0m to east and also within southern buttress to 0.2m height
- Staining to main stem at 1m to west and 0.3m + 2m to south
- Secondary leader with tight union at 2.5m to east - leader reduced 1.0m above resulting in excessive wound and misshapen crown; absent east / north crown
- Crown 60% dead - regenerative growth from pruning and / or regeneration at a lower height with very poor vitality / limited annual growth

5.3 No remedial measures (such as terraventing) are deemed appropriate for the tree with the decline projected as terminal for the tree.

Tree T2426 viewed to the west showing declining form

**Fell to ground level and grind out stump to minimum 300mm below ground level**

**Provide replacement planting - species and size to be agreed with LB Camden prior to planting**

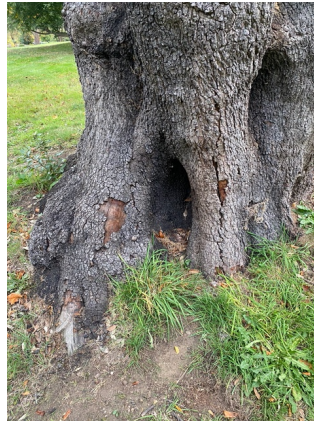
Southern buttress with fracturing and staining to initial main stem

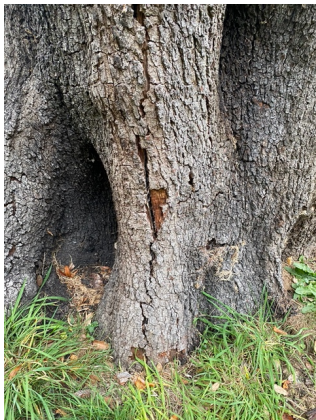
Eastern buttress with fracturing

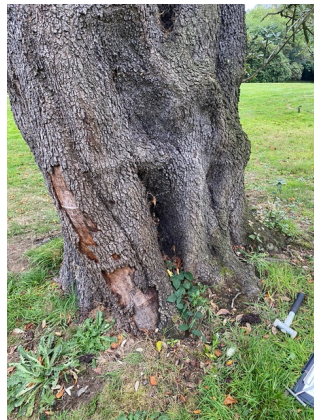
Northern buttress with fracturing

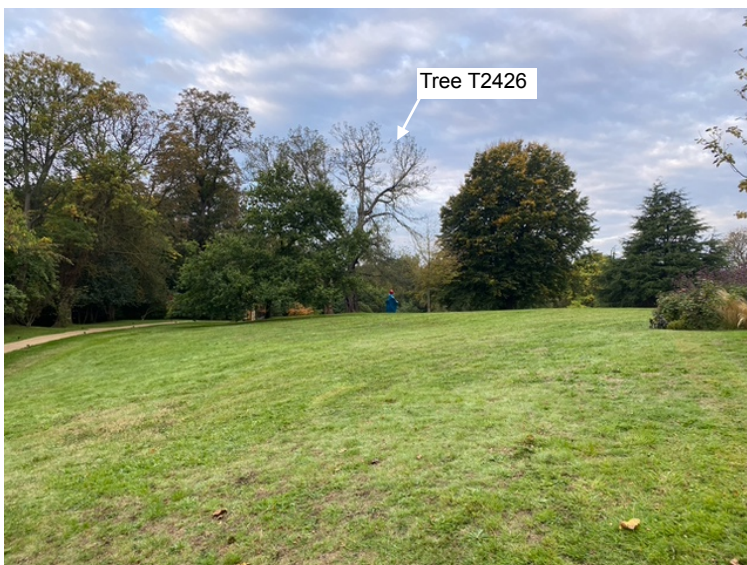
Declining form as viewed to south west within landscape
