ADDENDUM TECHNICAL REPORT

Deltamist Limited  
Flats 1 - 9  
8 Compayne Gardens  
NW6 3DH

SUBSIDENCE CLAIM

DATE 23 September 2022

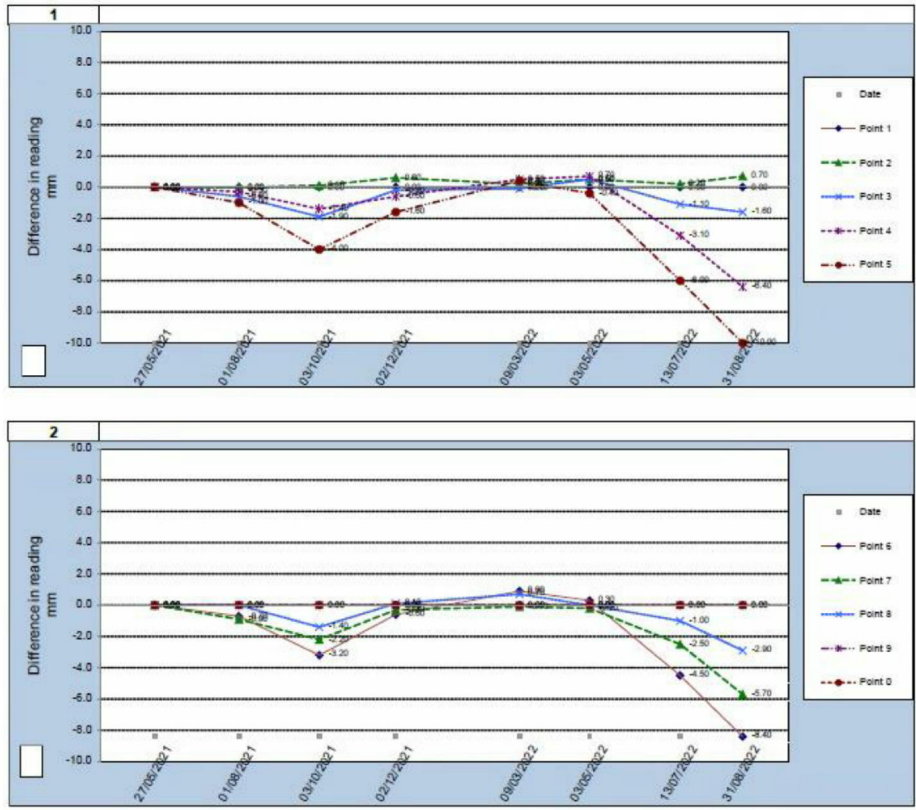
Cyclical movement has been recorded from May 2021 to August 2022, with the damaged area of the property moving downward through the dry summer period of 2021 and then upward during the wet winter period of the year. The August 2022 readings indicate further downward movement following the completion of the works to T3/SG2. This pattern of movement can only be created by clay shrinkage subsidence followed by rehydration of the clay soil.

Level monitoring has recorded a significant drop in the level of the foundation beneath the front right corner following this during the summer of 2022. This confirms that the lime tree on the pavement is the prime cause of the problem and the arboricultural consultant has recommended that it is removed.

In our initial Technical Report dated 4<sup>th</sup> May 2021 cracking with a maximum width of 5mm was recorded which falls into Category 2 "slight" of BRE Digest 251. Since then level monitoring has recorded downward movement of 10mm over the summer of 2022 and the occupants have reported that the condition has deteriorated, therefore we anticipate damage would now fall into Category 3 "moderate" or Category 4 "severe".

Following removal of the tree, we will continue the level monitoring through the autumn and winter to confirm that the foundations have recovered and stabilised, following which the building can be repaired. Repairs are estimated to be in the region of [REDACTED] provided that the tree work is completed promptly.

If the tree is not removed, the front left corner of the building will require underpinning and the cost of these works would be an additional [REDACTED] approximately.
