Job No. 221037
Fee ref LET 01
Date 18.10.21

Structural Design Studio Ltd
Studio 1 Three Eastfields Avenue
London
SW18 1GN

29 Great James Street, WC1N 3EY – Proposed Extension and Refurbishment Works

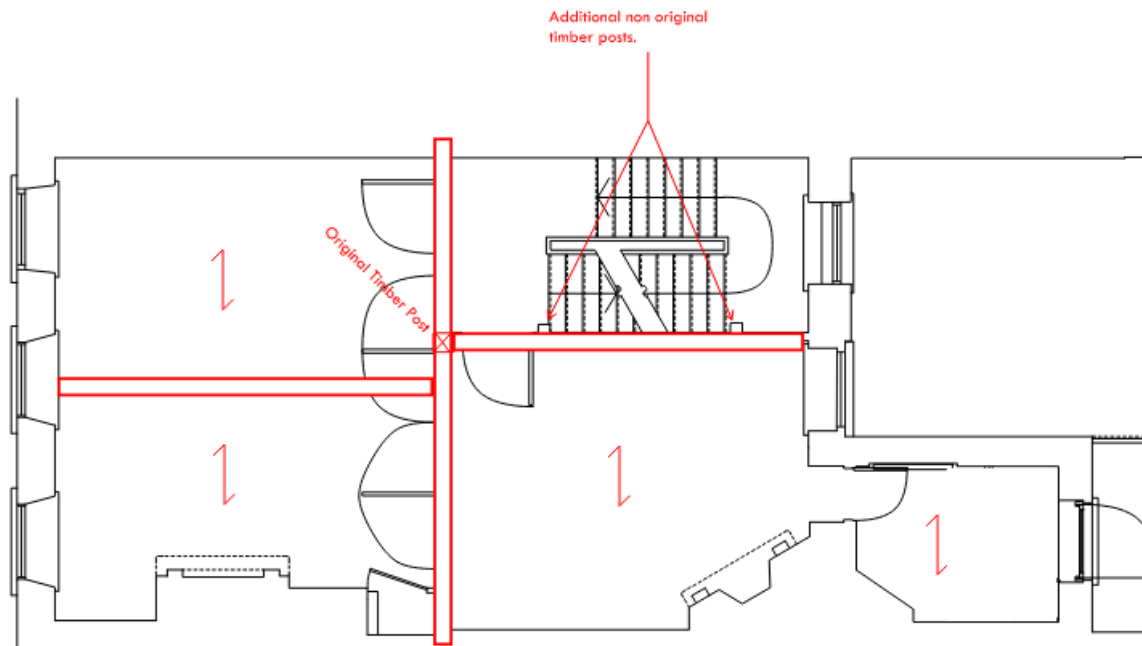
Image 1 – Typical Floor Construction

Based on our knowledge of the existing structure at no. 36 Great James Street, we understand that these buildings have existing timber joists which span from side to side from party wall to a central timber bressummer beam. The timber bressummer spans from the front to the rear of the property and is supported on a secondary timber beam spanning between party walls in the central spine wall location. The joists at no. 36 were typically 200mm deep x 60mm wide at 400mm centres and the existing bressummer beams were found to be 300mm wide x 200mm deep. No opening up works were completed as part of our visit to confirm the size of the joists and beams at no. 29 although we would expect them to be similar. Originally we understand that there was a single timber post in the location between the central spine wall and the stair wall. There appear to have been additional timber posts added at a later date up through the building in the stair wall. Presumably these were installed to strengthen the bressummer beam next to the stair.

In general the building is in a fair condition for its age and type. Generally the perimeter brick walls seem to be of sound construction and there is very little cracking evident to the external masonry walls. The floors however, have deflected significantly over time. This is likely due to creep of the existing timbers and also the timbers being insufficiently sized originally to support the loads. This is fairly typical of buildings of this era and the movement in the floor is consistent with that seen at other houses on the street. We would therefore propose that strengthening and levelling works are completed to the floors and ceilings at all levels to improve the overall robustness of the building. The main stair will also need to be strengthened and relevelled.

1. Existing floorboards should be numbered and then carefully lifted and set aside
2. The existing timber bressummer beams should be strengthened with a new steel plate bolted to the side.
3. The existing joists should be doubled up with new timber joists to match existing bolted to the side with M12s at 400mm centres. Alternatively, install wedges to the top of the joists to level out the floors.
4. Angle brackets should be installed at joist ends to strengthen the mortice and tenon connection between the beam and the joists.
5. The existing floorboards should be re-laid in their original positions and nailed down to the joists under.

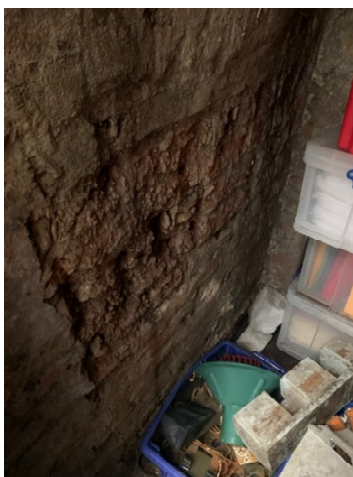
The lower ground floor under the main house seemed to be in fair condition and there was no obvious signs of any foundation movements. We wouldn't therefore expect a need for any structural repairs to this area. The brick arches to the front and rear vaults are also in a fair condition for their age and type. However, the mortar has become loose in some areas and there are signs of some brick erosion in areas with some bricks missing entirely. We would suggest the vaults be repointed with mortar to match existing and any damaged or missing brickwork be replaced.

Images showing brick erosion

1. Demolish existing modern timber frame extension
2. Existing brick arch vaults to be made good – missing brickwork to be carefully replaced with new bricks to match existing, loose mortar to be raked out and repointed with new lime mortar to match existing.
3. Temporarily prop and protect the vaults
4. Install new spreader beam at ground floor level under proposed new elevation on top of compressible material to avoid loading the vaults
5. Install the new strip footing where the extension is outside of the footprint of the vaults.
6. Construct a new ground bearing slab where the extension is outside of the footprint of the vaults
7. Construct new extension perimeter walls
8. Install new steelwork for the roof terrace and timber roof joists
