Arboricultural Appraisal Report

Subsidence Damage Investigation at:

Flat 1, 129 West End Lane
London
NW6 2PE

CLIENT:	Crawford & Company
CLIENT REF:	 
MWA REF:	
MWA CONSULTANT:	Andy Clark
REPORT DATE:	16/05/2022

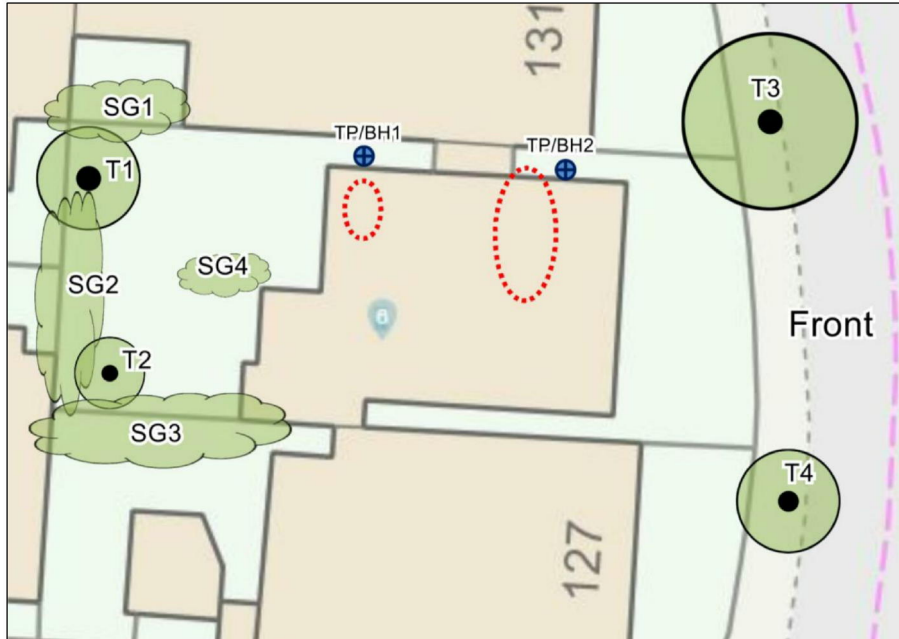
Site Plan

Approximate areas of damage

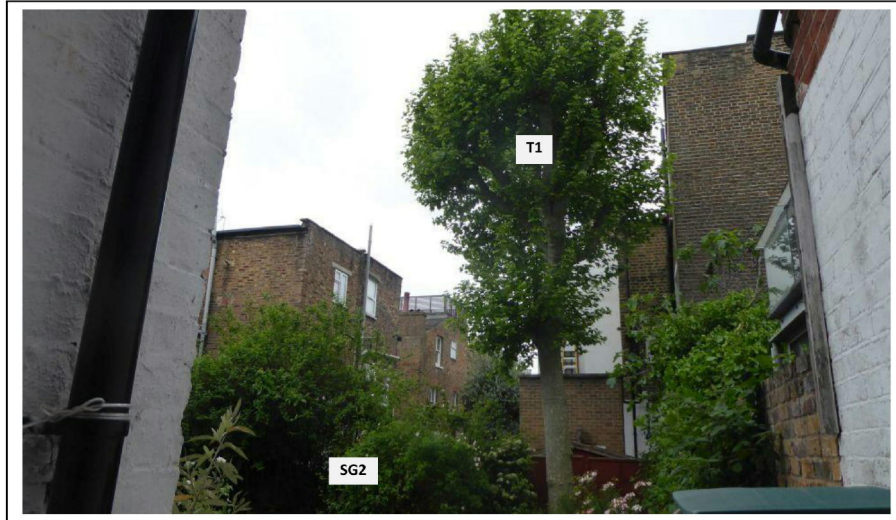
Roots were observed to a depth of 1.1m bgl in TP/BH1, and recovered samples have been positively identified (using anatomical analysis) as *Platanus* spp.; the origin of which will most likely be the Policy Holders T1 London Plane at the rear of the building.

Whilst T1 London Plane is likely to be a contributor to the damage, the tree appears regularly pollarded and as such its moisture uptake is controlled. The significantly larger T3 London Plane will have a much greater soil moisture use and in our view is the likely principal cause of the damage.

View of T1 London Plane with SG2 understorey

If an arboricultural solution is to be implemented to mitigate the influence of the implicated trees/vegetation we recommend that T1 London Plane and T3 London Plane are removed.

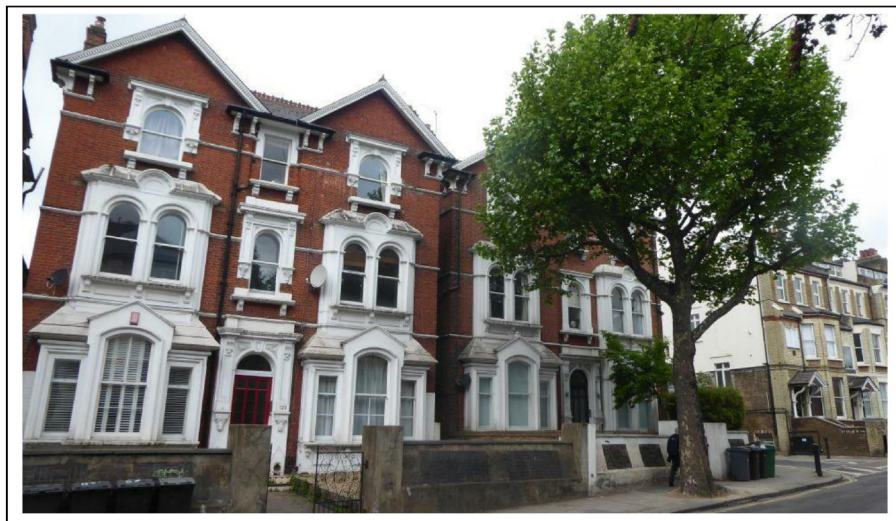
View of T3 London Plane

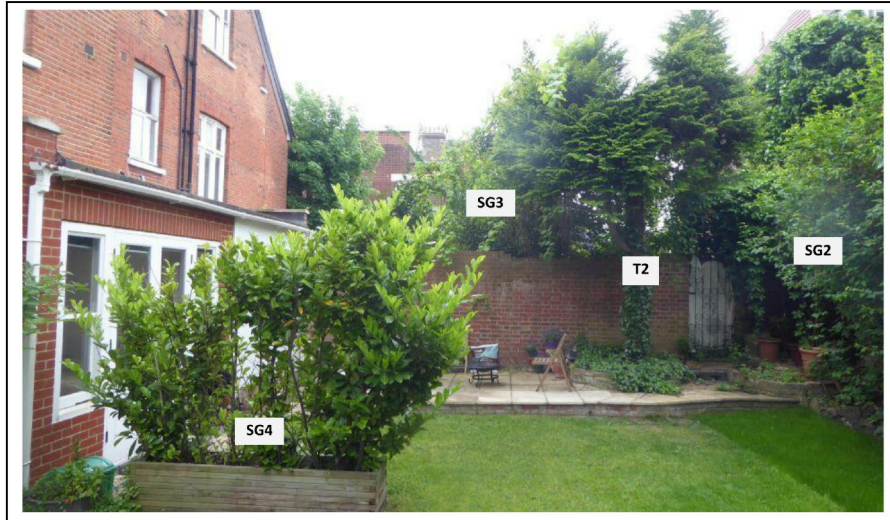
Overview of property rear
