**TECHNICAL REPORT ON A SUBSIDENCE CLAIM**

**129 West End Lane Management  
Flat 1  
129 West End Lane  
London  
NW6 2PE**

**SUBSIDENCE CLAIM**

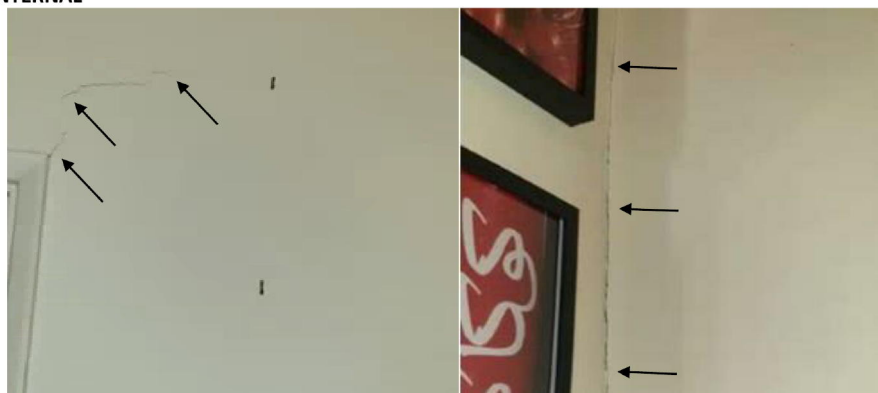
Tapered cracking above door frame

Vertical cracking between the wall junctions

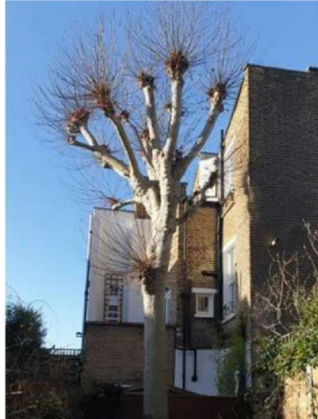
Insured owned Plane tree.

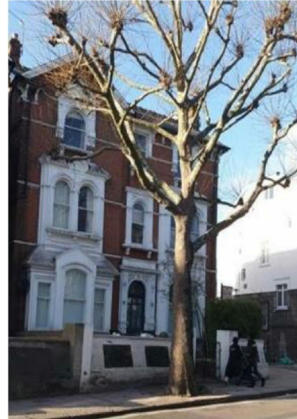
Local Authority Plane tree.

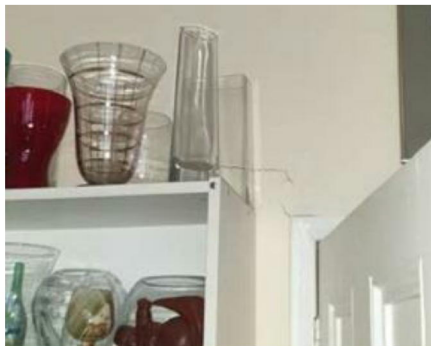
- 1mm slight diagonal crack radiating from the top left corner of hall door up to left hand wall. This crack is reflected in the hall.
- Approximately 1mm vertical crack at junction of kitchen division wall and right elevation.
- The door scrapes on the floor and has been planed three times in the past five years to avoid it getting stuck on the wooden floor.
- The floor slopes from the entrance hallway, up into the living room and then falls towards the front right corner of the lounge.

Cracking above door frame.

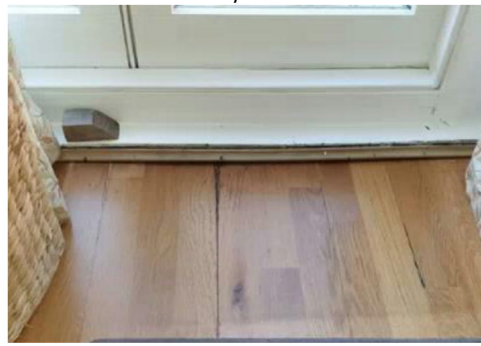
Sloping floor.

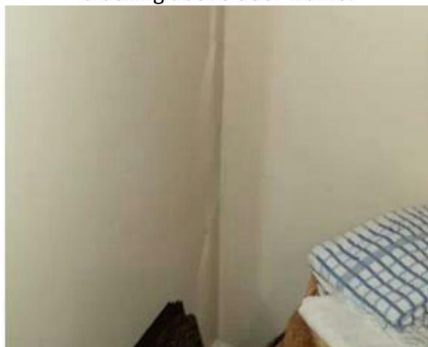
Cracks underneath lining paper.
