# Site Investigation Report

Job Information	
Client	Crawford & Co
Client ref	[Redacted]
Visit date	07/03/2022
Report date	07/03/2022

Job Summary	
✓	CCTV survey undertaken. <a href="#">Read more.</a>
!	Drainage repairs required. <a href="#">Read more.</a>
⚠	1 trial hole undertaken. <a href="#">Read more.</a>
!	Trial Hole 2 Aborted. <a href="#">Read more</a>

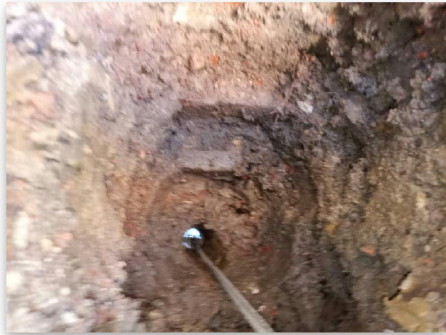
Trial Hole 1	
Fig 1.1: Trial Hole 1 Location	Fig 1.2: Trial Hole 1 Footing

Depth (m)	Symbolic Log	Strata Description	Insitu Tests		Soil Sample	Root Sample
			SV(19)			
0.0		Ground Level				
		Concrete				
		Brickwork				
0.5		Triple Step				
1.0		Water encountered				
		Brown fine to coarse gravelly silty CLAY	48kpa		Soil @ 1.1m	Root @ 1.1m
1.5		Brown fine to medium gravelly silty CLAY	62kpa		Soil @ 1.6m	
2.0		Brown fine to medium gravelly silty CLAY	74kpa		Soil @ 2.1m	
2.5		Brown fine to medium gravelly silty CLAY	76kpa		Soil @ 2.6m	
3.0		TRIAL HOLE TERMINATED	80kpa

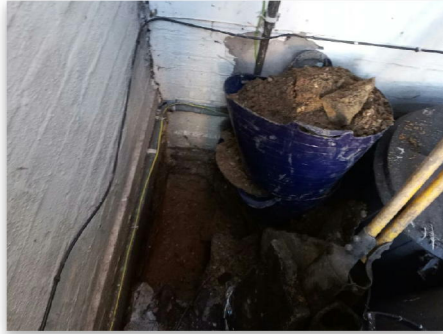
Fig 2.1: Attempted Trial Hole 2 Location

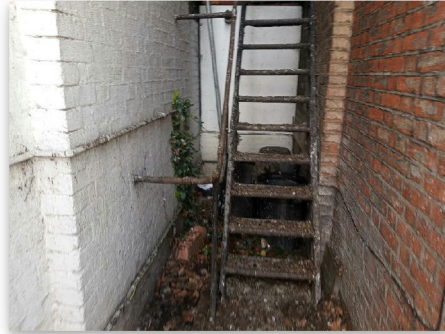
Fig 2.2: Confined Trial Hole 2 Location

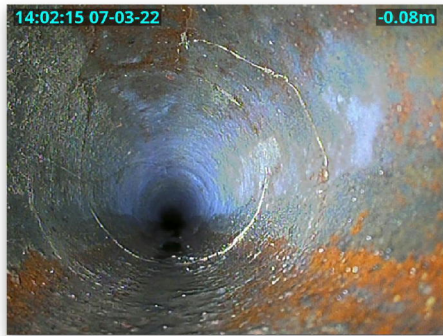
Fig 3.1: Line 2 Cracking

0.0m	Start of Survey Length
0.0m	Start of Survey Length
0.2m	Fracture - Longitudinal
0.7m	Line of Sewer Deviates Right
0.9m	Line of Sewer Deviates Up
1.2m	Finish of Survey Length
2.3m	Line of Sewer Deviates Left
6.2m	Fracture - Circumferential
10.0m	Finish of Survey Length

Recommendations	
Refer Back to Client	<p>It is recommended that the following repairs are carried out to prevent an escape of water from the system:</p> <p><b>Line 2</b> Excavate and replace WG1 and 1m of 100mm pipework directly downstream of this at a depth no greater than 1.0m through paving slabs. We also propose to install 4m of 100mm liner directly upstream of MH2 to cover areas of cracking.</p> <p>Auger have not allowed or will not be held responsible for any alteration or modification to the above ground drainage following the removal of the existing gully and reinstatement of a new gully. The customer must ensure that the above ground drainage correctly expels into the gully pot and avoids overcrowding the gully with numerous downpipes which could lead to the gully overflowing.</p> <p style="text-align: center;"><b>We will now refer the claim back to the client in order to progress the claim.</b></p>

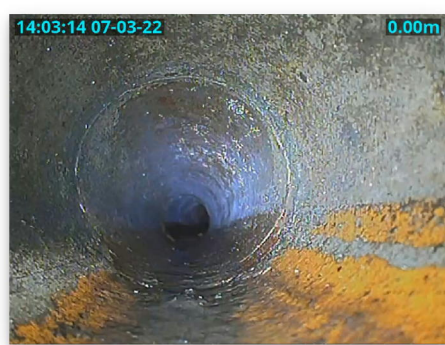
Fig 3.2: Line 2 Cracking

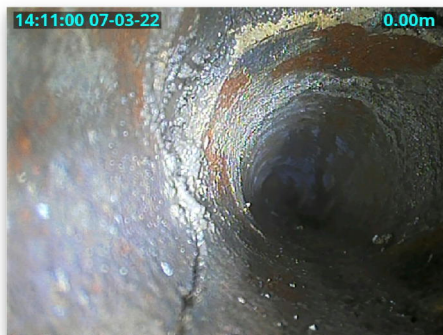
<b>Visual Inspection</b>	<p>A visual inspection of the site revealed WG1, which was noted to serve foul water, has broken/cracked (see fig 3.3/4.1). The visible defects identified are affecting the function of the system and could be allowing an escape of water.</p> <p>We carried out a water mains listening test whilst on site which revealed that there was no evidence of a leak on the incoming water supply serving the property.</p>
<b>Drain Survey</b>	<p>We carried out a CCTV survey of the below ground drainage system, our findings of which are as follows:</p> <p><b>Line 1 - From MH1 upstream to SVP</b> Our survey of line 1 revealed no significant defects to the pipework on this line which could be allowing an escape of water.</p> <p><b>Line 2 - From WG1 downstream to MH2</b> Our survey of line 2 revealed cracking throughout the line (see fig 3.1-3.2).</p> <p>The above mentioned defects to the below ground drainage system have been caused by ground movement.</p>

Fig 3.3 :Cracked Gully Base

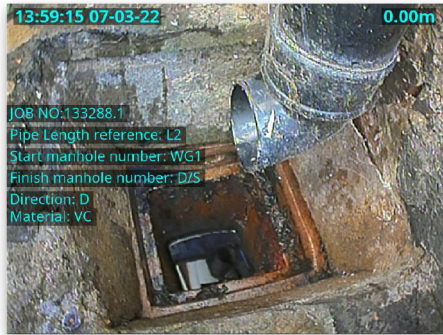
Fig 4.1: Damaged Gully

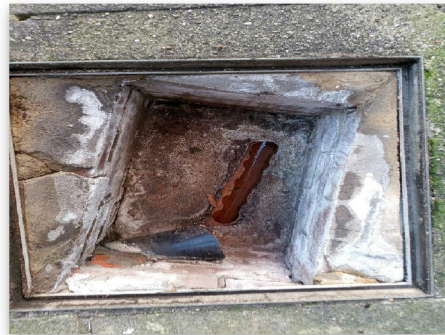
Fig 4.2: Access for Lining

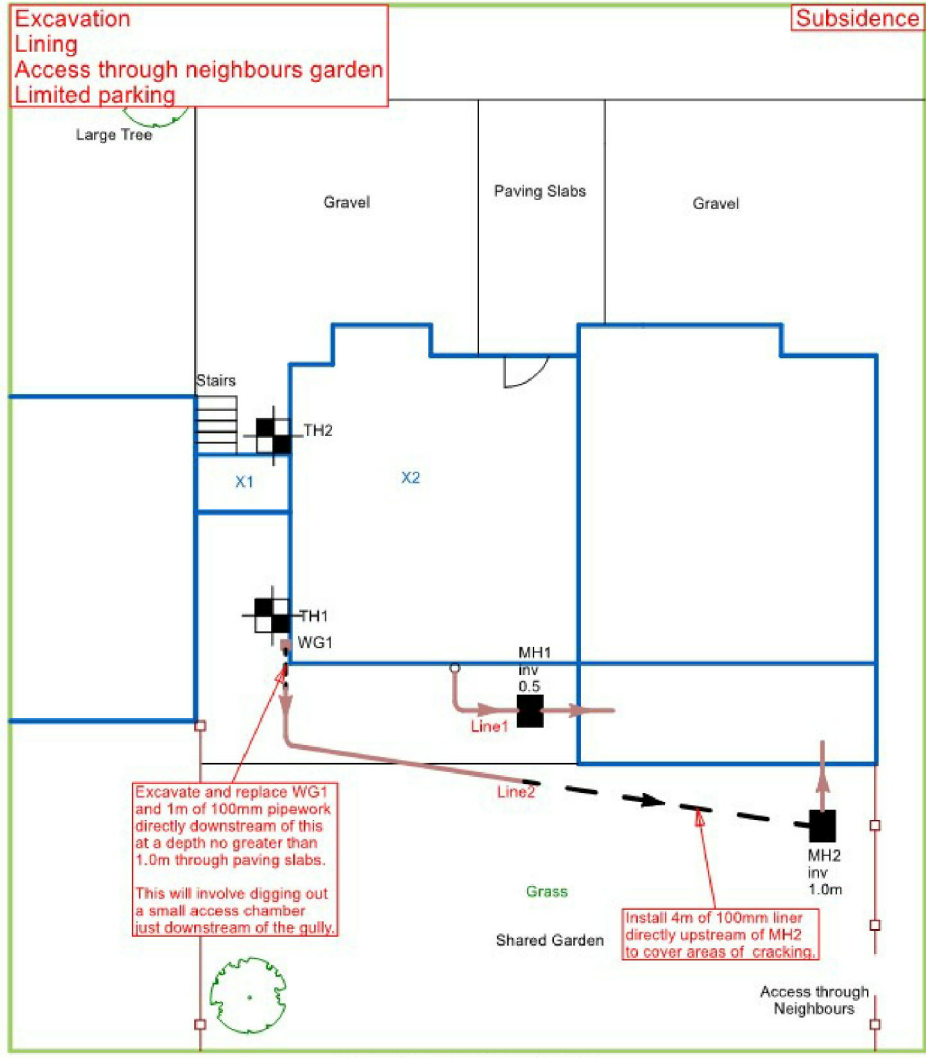
L2			
<b>Direction</b>	Downstream	<b>From</b>	WG1
<b>Pipe Size (mm)</b>	100	<b>Depth (m)</b>	1.0m
<b>Pipe Material</b>	VC	<b>To</b>	MH2
