**RE: GOSH REDEVELOPMENT AND WEAK VAULTS UNDER
BOSWELL ST**

Re: BEVAN HOUSE, BOSWELL STREET, LONDON WC1N 3BT

1.0 BACKGROUND INFORMATION

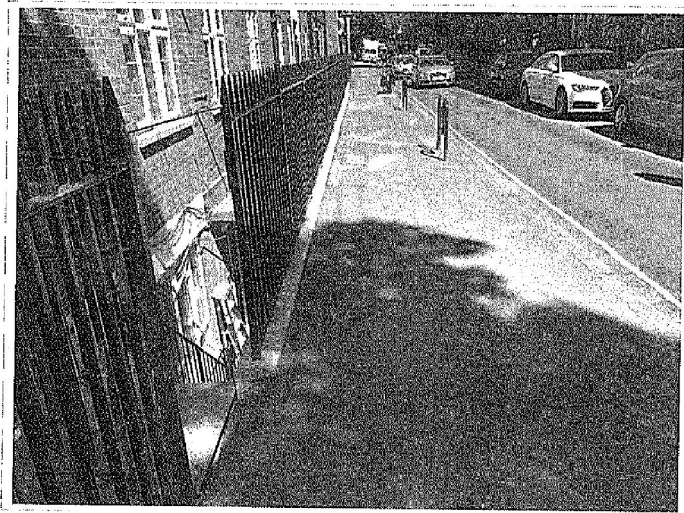
Plate 1.

- 1.3 It should be noted that the width of Boswell Street is narrow with cars parked down one side refer to Photo 1 and this should be considered, with regards to width of any equipment that is planning to use the road as access. As can be seen in the photos there are cycle loops located on the footpath, and whilst the vaults primarily extend beneath the footpath, some of these also extend slightly further into the road. If the construction equipment needs to utilise the pathway, we would recommend contacting the Council first as the cycle loops would need to be removed to facilitate this.

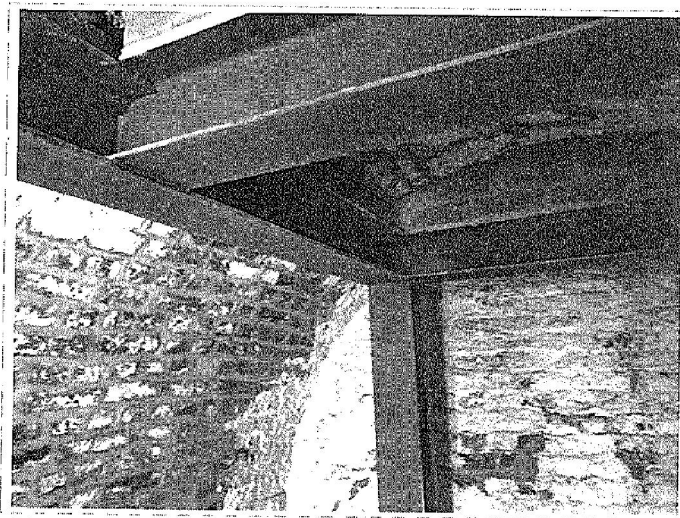
Plate 2.

- 2.2 Whilst on site carrying out our latest inspection, we can confirm that steelwork has been installed within each of the vaults, however whilst our drawings depict bolted connections, the steelworks sections appear to all have been site welded, refer to Photos 2 & 3.

- 2.3 Whilst this detail does not match our specification, we have no concern over the strength or durability of these connections and can confirm that they are capable of carrying the original loads that the bolts were designed for.
