Landmark Trees

Your ref: Camden Planning Applications - 1965, 1966 and 1967 - 29 Maresfield Gardens
Planning ref: 2022/1967/P
Our ref: 29MFL/29MFD/LOS/01

16th November 2022

RE: Erection of single storey outbuilding with green roof in rear garden (Retrospective)
29 Maresfield Gardens, London NW3 5SD
- Impact of concrete slab in proximity to **Tree of Heaven**

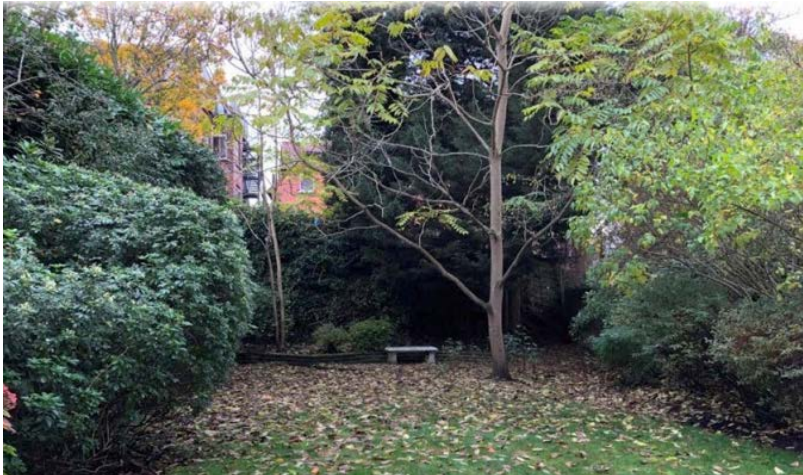
depth of the hard surfacing and any sub-base on which it stands are unknown, their presence would have meant that the tree roots would have been somewhat deeper than if surrounded by soft landscaping - in the soil at the interface with and beneath the sub-base where growing conditions were more conducive. The surfacing and dwarf wall are visible in the photograph extracted below from the SUDS report submitted with the same application:

Extract from
LBHGEO Surface
Water Drainage
Assessment &
Outline SUDS
Strategy

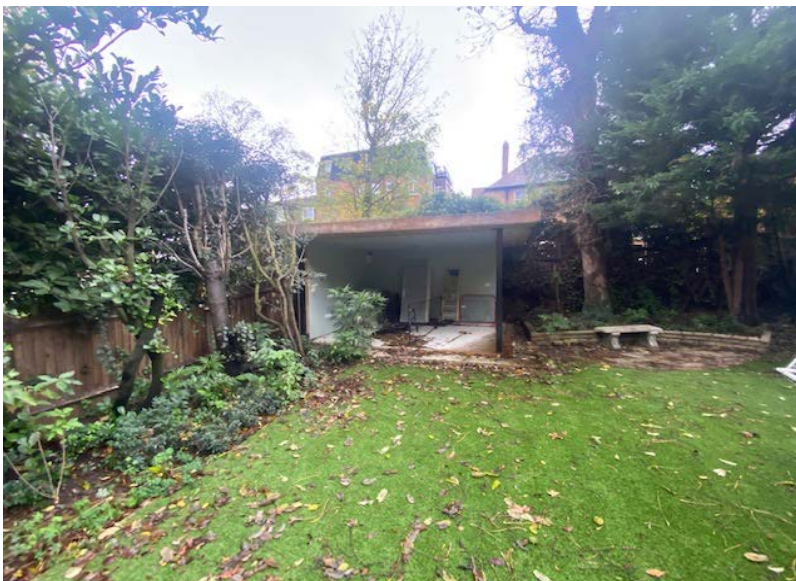
The concrete slab that has been constructed subsequently has, at least in part, been laid on top of this pre-existing hard surfacing. The following photograph shows the new slab in relation to the extant surfacing and bench.

Photograph showing new slab in relation
to extant hard surfacing and bench

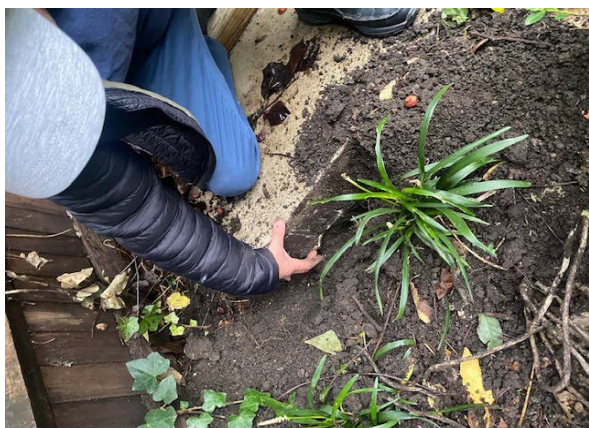
Due to the presence of the pre-existing hard surfacing on which the slab has been laid, it is difficult to excavate a trial hole to demonstrate the depth of new concrete on the eastern side without risking damaging the tree roots (the roots are likely to proliferate at and just below the soil interface), so a trial investigation pit has been dug on the side away from the tree where there is a shrub bed. The new slab is slightly raised and, as the photographs below show, is some 150mm deep (only approx. 90mm below ground level).

Photograph showing position of trial investigation and depth of new slab

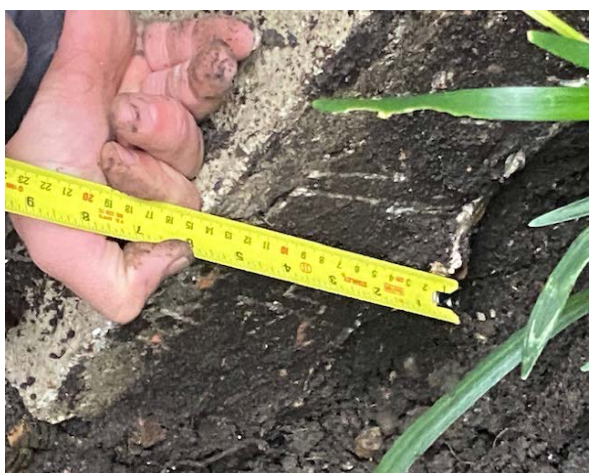
Photograph showing new slab to be just under 150mm depth, of which 90mm below ground level

It is also evident that the soil structure still appears reasonable (e.g. not smeared / puddled due to working with heavy equipment in wet conditions), indicating that compaction and associated deterioration in growing conditions is unlikely.

Given the retention of the existing hard surfacing; the limited lowering of levels otherwise within the root protection area; and the apparent lack of damage to soil structure, it seems unlikely that significant roots from the Tree of Heaven have been damaged - the tree currently appears to be unaffected by the construction of the new slab and in good health. However, in the circumstances, it would be prudent to monitor the tree as it comes into new growth in the coming year, with further assessment in the summer to check whether any mitigation measures would be appropriate (such as terraventing to improve soil aeration).

To maintain the health of existing trees, it is important that the surrounding area allows for adequate infiltration of water and free gas exchange, reduction of water evaporation and the retention of an open soil structure to encourage root growth. In accordance with BS5837: 2012, on the basis of a stem diameter of 650mm, the Tree of Heaven would have a root protection area of 191 m² - equivalent to a nominal circle protection radius of 7.8 metres. The Standard also notes at 7.5.3 that *"Where a slab for a minor structure (e.g. shed base) is to be formed within the RPA, it should bear on existing ground level, and should not exceed an area greater than 20% of the existing unsurfaced ground"*. The cumulative impact of the construction of the slab / outbuilding together with the extant hard surfacing mean that, even if the original hard surfacing was somewhat permeable, the ground surrounding the Tree of Heaven now has a reduced area for water infiltration and gaseous exchange. Measures should therefore be put in place for the longer term to ensure that appropriate infiltration and exchange are possible – these could include routing surface water landing on impervious surfacing towards the tree's roots and improving soil aeration, as well as mulching the unsurfaced RPA.
