07 October 2022

Our reference: 35906

CCTV CAMERA INSPECTION REPORT

Site Location – 25 Oakhill Avenue, London, NW3 7RD

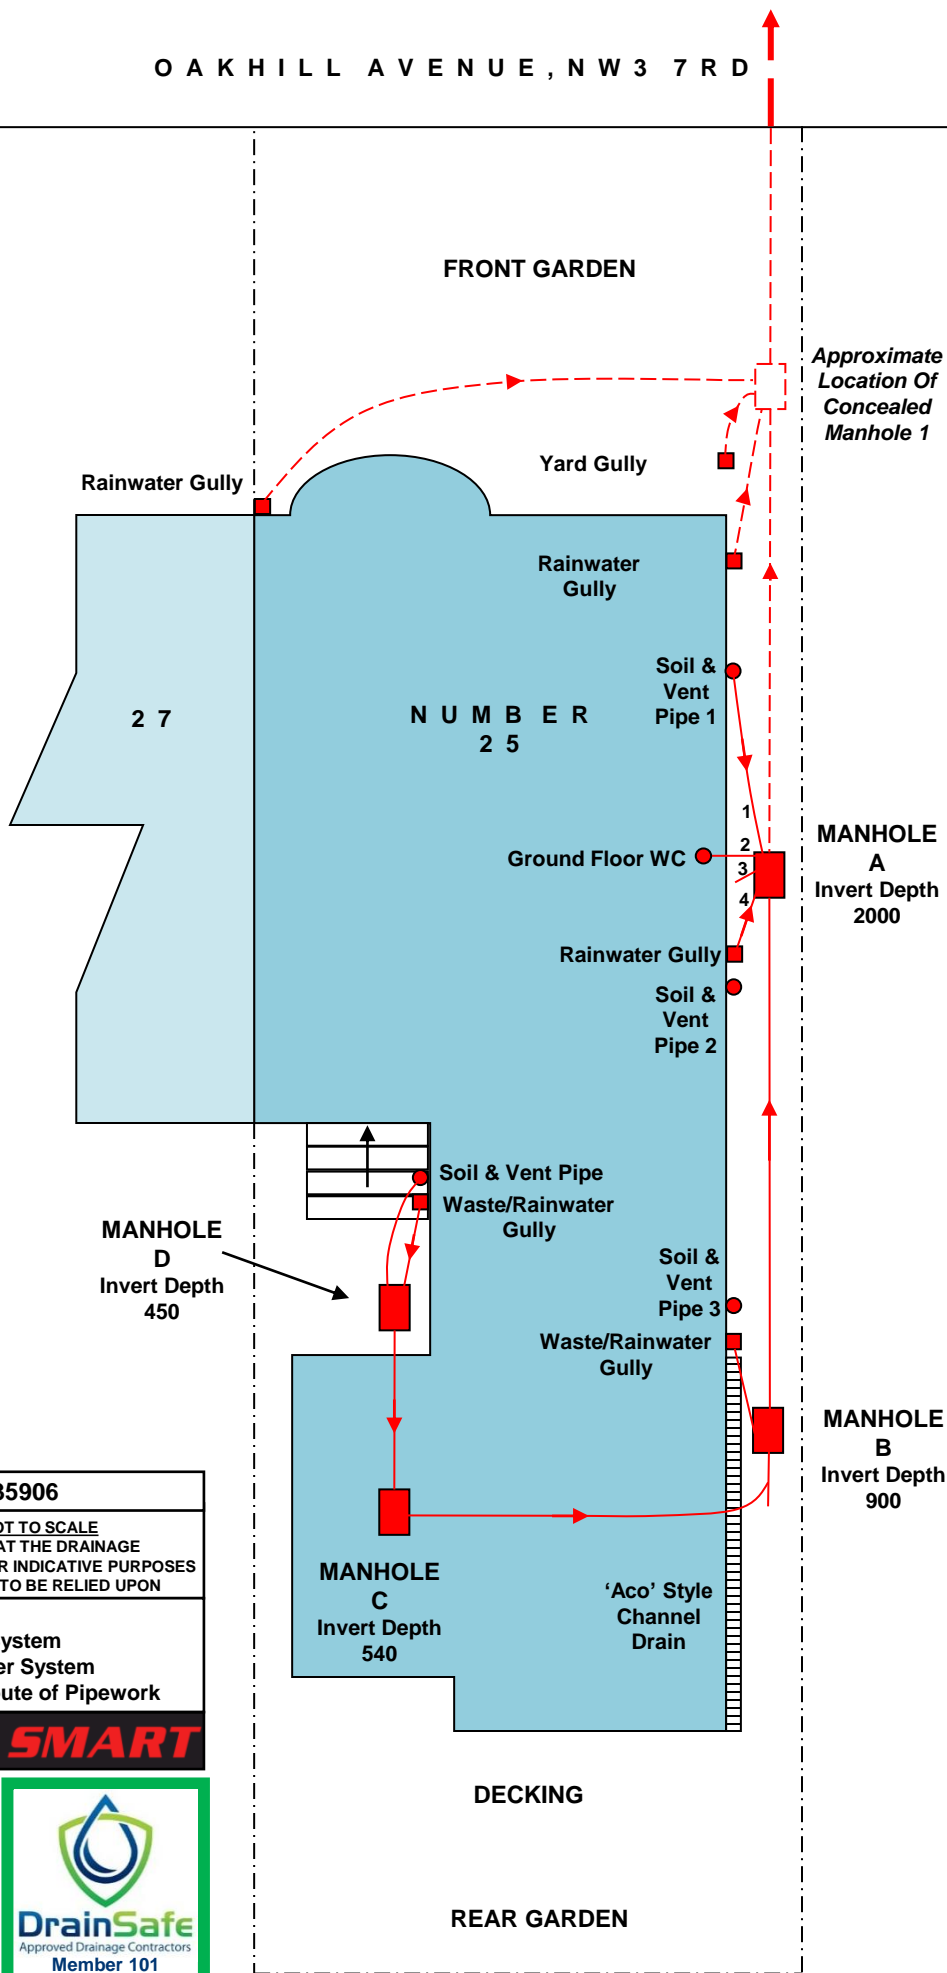
OAKHILL AVENUE, NW 37 RD

DRAWING NOT TO SCALE
PLEASE NOTE THAT THE DRAINAGE
ROUTES SHOWN ARE FOR INDICATIVE PURPOSES
ONLY AND ARE NOT TO BE RELIED UPON

Key-
— Foul Water System
— Surface Water System
- - - Assumed Route of Pipework
