Defect Inspection

Garden Flat 44 Denning Road, London NW3 1SU

Report For: Stella Khan

Thursday 27th October 2022

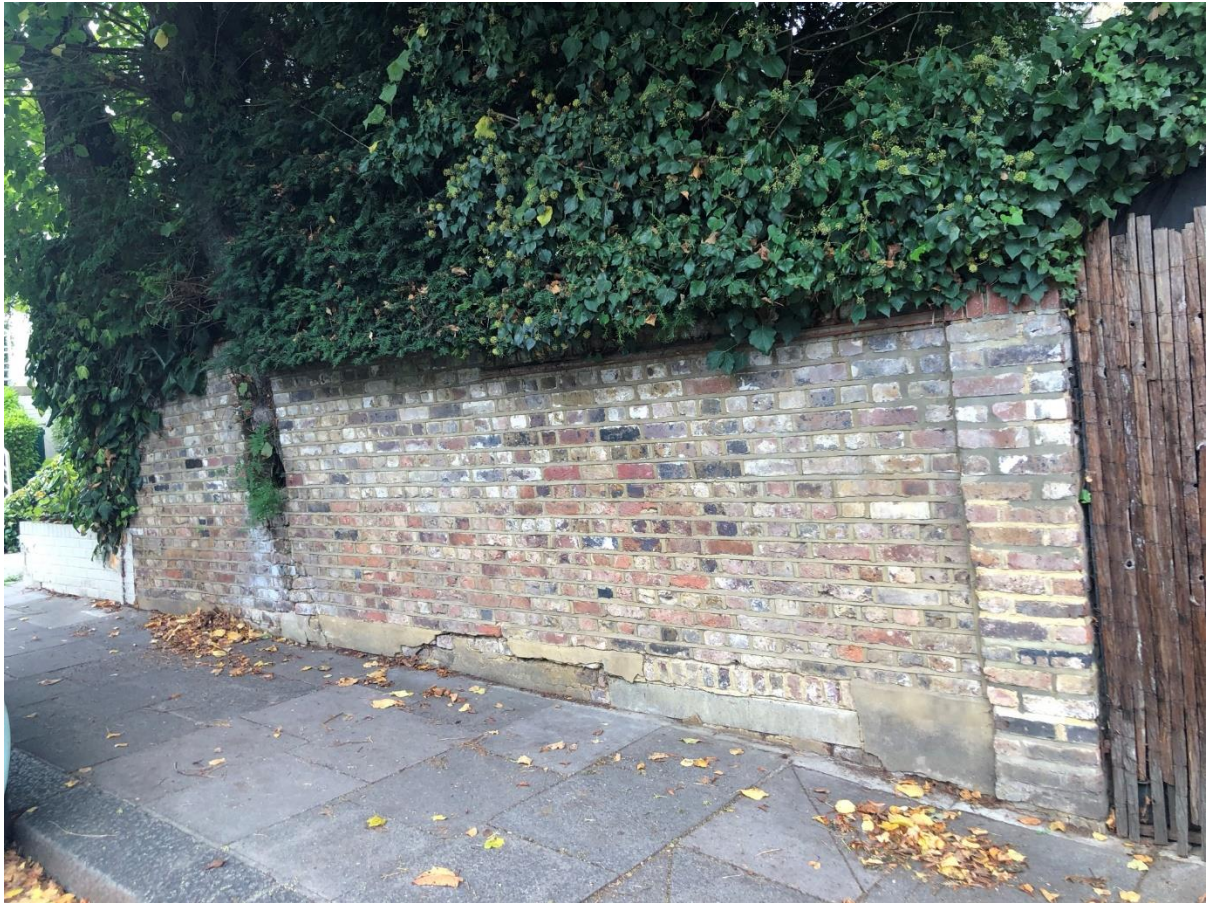
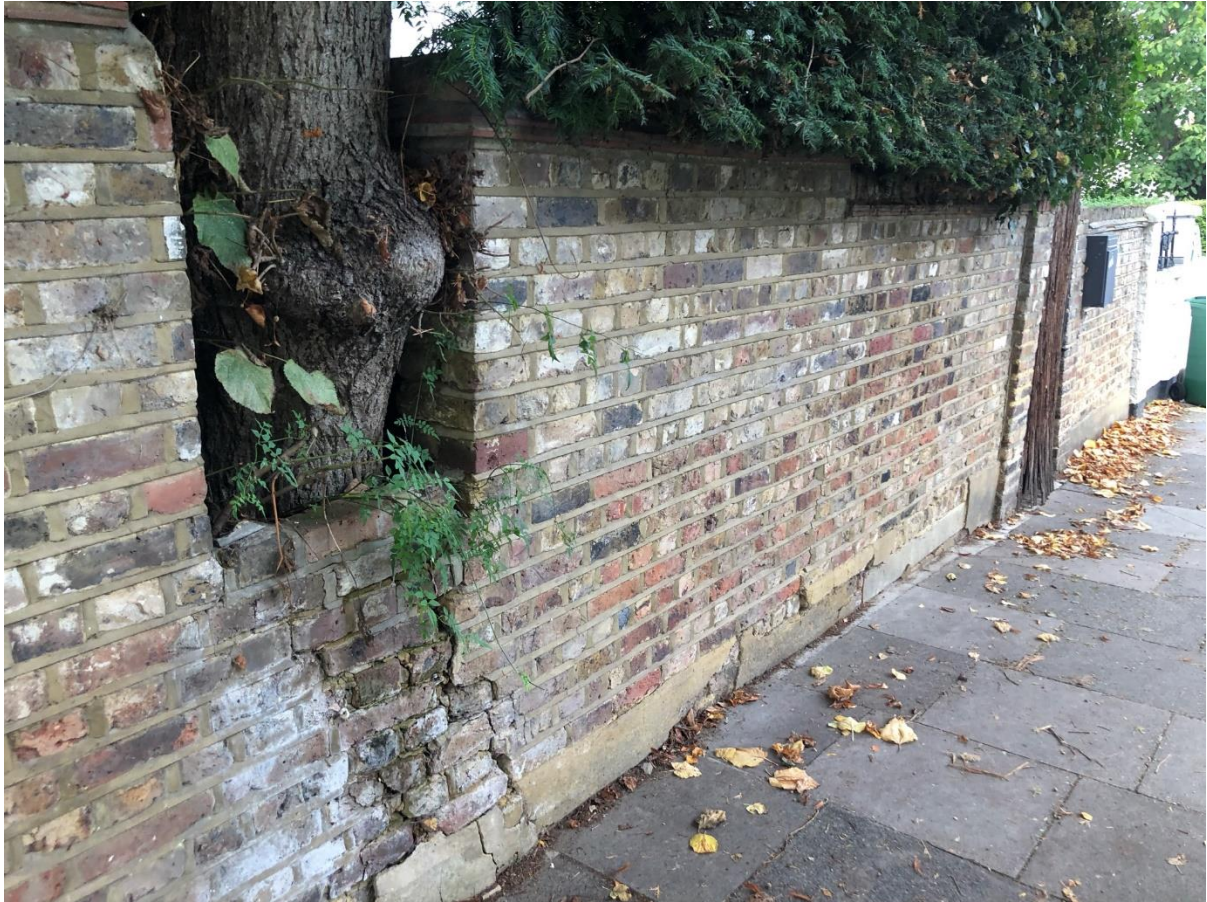
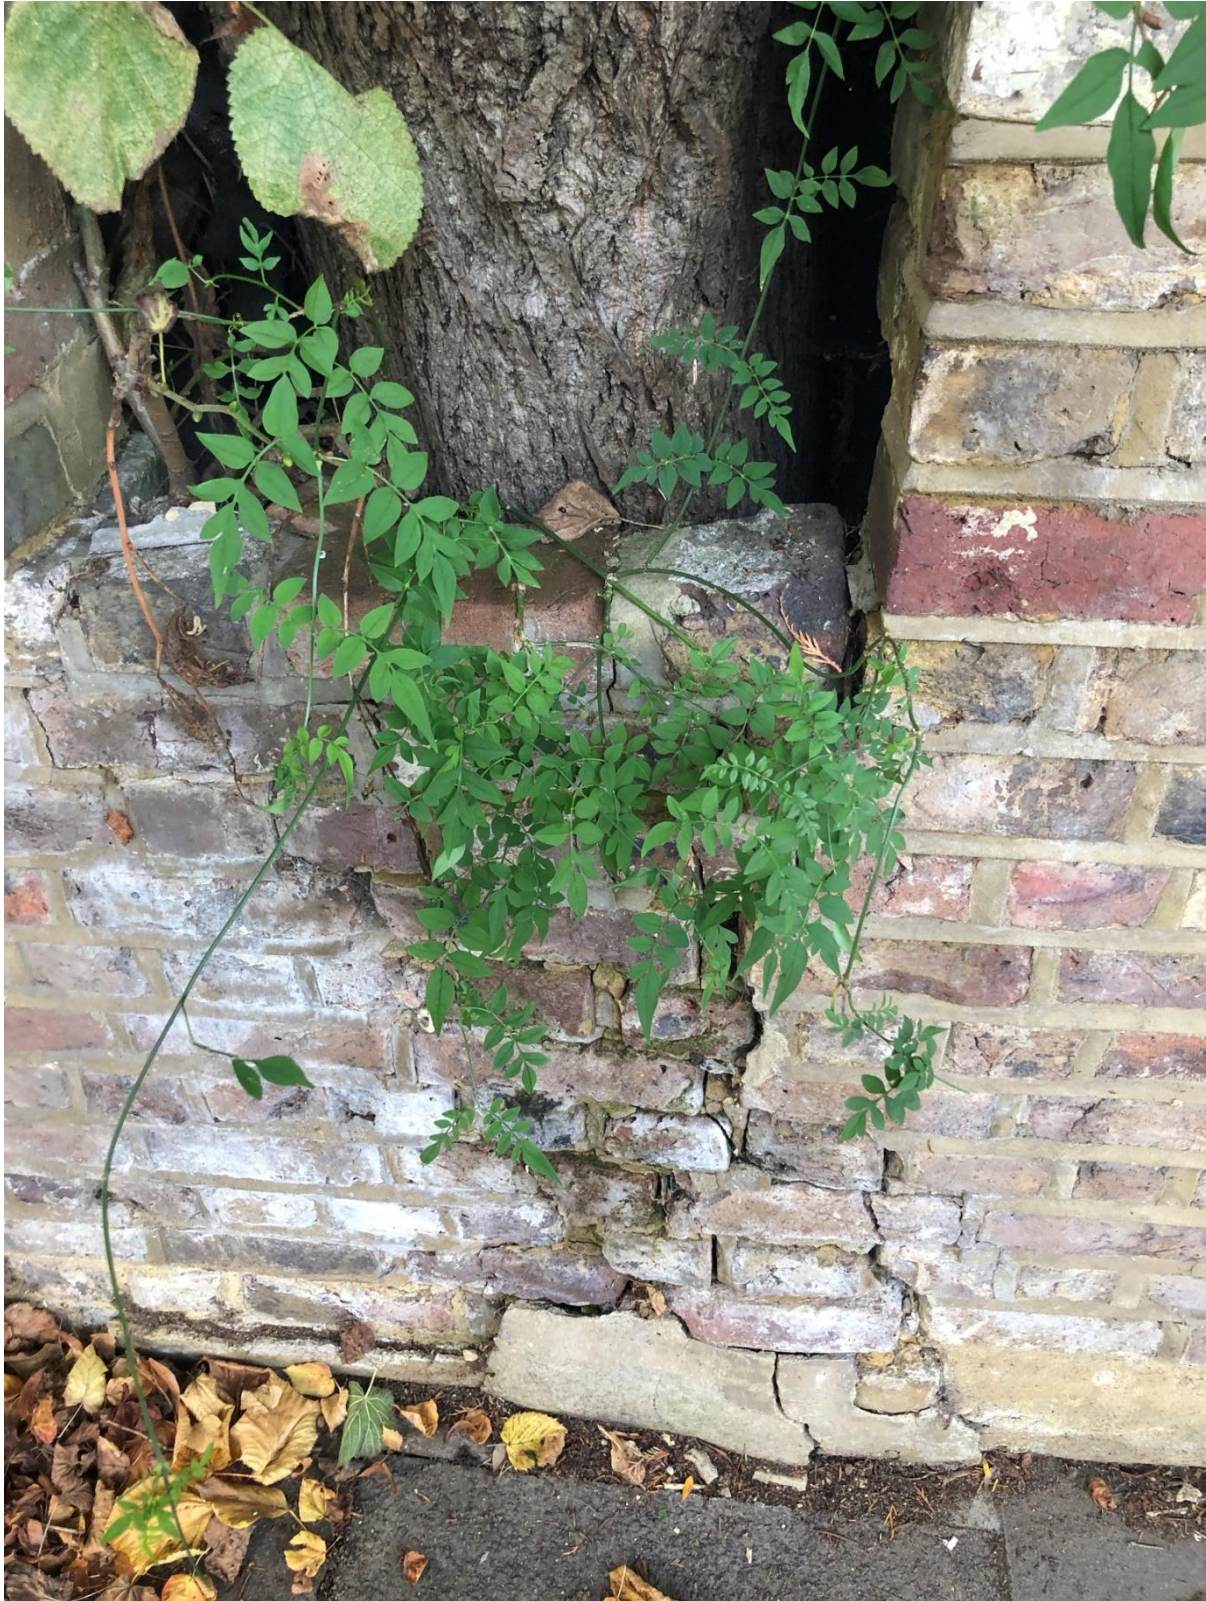
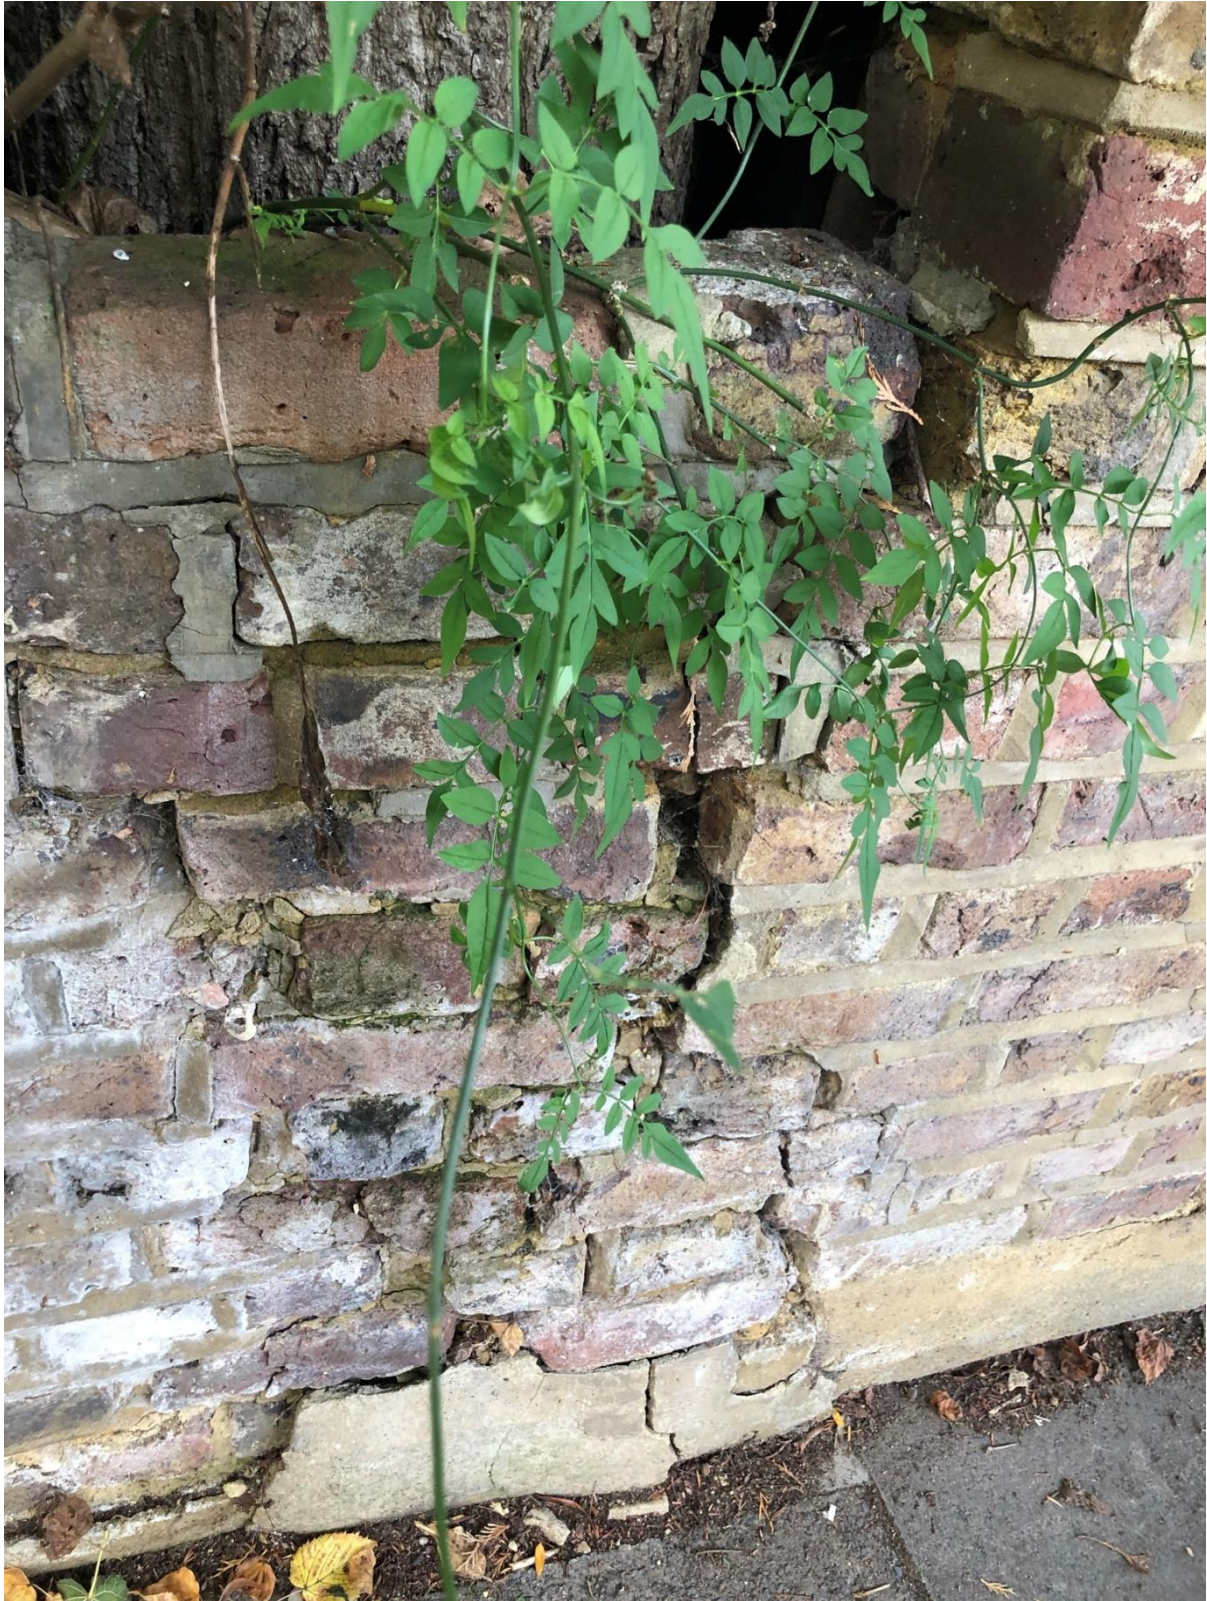
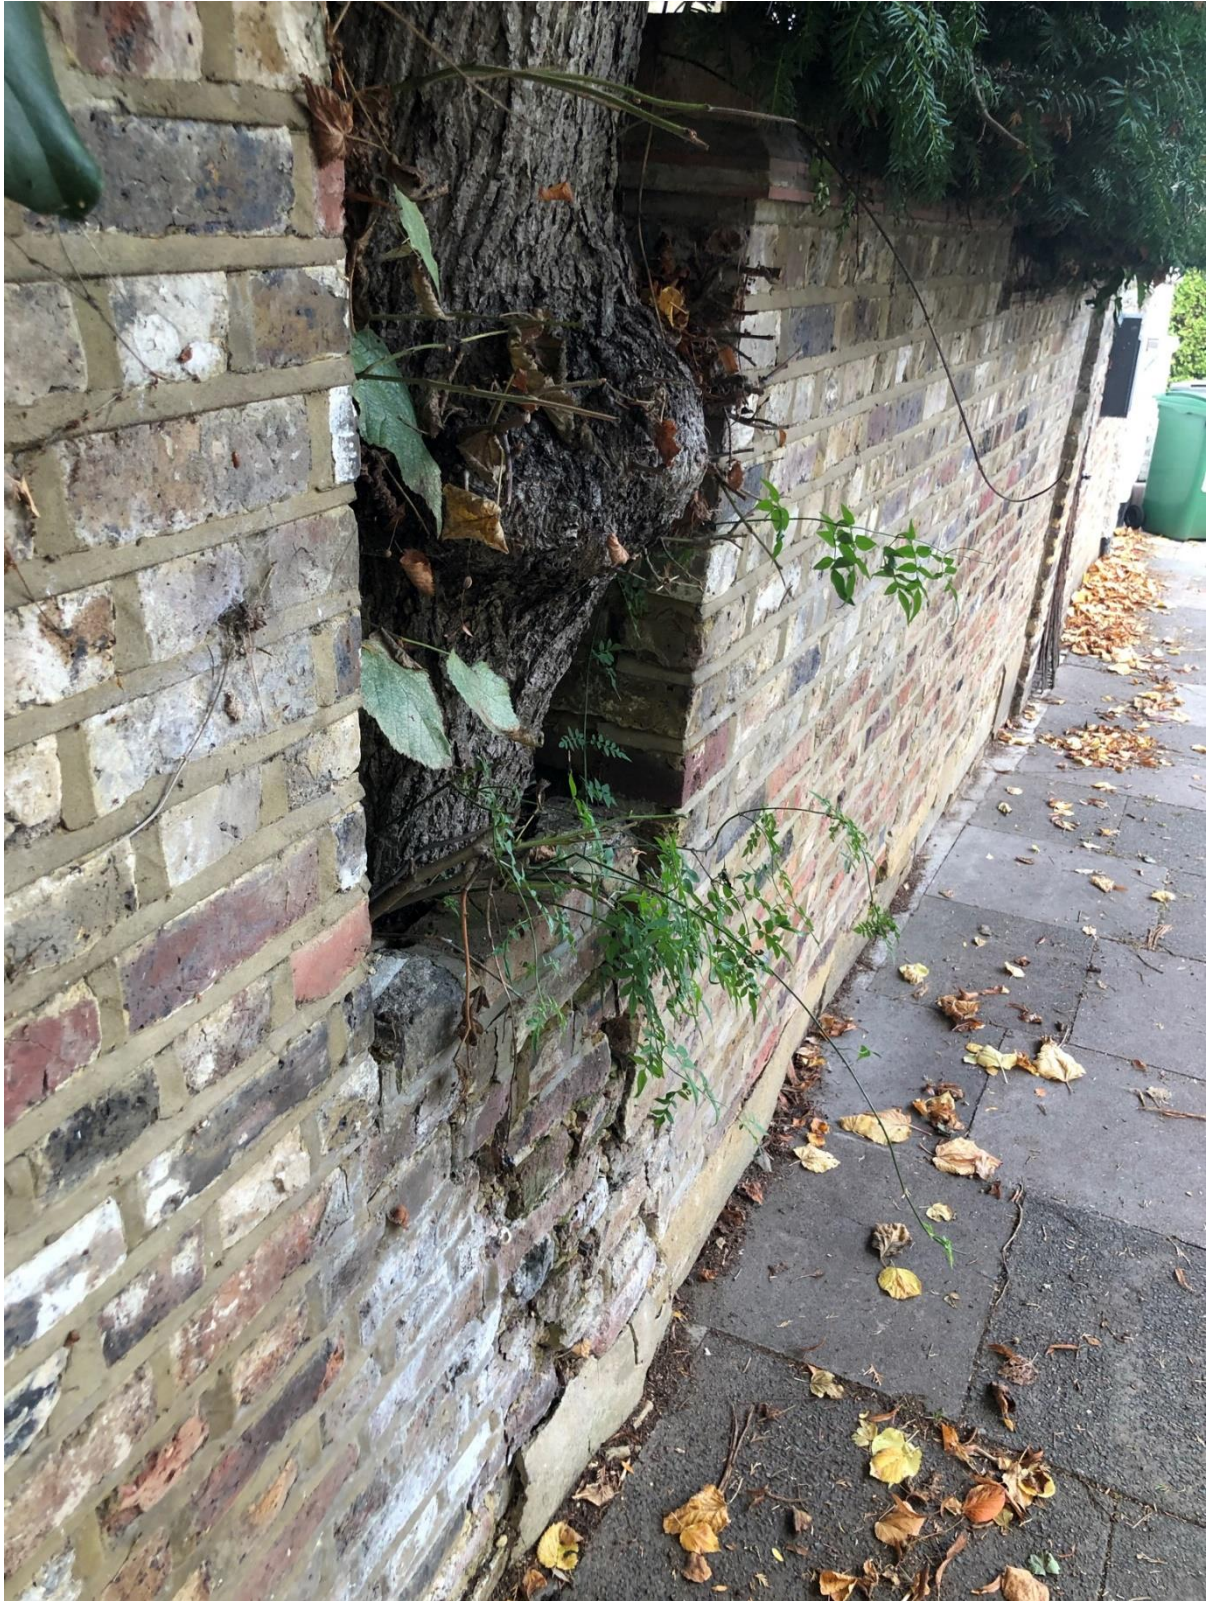
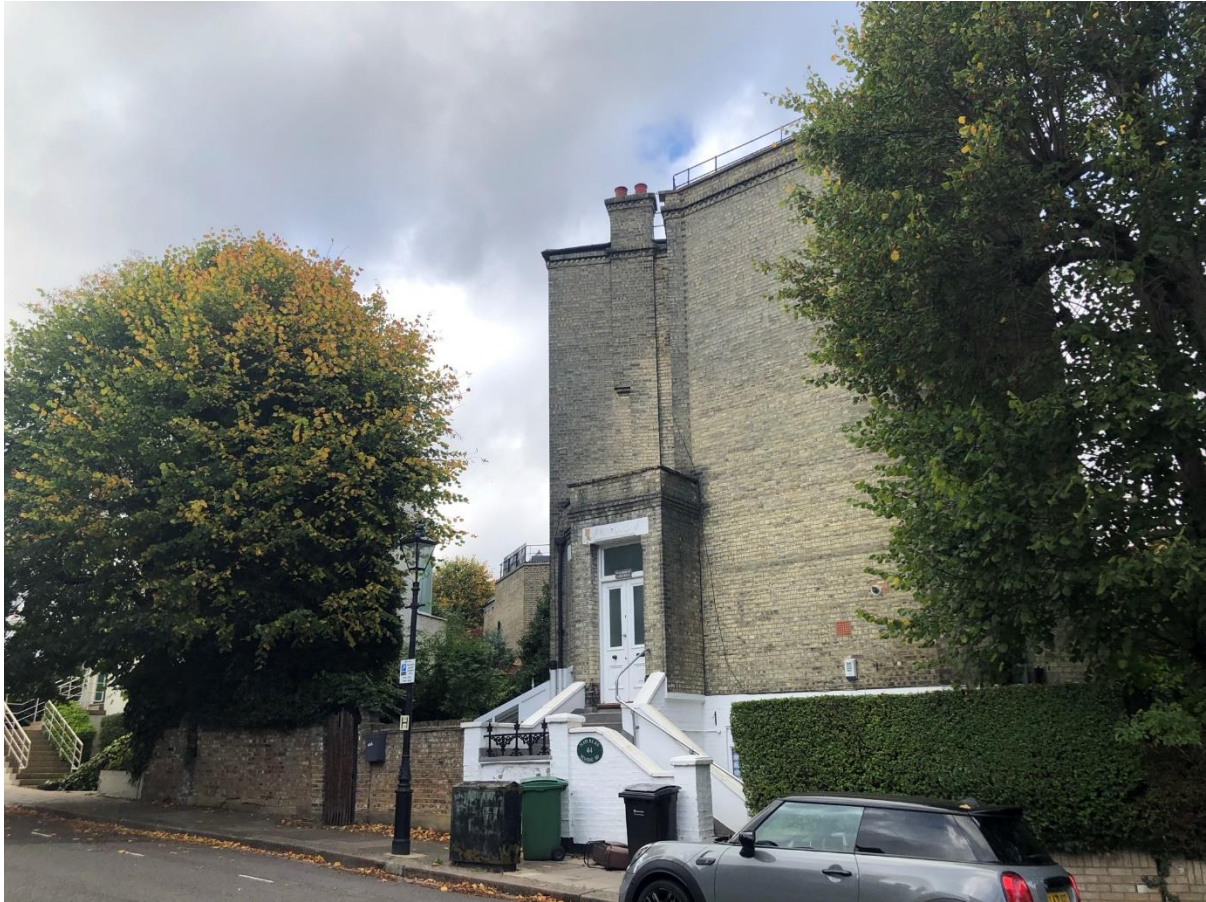
3.02 The aforementioned two large Lime trees in the front garden are causing the front boundary brick wall facing Pilgrim Lane to lean out towards the pavement beyond acceptable limits i.e. more than one third of the thickness of the wall measured at its base. This means that the wall is unstable and could suffer collapse on passers-by and users of the subject flats' front garden. Furthermore there are significant structural cracks in the boundary wall weakening the wall, wanting urgent remediation.

3.03 There is evidence of what appears to be direct mechanical action of the trees on the wall as well as indirect action of the tree roots on the soil volume i.e. tree root induced clay shrinkage subsidence.

3.05 To consider simple pollarding for a tree within 5.0m from a building or structure, according to the Kew Study for Trees, would likely entail removing the entire leafy area. In order to avoid rot and destabilisation of a degrading leafless stump, felling of the two Lime trees is advised.

3.07 P.G Biddle, states within his Arboricultural Advisory Information advice note 108/92 EXT: "If the movements are entirely seasonal, it may be possible to reduce the amplitude of this movement to an acceptable level by pruning the tree so as to remove leaf area ... greatest benefits will be achieved if the building is near the outer limits of influence, pruning a large tree which is only a few metres from the building will probably have little benefit ... if there is a significant persistent deficit, pruning alone will not be effective". On this basis and since the trees appear younger than the adjacent buildings and structures, I recommend felling the two Lime trees under guidance of a qualified tree specialist.
