To:	Emma Henderson, British Museum	Job number:	1635-02
From:	Civic Engineers	Date:	02/09/2022
Subject:	British Museum - KEB Window Frames	Cc:	Darren Thomas, Stace

## British Museum – KEB Window Frames

Project British Museum - KEB Tunnels - Window				
Title Elevation, Section and Schematic of damaged window				
Project Number	Drawing Number	Scale @ A3	Revision	
1635-02	SK300	As Shown	P01

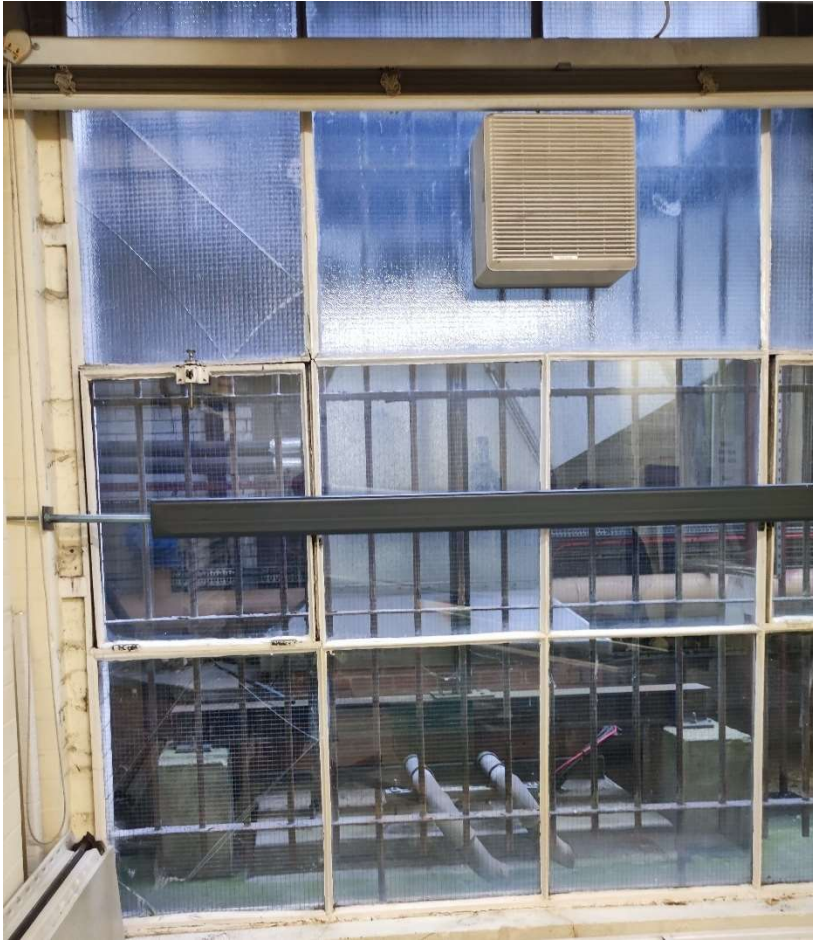
The window was viewed on site and significant bowing could be seen in the window with the glass panels pushing inwards in a curve. Refer to section on SK 300 at the end of this note to see curvature. The curve of the window was causing the metal of the window frame to crack. It was noted that the bottom of the window frame had significantly expanded. The frame had expanded more at the east end than the rest of the bottom of the frame. A couple of panes of glass had cracked at the east end of the window.

*Figure 2: Expansion of window frame at base at east end and cracked window panes above*

It seems sensible to remove the glazing and window frame of Window W1 and clean out any rusting metalwork and repair any cracks in the stone sill. This should allow a new window or the existing one refurbished and repaired to be installed. Advice should be sought by a window or waterproofing specialist for the installation of new windows and repair work and how they can be detailed to avoid the issue recurring. We also recommend that the other windows W2-W7 are also repaired as they seem to be deteriorating in a similar way. We would envisage that the remedial works to the drainage outside the window W1 could cause further damage to the window and it would be sensible to either replace this window during the works or to put up protection over the window before the works are undertaken in case of the window deteriorating during the works.

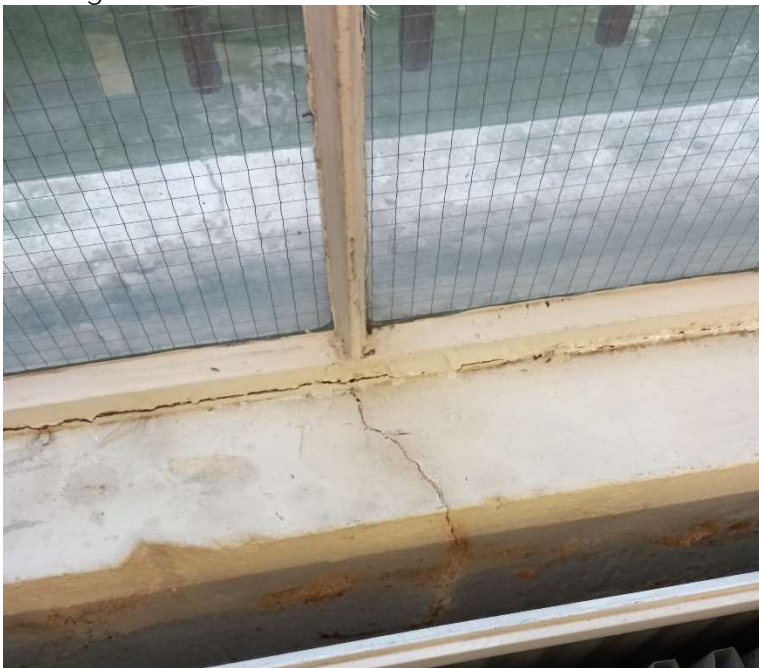
Signs of damp, such as peeling paint and staining were noted on and below the window sill on the inside of the building. The external stone window sill was cracked in the middle and this crack was visible internally as well.

*Figure 3: cracked window sill*

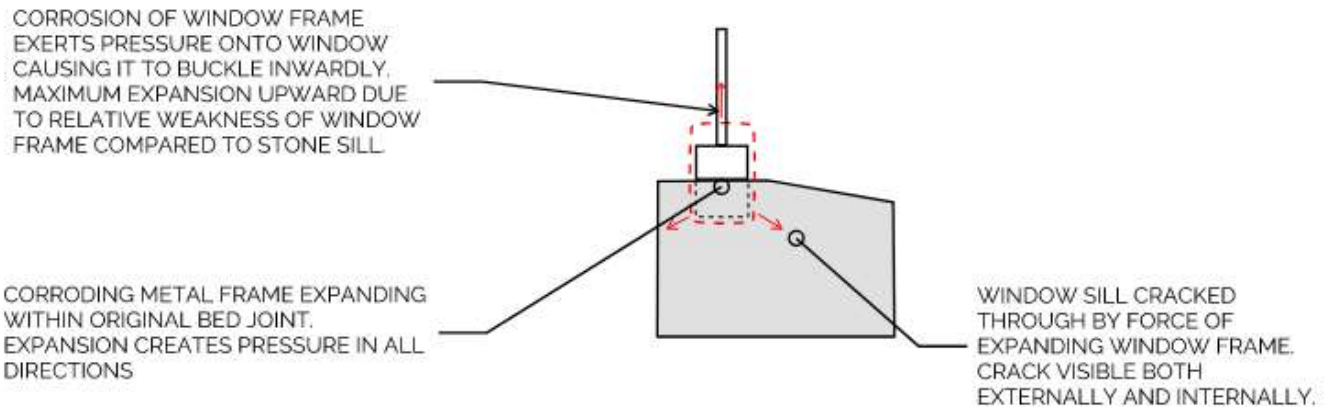
Figure 4: Schematic of action within sill

It seems likely that that the damage seen in the window frame is caused by corroding metalwork of the frame. When steel corrodes and turns into rust it expands by approximately six times it's original volume. This generates a significant amount of pressure. In this case it appears that the expanding steelwork at the bottom of the window has caused the whole window to bow as the force of the rusting window frame pushes the window up against the masonry arch at the top of the window. The force of this rusting appears to also have cracked the window sill at the mid point. Water hitting the window from rain would run down the window and sit on the bottom of the frame before running down the sill. As the bottom of window frame has corroded this has allowed more of the protective paint to be pushed aside and for water to access the metalwork underneath exacerbating the situation.

As such we do not think this is a structural issue (for example indicating foundation movements), but a local problem with the window frame.

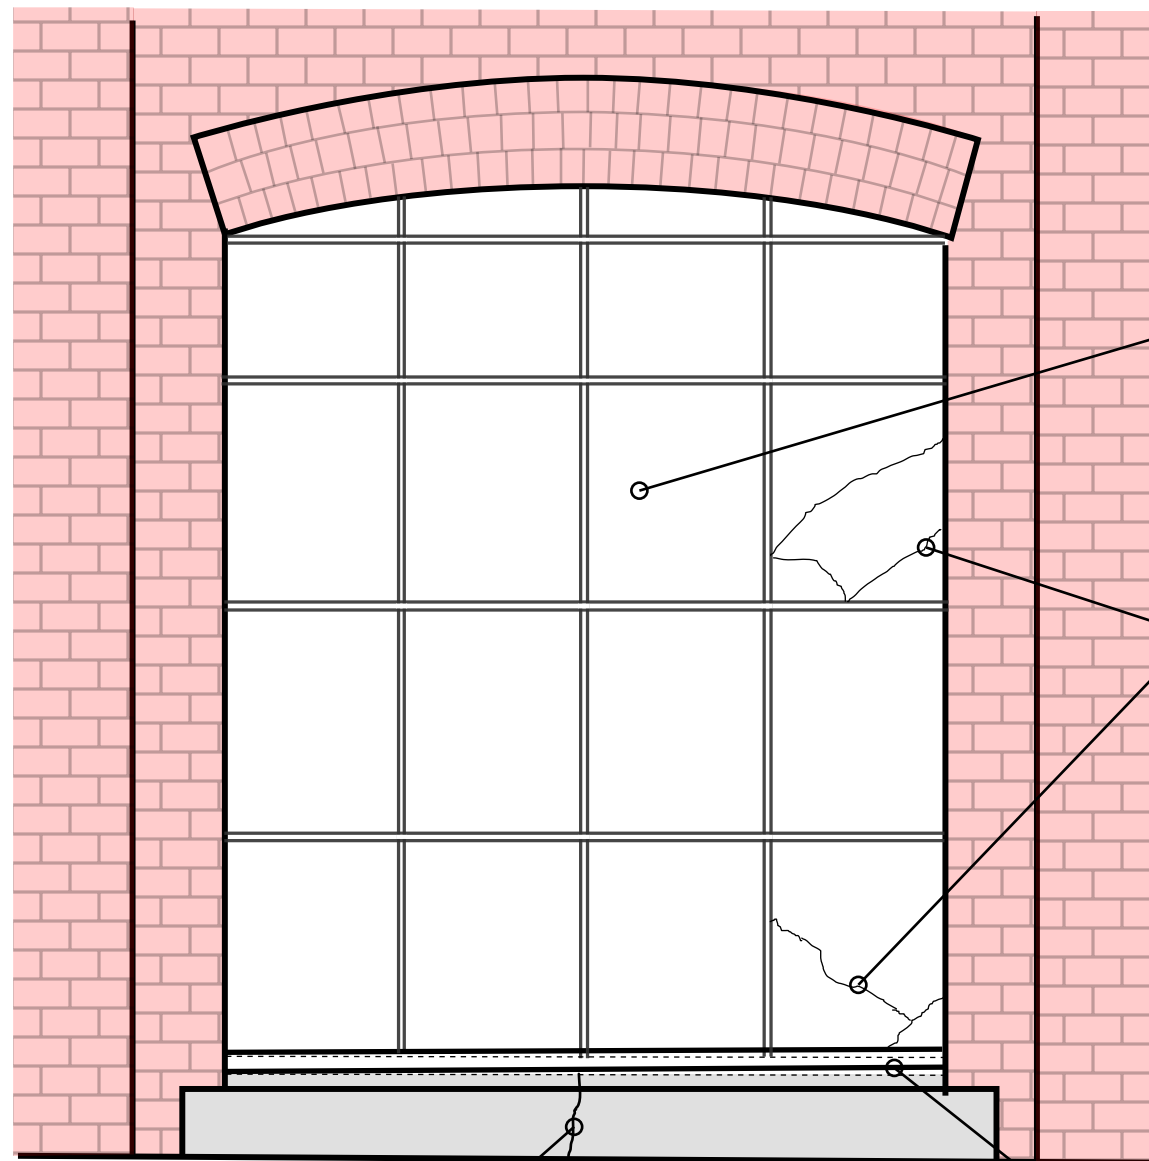
**ELEVATION OF WINDOW W1**  
1:20 @ A3

CRACKING TO A NUMBER OF WINDOWS AS FRAME HAS BUCKLED

CRACKING THROUGH WINDOW SILL NOTED INTERNALLY AND EXTERNALLY

EXPANSION OF WINDOW FRAME AT BASE OF WINDOW HAS CAUSED WINDOW FRAME TO BULGE INWARD. DOTTED LINE REPRESENTS ASSUMED ORIGINAL POSITION OF WINDOW FRAME

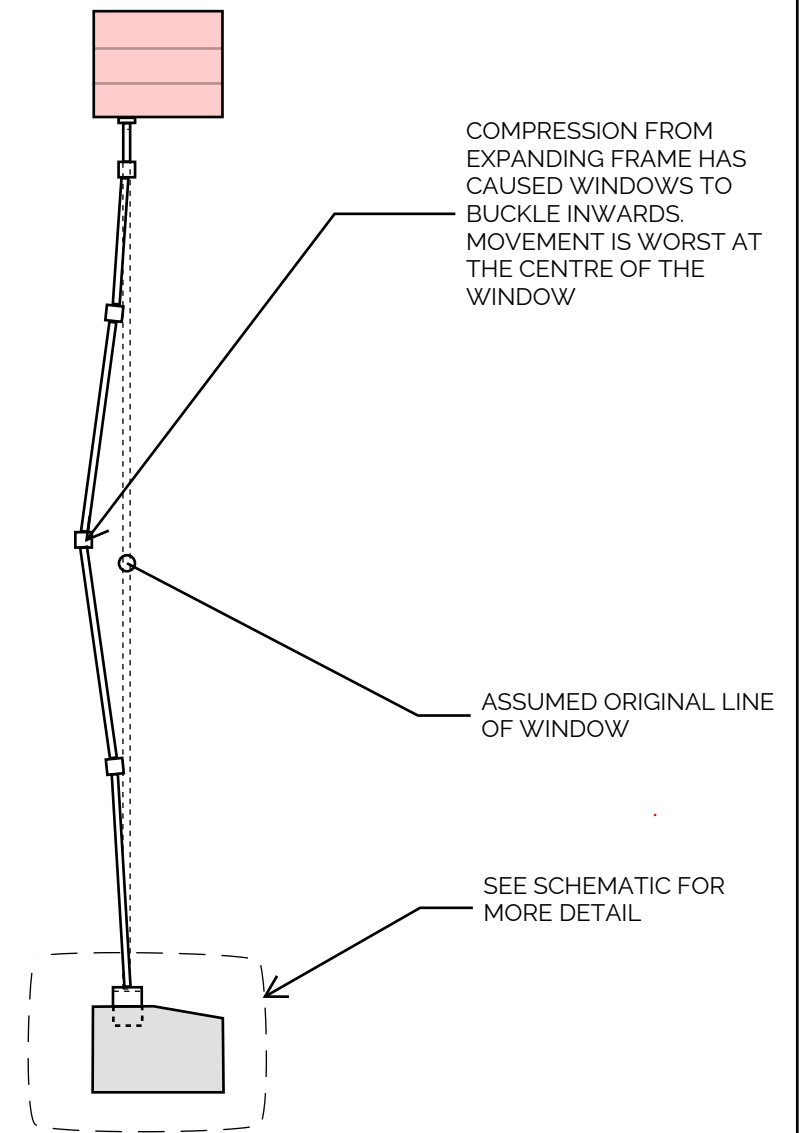
**SECTION THROUGH CENTRE OF WINDOW**  
1:20 @ A3

COMPRESSION FROM EXPANDING FRAME HAS CAUSED WINDOWS TO BUCKLE INWARDS. MOVEMENT IS WORST AT THE CENTRE OF THE WINDOW

ASSUMED ORIGINAL LINE OF WINDOW

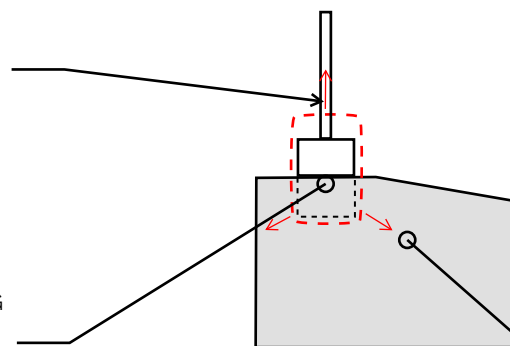
**SCHEMATIC OF ACTION WITHIN SILL**  
1:10 @ A3

CORROSION OF WINDOW FRAME EXERTS PRESSURE ONTO WINDOW CAUSING IT TO BUCKLE INWARDLY. MAXIMUM EXPANSION UPWARD DUE TO RELATIVE WEAKNESS OF WINDOW FRAME COMPARED TO STONE SILL.

CORRODING METAL FRAME EXPANDING WITHIN ORIGINAL BED JOINT. EXPANSION CREATES PRESSURE IN ALL DIRECTIONS

WINDOW SILL CRACKED THROUGH BY FORCE OF EXPANDING WINDOW FRAME. CRACK VISIBLE BOTH EXTERNALLY AND INTERNALLY.
