TREE CONDITION REPORT ON ONE ATLAS CEDAR TREE

No. 2 Langland Gardens, London NW3 6PY

CLIENT:	The Plumbing Team Limited
CLIENT REF:	DF/LGL
AAAL REF:	SAL/KMA/11358
AAAL CONSULTANT:	Shane A Lanigan
REPORT DATE:	5th December 2022

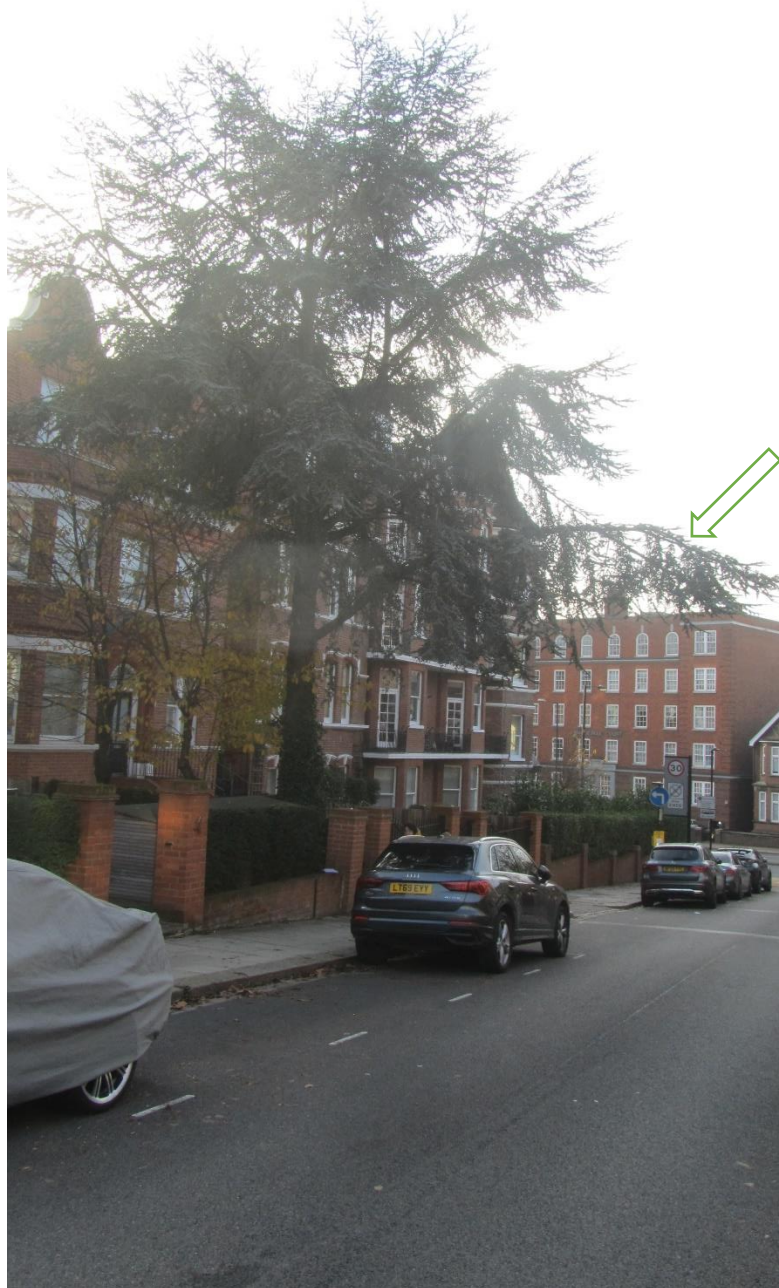
3.3 Physiological condition of the tree is good, structural condition less so. The tree form is now over-extensive laterally and gives rise to concern about breakage of the longer lateral branches. Atlas cedar is probably more susceptible to branch-break than either Lebanon or Himalayan cedars, seemingly due to poorly formed branch unions. In this location the propensity toward branch-break is of significant concern.

**PHOTOGRAPH NO. 1 - T1 – ATLAS CEDAR – VIEWED FROM THE NORTH
SHOWING OVER-EXTENDED WESTERN LATERAL BRANCH (ARROWED)**

5.1 **T1 – Atlas cedar** – reduce the over-extended westerly-growing branch above the roadway by around 3 m. All other lateral branches should be reduced by around 2 m with the aim of achieving a balanced crown form. A minimal height reduction of 1.5-2 m will serve to achieve a reasonably symmetrical form. The ivy growing on the trunk should be severed at ground level. All pruning works shall conform to the recommendations provided within British Standard BS 3998: 2010.

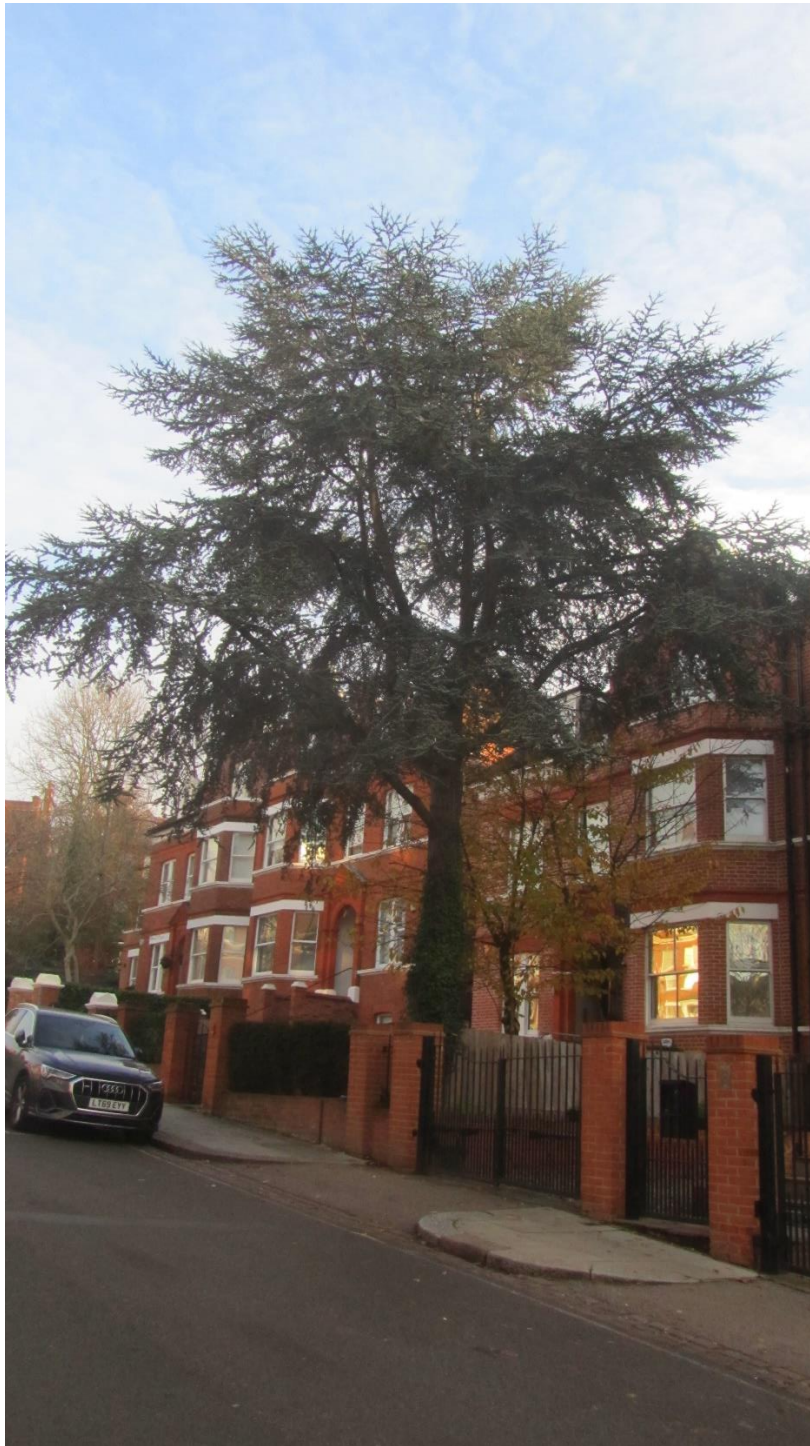
2.3 Tree condition: I made an initial ground-based visual inspection of the tree from around 270° of its circumference. Top height is around 14 m and the crown spread is now extensive, disproportionately so on the western side (see photograph 3). It is not a maiden tree, having been historically topped. Due to this action, it now has essentially three leading stems. General physiological condition is good although it is heavily covered by ivy on areas proximal to the trunk to a height of around 8 m above ground (see photograph 2). Annual shoot extension growth is high, indicating high vitality.

PHOTOGRAPH NO. 2 - T1 – ATLAS CEDAR – VIEWED FROM THE SOUTH

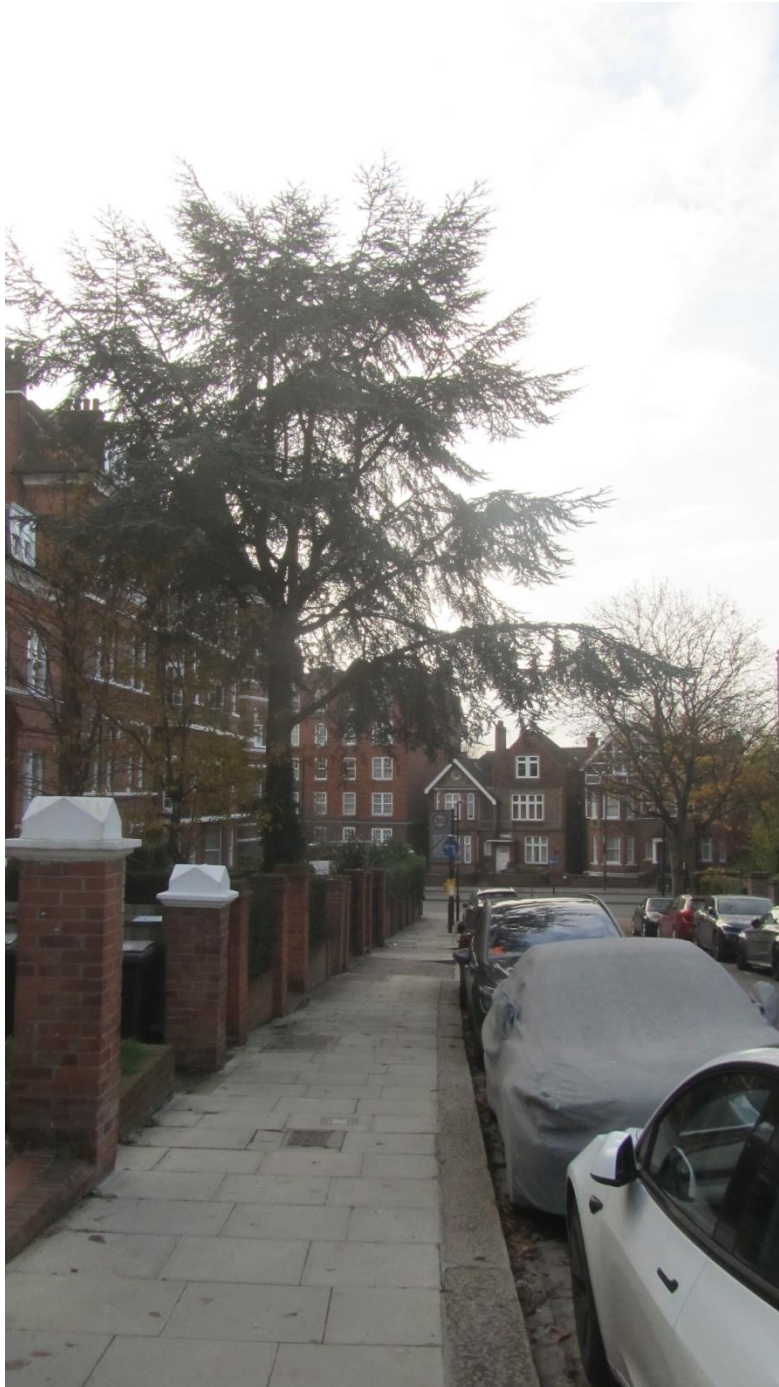
3.2 The tree is now effectively 'open-grown' and as such with no immediate competition, is growing very rapidly in both height and spread. Many of the laterally growing branches have been able to grow faster and further than they might otherwise have done due to the short-term loss of hormone controlled apical dominance induced by the topping operation. This effect is particularly noticeable on the western side (see photograph 3).

PHOTOGRAPH NO. 3 - T1 – ATLAS CEDAR – VIEWED FROM THE NORTHEAST

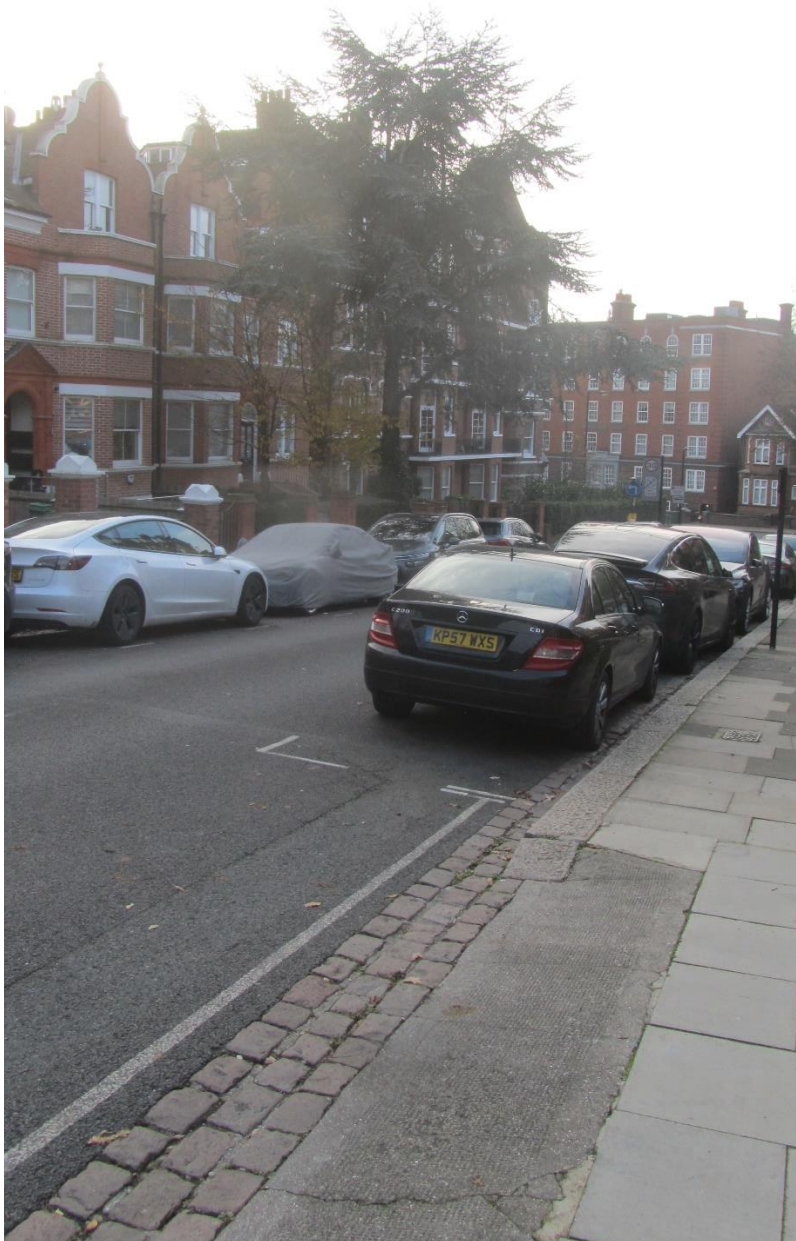
2.2 Location: I saw that the tree is growing to the northwest of the dwelling house. It is growing directly on the boundary line between Nos. 2 & 4 Langland Gardens around 1 m southeast of the front boundary (see photographs 1, 2, 3 & 6). The western side of the tree crown encroaches over public land to the front of the property, including the pedestrian footway and road (see photograph 1). Much of the north eastern crown area extends over the front garden area of No. 4 (see photographs 3 & 4).

PHOTOGRAPH NO. 4 - T1 – ATLAS CEDAR – VIEWED FROM THE NORTH

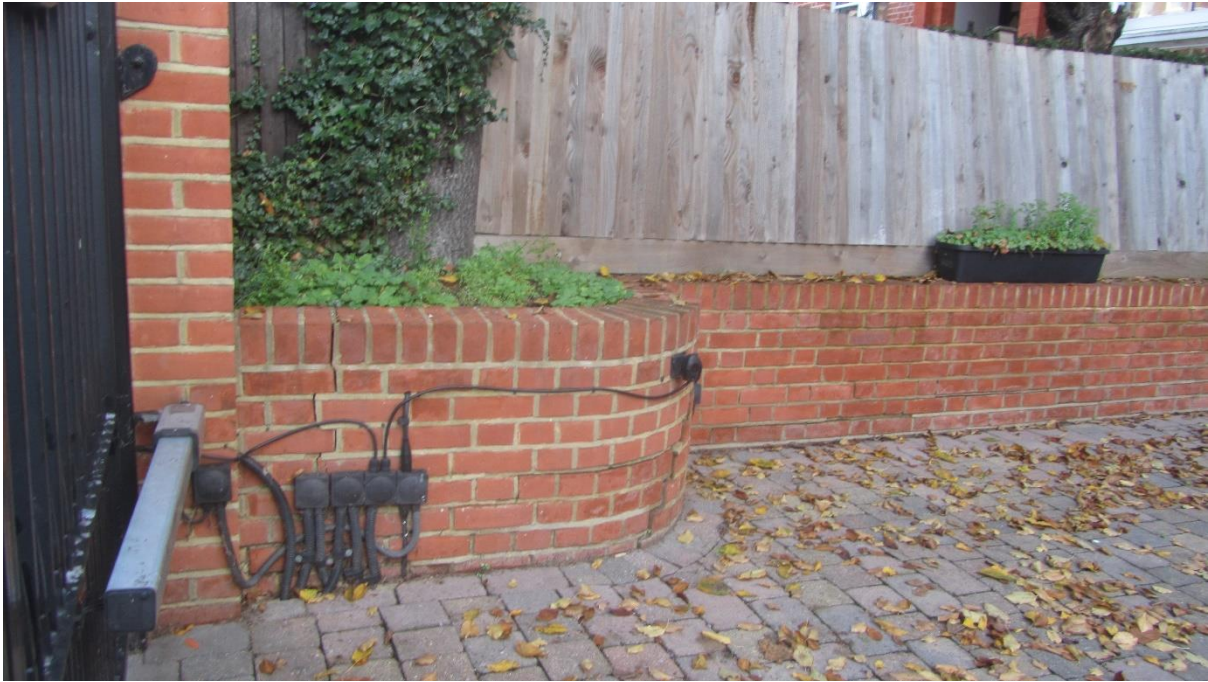
PHOTOGRAPH NO. 5 - CRACKING OF THE RETAINING WALL SOUTH OF THE TREE BASE

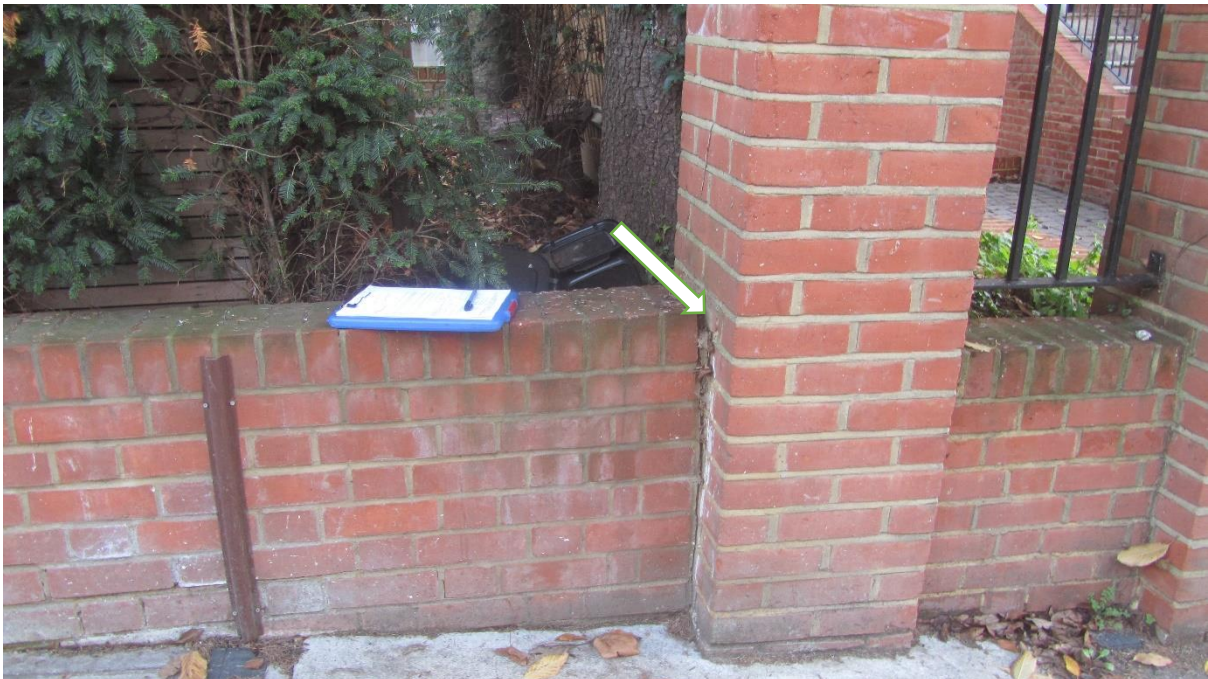
Tree 1	Atlas cedar – <i>Cedrus atlantica</i> (Endl.) Family: Pinaceae
Ownership:	No. 2 Langland Gardens - although a significant part of the tree's trunk has grown across the boundary into the curtilage of No. 4 Langland Gardens (see photograph 6, Appendix 1 at the back of this report).
Grid reference:	TQ 259 852
Elevation:	70 m
Age Class:	Mature (being within the middle one-third of its probable life expectancy)
Height:	14 m (estimated)
DBH (diameter at breast height)	430 m (estimated due to lack of access and significant ivy cover)
Physiological condition:	Good – the tree shows high vitality (growth within its current location) – as opposed to vigour which is a genetic trait)
Structural condition:	Fair – my visual inspection showed that the tree was historically ‘topped out’ (decapitated). It has since regrown strongly with one leading shoot assuming apical dominance and two primary rival leaders growing up on the south and north sides (see photographs 1, 2 & 3). The topping operation altered the growth pattern of the tree temporarily and allowed the lateral branches to develop further and faster than they might normally have done.

PHOTOGRAPH NO. 6 - BASE OF T1 ENCROACHING INTO THE CURTILAGE OF NO. 4, ALSO SHOWING MOVEMENT OF THE FRONT BOUNDARY WALL (ARROWED)
