TECHNICAL REPORT ON A SUBSIDENCE CLAIM

**29 Elsworthy Road
London
NW3 3BT**

SUBSIDENCE CLAIM

DATE 17 December 2018

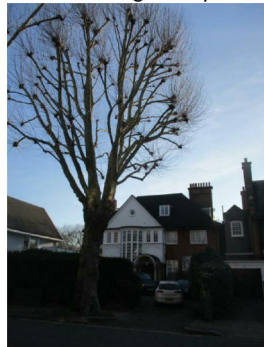
View of council plane tree to front of property

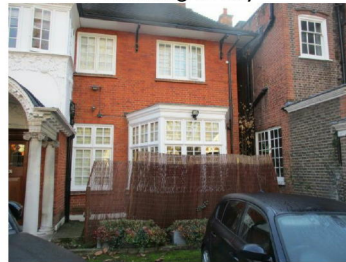
Front Bay - 5mm vertical tapering separation to left and right hand side junctions, historic distortions noted to bay structure.

View of bay window

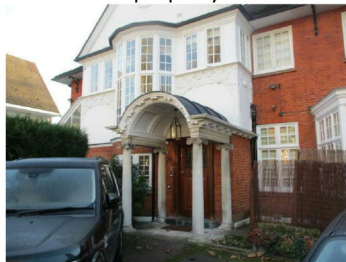
Portico - 15mm vertical cracking above left hand column, 9mm diagonal cracking above right hand column, 23mm tapering gap across stone step front section junction, 1mm crack to underside of portico roof on right hand side, tarmac cracked and dropped in front of portico.

View of portico

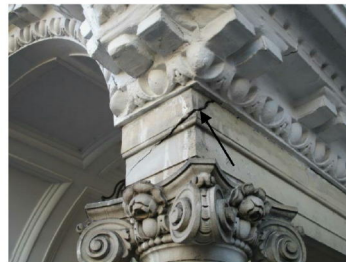
Cracking to portico
