Arboricultural Appraisal Report

Subsidence Damage Investigation at:

29 Elsworthy Road
London
NW3 3BT

CLIENT:	Crawford & Company
CLIENT REF:	[REDACTED]
MWA REF:	[REDACTED]
MWA CONSULTANT:	George Peters BSc. (Hons), M.Arbor.A
REPORT DATE:	09/09/2019

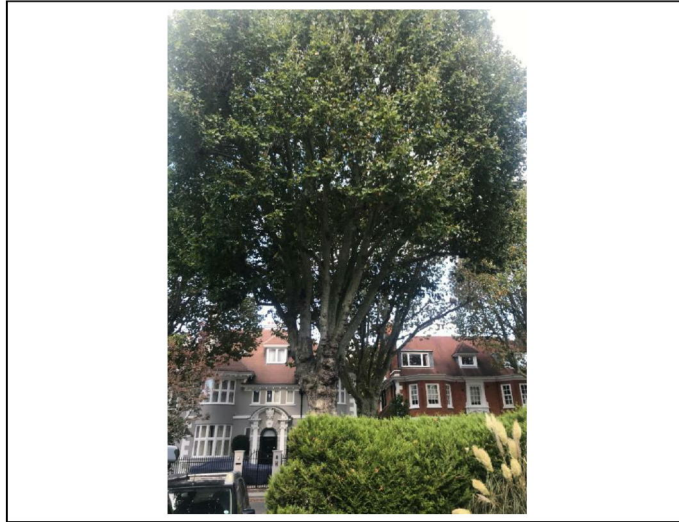
Roots were observed to a depth of 2400mm and 2200mm bgl in TP/BH1 and TP/BH2. Recovered samples have been positively identified (using anatomical analysis) as *Platanus* spp., and *Cupressaceae* spp., the origin of which will be T1 (London Plane) and H1 (Cypress) confirming their influence on the soils below the foundations.

Based on the technical reports currently available, engineering opinion and our own site assessment we conclude the damage is consistent with shrinkage of the clay subsoil related to moisture abstraction by vegetation. Having considered the information currently available, it is our opinion that T1 and H1 are the principal cause of or are materially contributing to the current subsidence damage.

View of T1 London Plane, current claim.

If an arboricultural solution is to be implemented to mitigate the influence of the implicated trees/vegetation we recommend that T1 is re-pollarded, and committed to strict re-pollard interval of every 2 years, and H1 is removed to achieve 4 metres clearance from the insured property. Other vegetation recorded presents a potential future risk to building stability and management is therefore recommended.

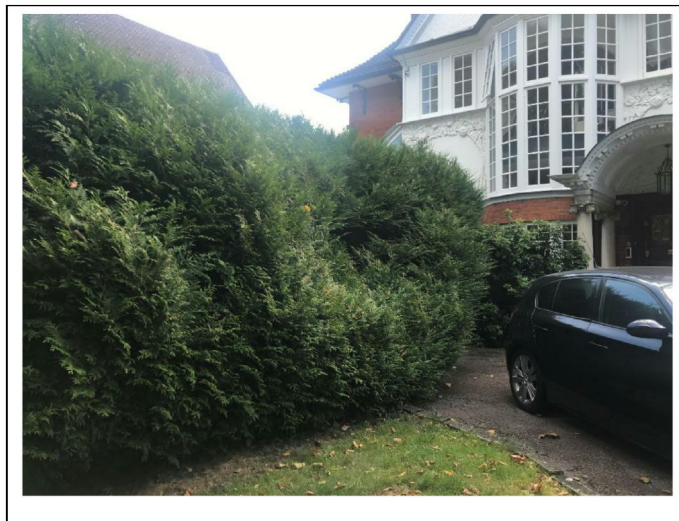
View of H1 Cypress, current claim.

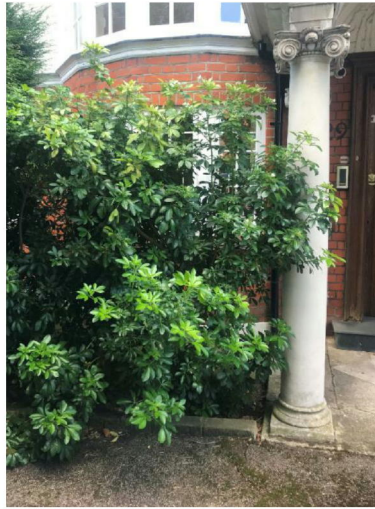
View of S1 Choisya, future risk.

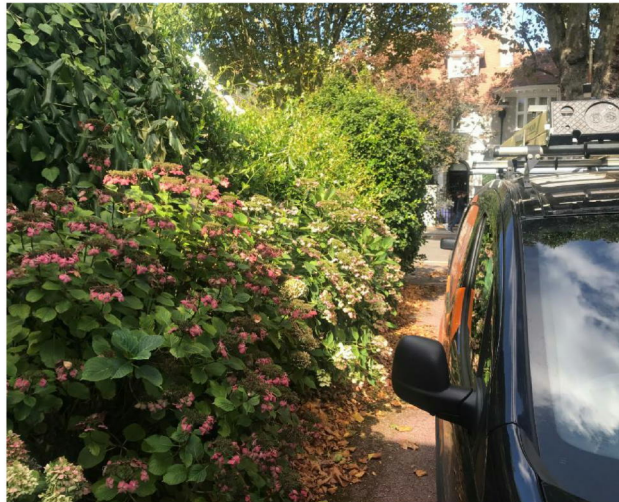
View of SG1 mixed species, future risk.
