## SITE INVESTIGATION FACTUAL REPORT

29 Elsworthy Road

15/05/2019

# Drainage Layout Plan

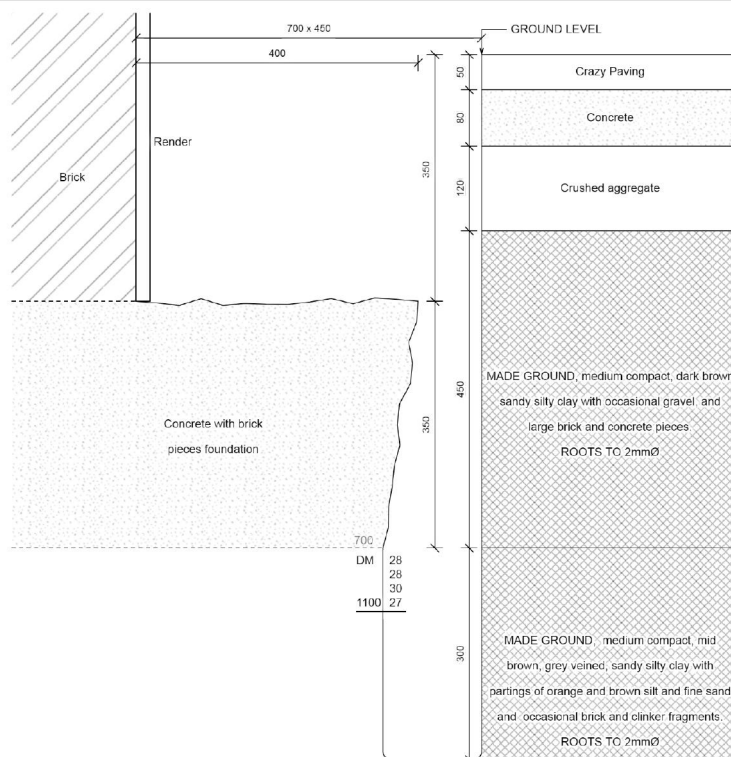
TEST REPORT: Trial Pit

For Strata below 1000mm see Bore Hole log

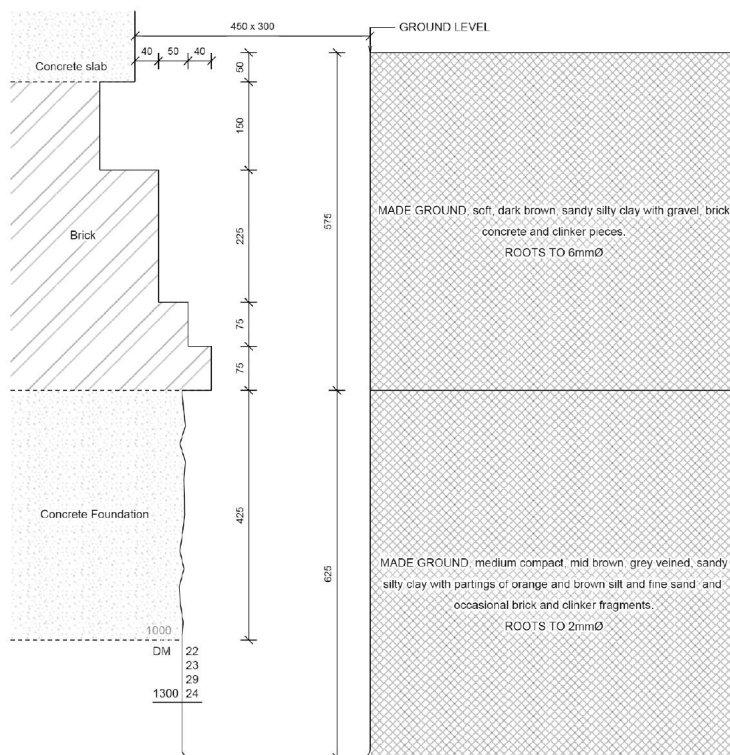
TEST REPORT: Trial Pit

For Strata below 1200mm see Bore Hole log

Concrete Slab is 150mm thick. 100mm is above GL.
