Tree Report
Picus Testing – 87 Canfield Gardens NW6 3EA

1.1 Inspection date: 30th November 2022 by Mr. Kim Gifford, undertaken in the area of test and at the time of inspection.

1.6 Lombardy Poplar by the fence.

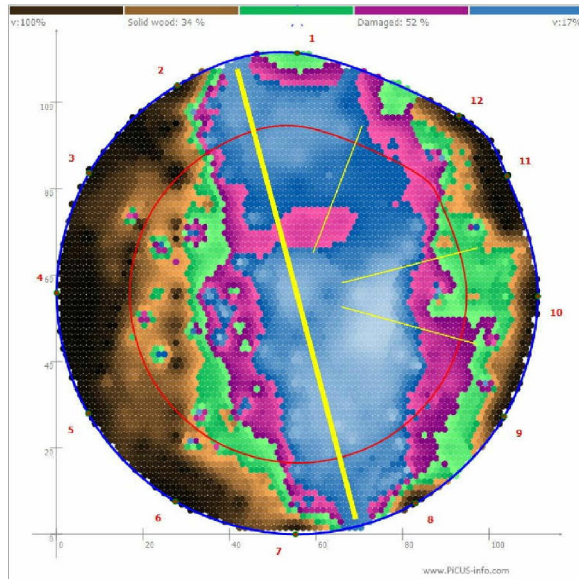
Test 1 @ level: 120cm approximately from ground level.

Test point 1 orientation North.

The measuring point readings give evidence of low velocities overall in the area of test representation showing as altered timber. The tomographic images shown above has a percentage amount of altered timber. With reference to the 'colour chart see figure 2', the slower sonic speed of sound is represented by three bands of data representation blue/violet/white being the slowest altered/decayed timber, green being faster altered timber, brown being fast sonic-speeds solid timber.

The resulting Picus tests are of unacceptable limits in relation the altered timber. This ratio called a 'trunk ratio' TR (*reference Claus Mattheck*) has been calculated to be a guideline in terms of stability and rigidity of cylindrical structure. Although a debated theory in arboriculture in general terms the TR of 30% is an average.

The Picus test shows there is extensive altered timber. The whole specimen is severely leaning towards the neighbouring property. This specimen is unstable and liable to collapse in this condition.

It would be appropriate to recommend that this specimen is completely reduced down to approximately 5m from ground level as a monolith or completely removed on the grounds of health and safety within the near future.
