Arboricultural Impact Assessment

76 Lawn Road, Camden NW3 2XB

Project Number: P3430.1.3

Date: 25 August 2021

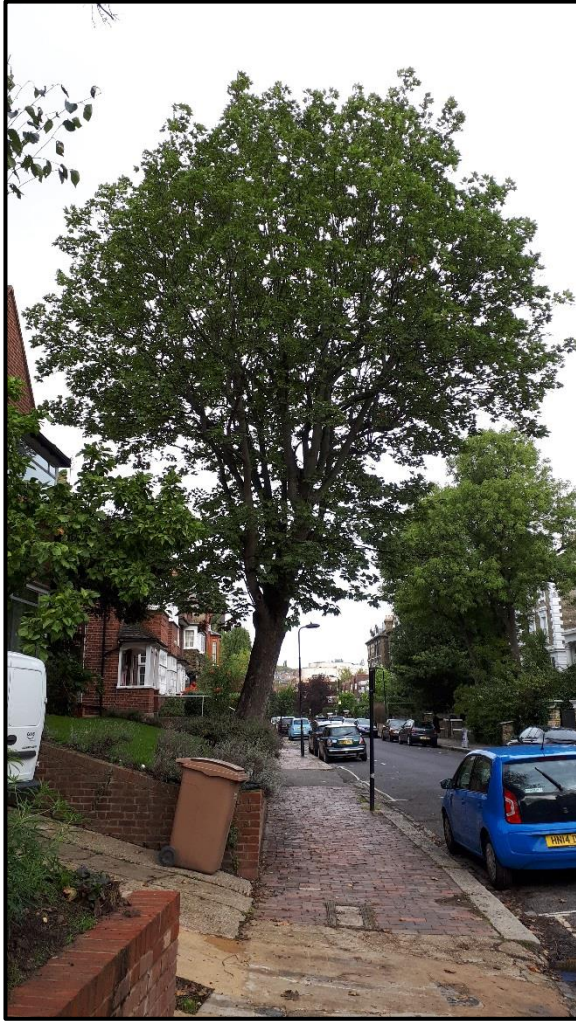
The removal of T1 would have a significant impact visually, as this tree is prominent within the street scene. Given the clearly visible damage to the wall and that the tree leans towards the road, its removal appears to be inevitable at some point. If left, the risk of wall collapse will increase, which poses a threat to pedestrians and road users. It is not clear what the consequence of wall collapse would be on the tree's stability, but in a worse-case scenario, the tree could also fail onto the road.

Photograph 1. T1, sycamore, located to the west of Lawn Road in raised front garden. Viewed looking towards the north.

The tree is subject to a TPO. There would be scope to plant a new tree within the front garden to compensate for the loss. This should be planted further back from the boundary wall to minimise future potential for damage.

It is recommended that the opportunity is taken now to address this situation, as part of the planning application, rather than wait until a later date and force the development to be designed around a tree that clearly has no long-term viability. So, though the removal of T1 will alter the design, development would not be the reason for its removal.

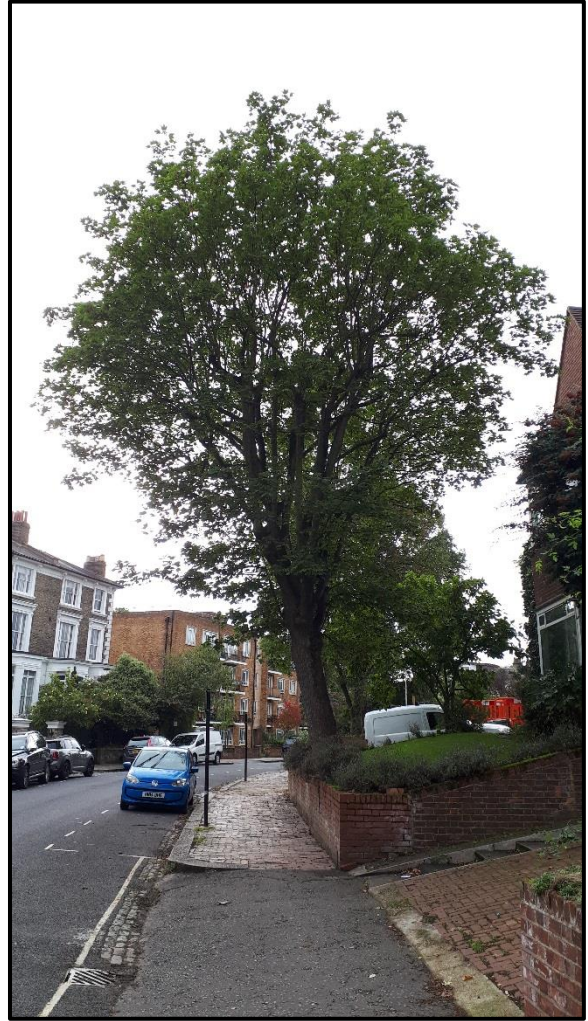
Photograph 2. T1, viewed looking towards the south.

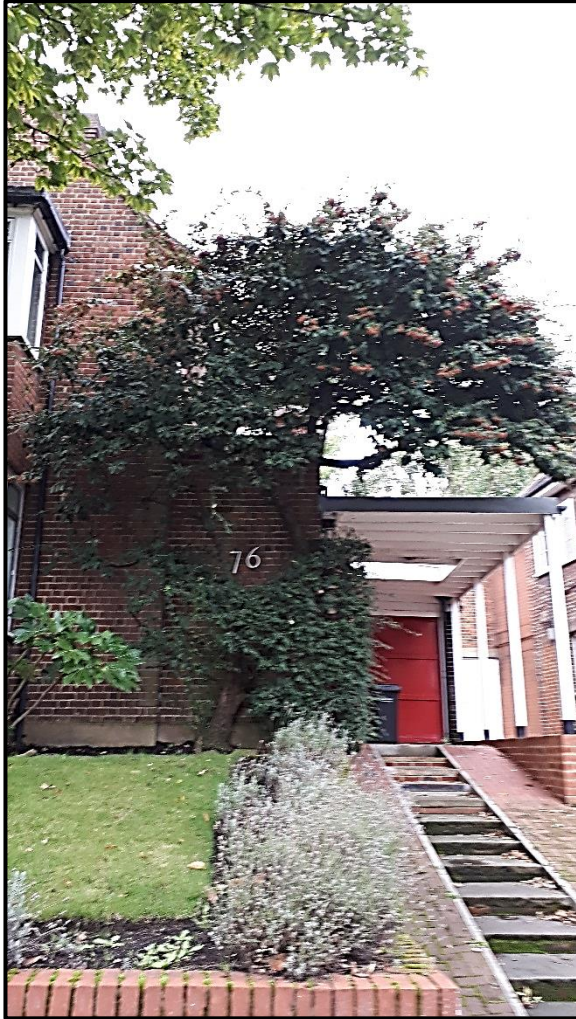
Photograph 3. T2, cotoneaster, located close to the property elevation. Viewed looking towards the west.

- Removal of T2 to prevent property damage; and
- Crown reduction of T4 to prevent obstruction of the garden space.

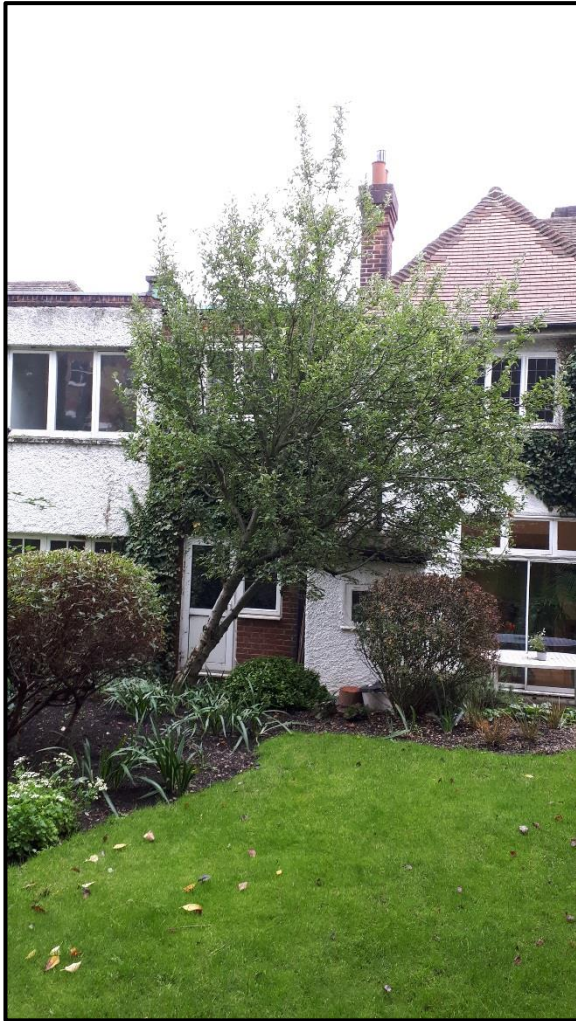
Photograph 5. T4, apple. Located in the rear garden. Note lean of main stem. Viewed looking towards the north-east.

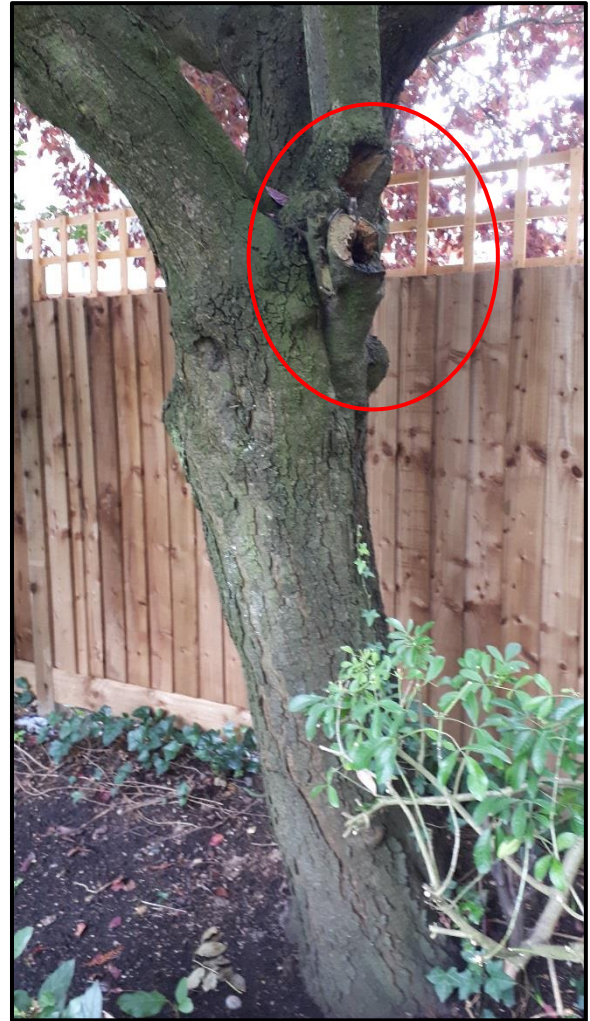
Photograph 8. Close-up of T6, showing pruning wound with associated decay and cavity (circled).

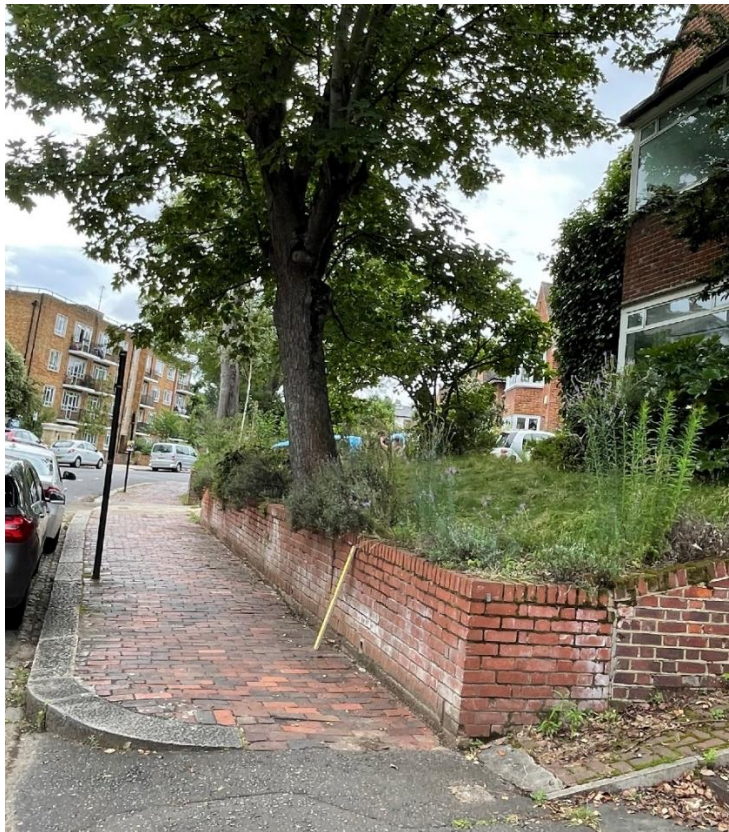
The severe distress to the wall has been caused by the tree.

Photo 1 -View of front garden wall and tree

It is therefore recommended that the tree is removed and the wall reconstructed

Our proposals for the reconstruction of the wall are shown on drawing R11438/EXT1. The wall would be reconstructed in reinforced concrete clad with brickwork and designed to span between pads located at some distance from the tree in order to reduce the impact of the tree roots on the new construction.

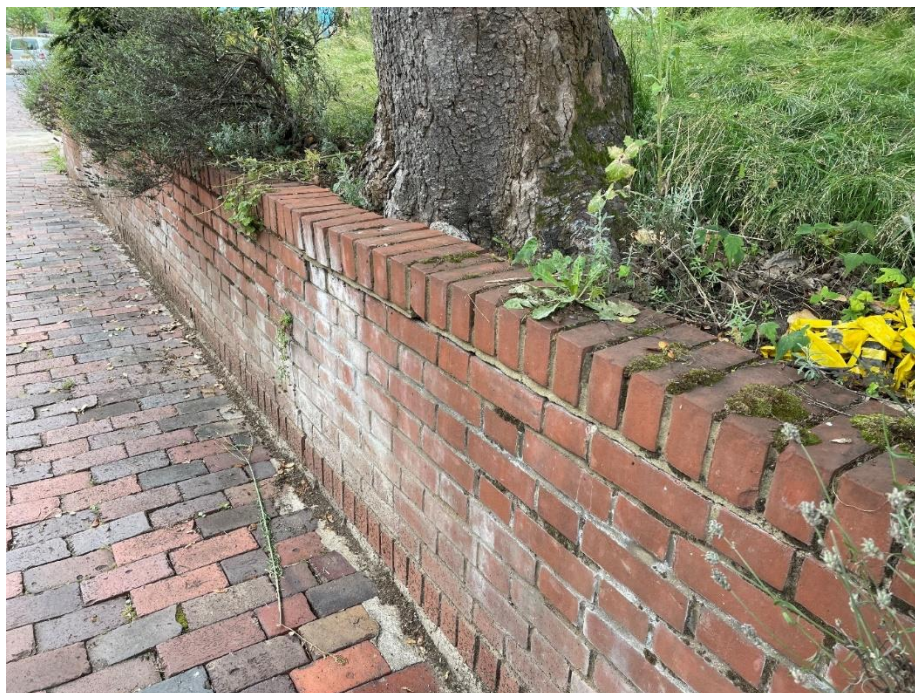
The wall is leaning outwards; maximum movement is severe at the location of the tree where the out of plumbness is of the order of 80mm to below the brick on edge coping. The coping itself has been forced further outwards by a further 30mm. The brick on edge coping has also lifted significantly in the vicinity of the tree forming a horizontal crack. The tree trunk is in contact with the wall (photo 2),

The outward movement appears to have been caused by the physical growth of the tree trunk.

Photo 2 - Leaning wall at tree location

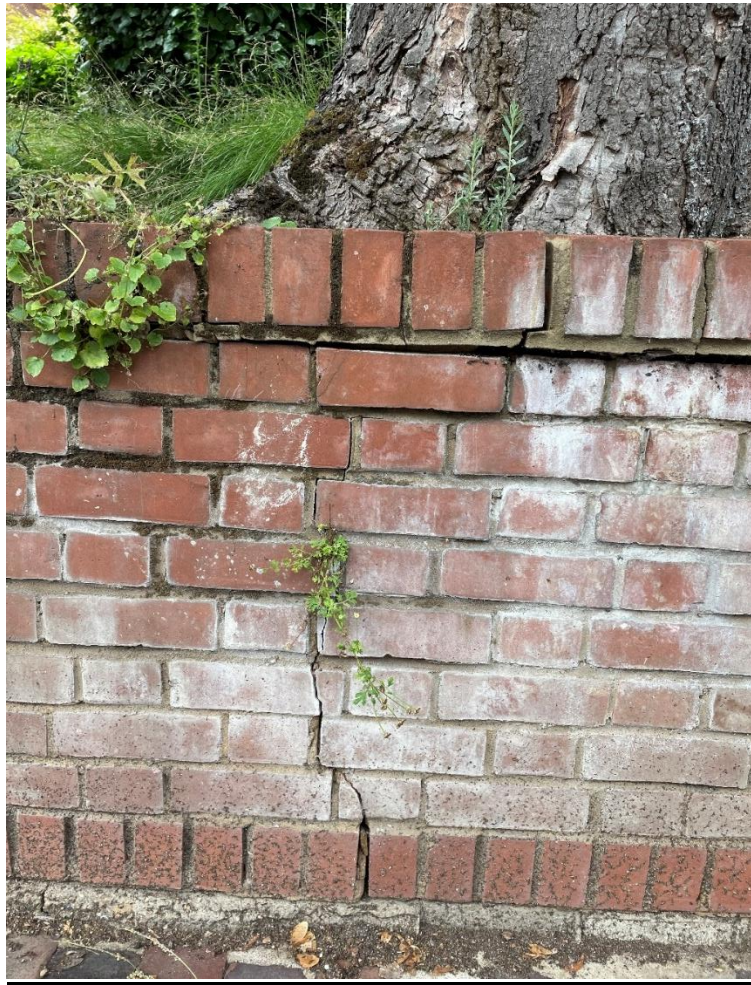
A near vertical crack at the location of the crack varies in width between 2 and 5mm.

Photo 5 – Cracking at the tree location
