Existing Window Report

Nov 2022

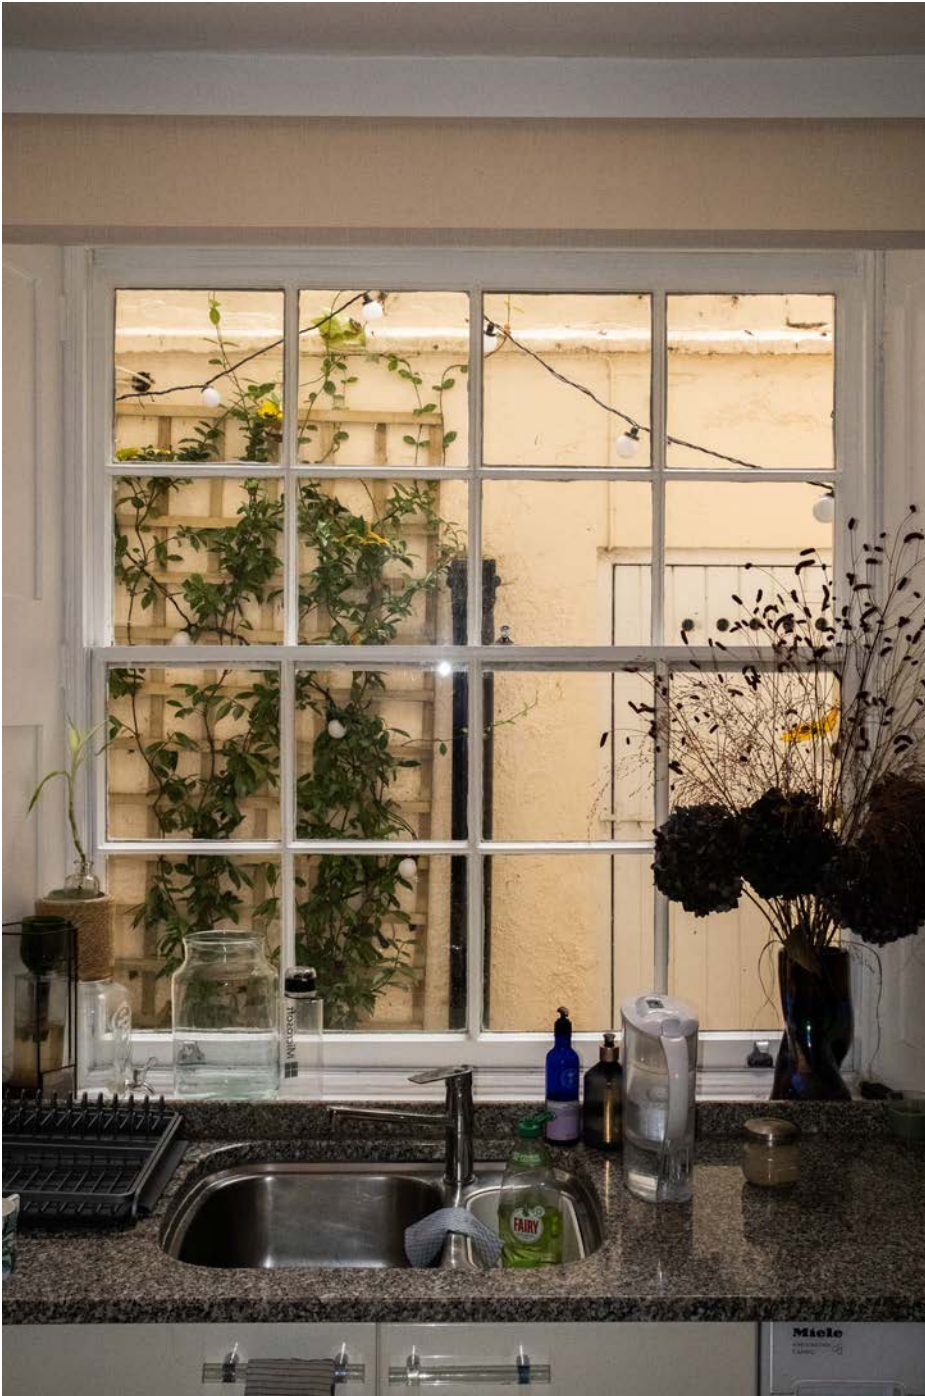
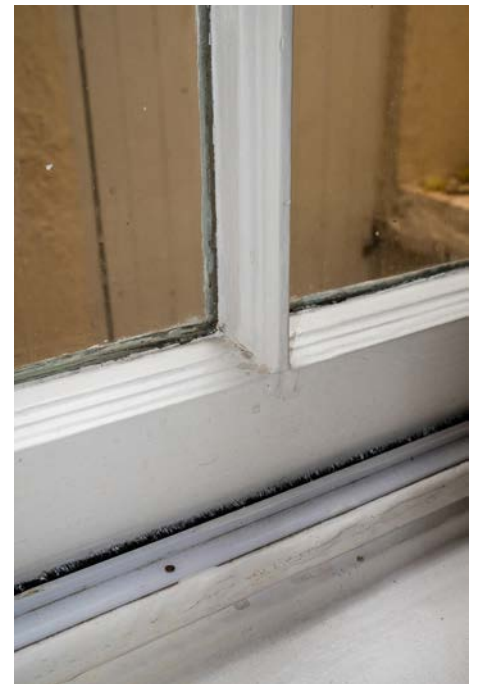
Window Ref:
WN B.01

Location:
Basement Front Sash

Condition:
Window in good condition with uniform reverse ovolo profiling and is to be retained.

Exemplar window, with uniform reverse ovolo profiles. All proposed windows are to be modelled on these profiles like-for-like. See detail drawing A609.

Profile:
Reverse Ovolo

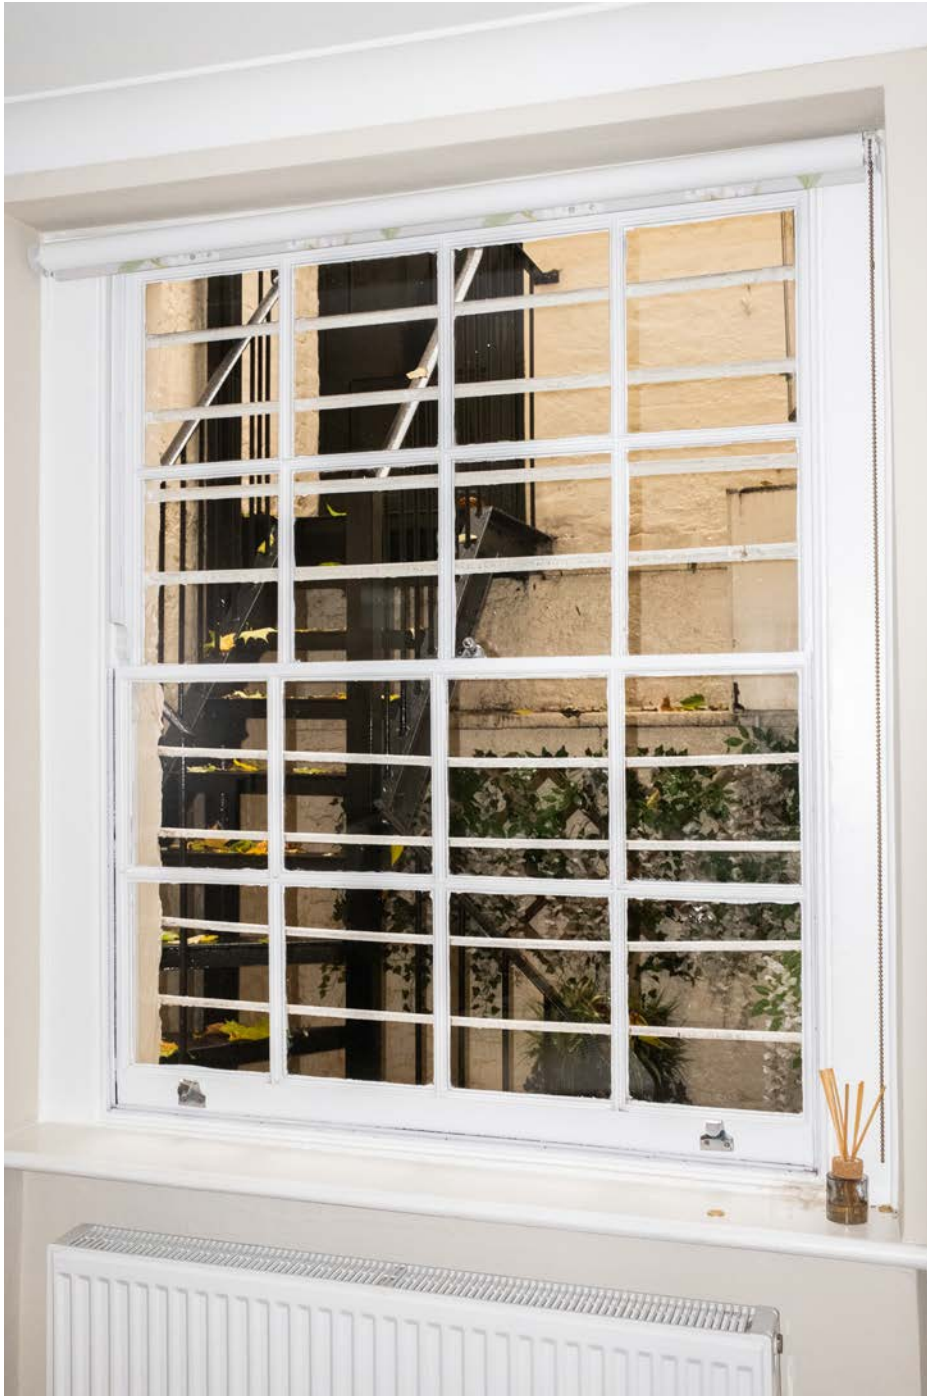
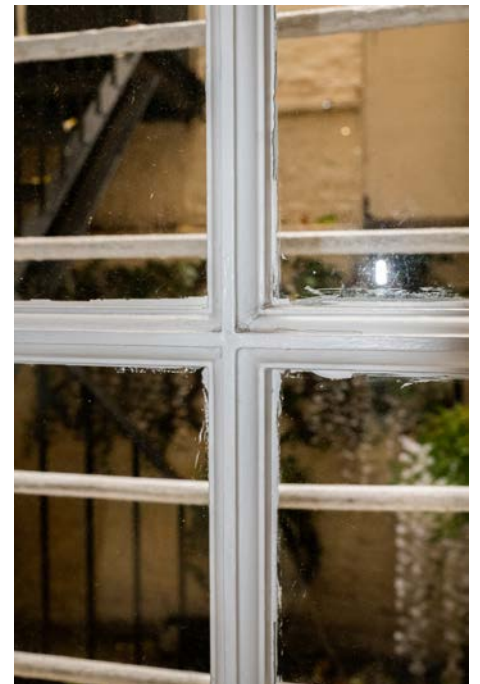
Window Ref:
WN B.02

Location:
Basement Rear Sash

Condition:
Window in fair condition.

Profile:
Ovolo

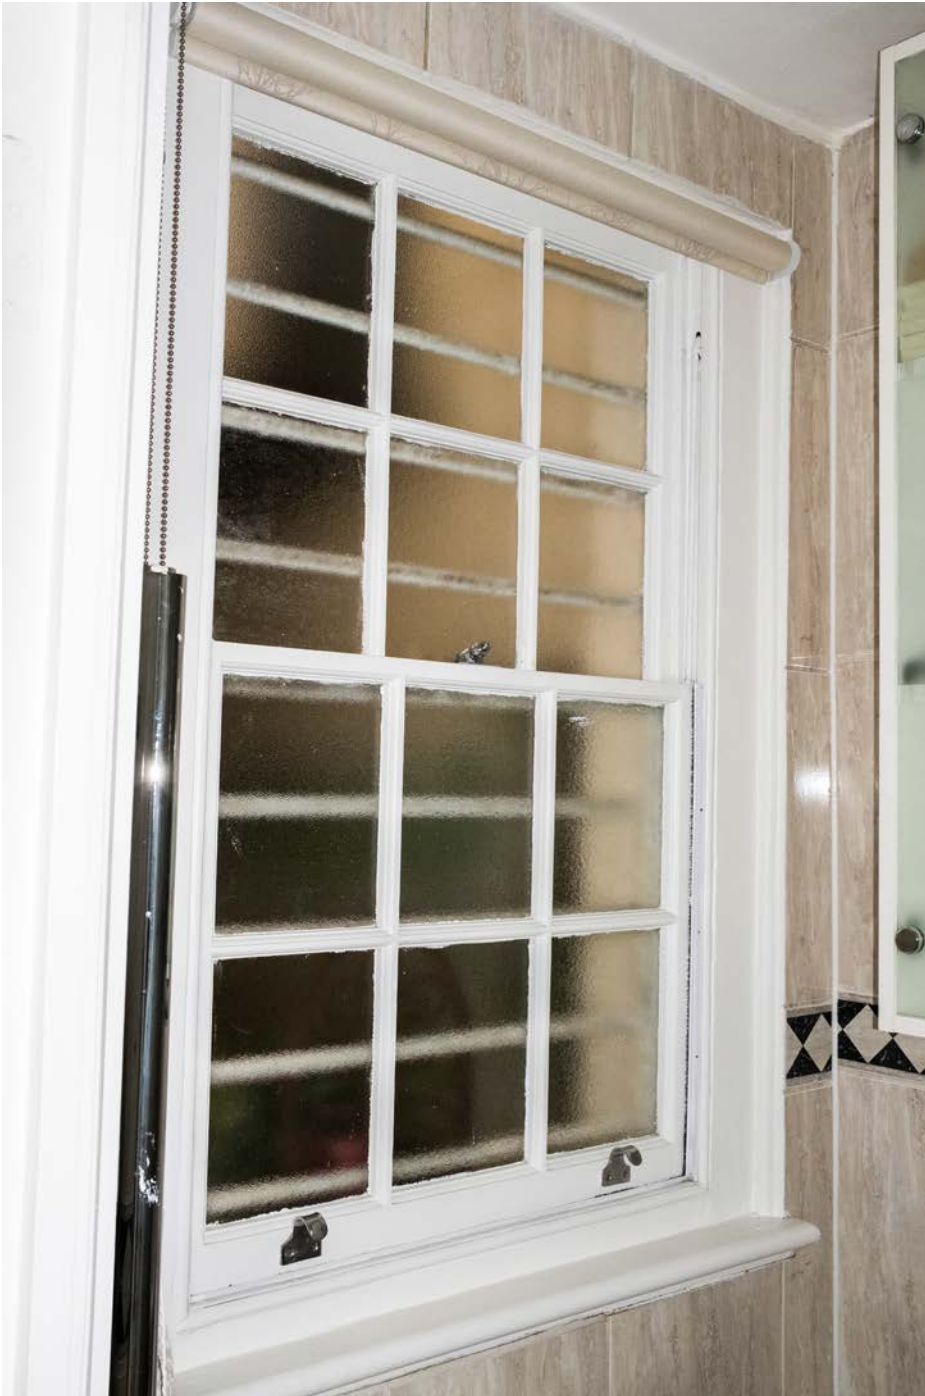
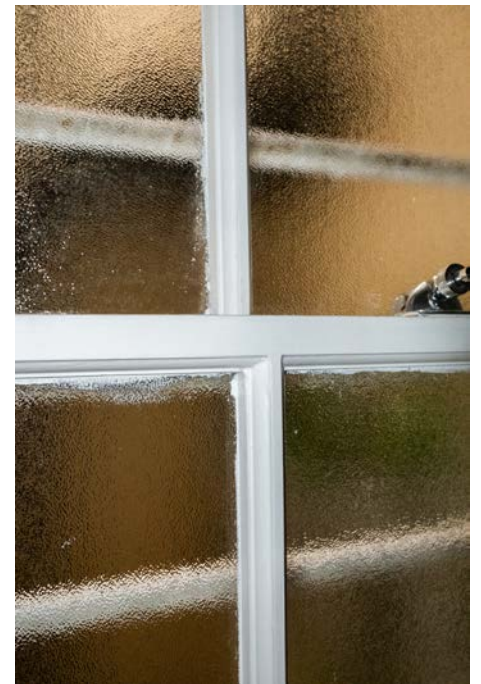
Window Ref:
WN B.03

Location:
Basement Rear Toilet Sash

Condition:
Obscured glass window in fair condition

Profile:
Ovolo

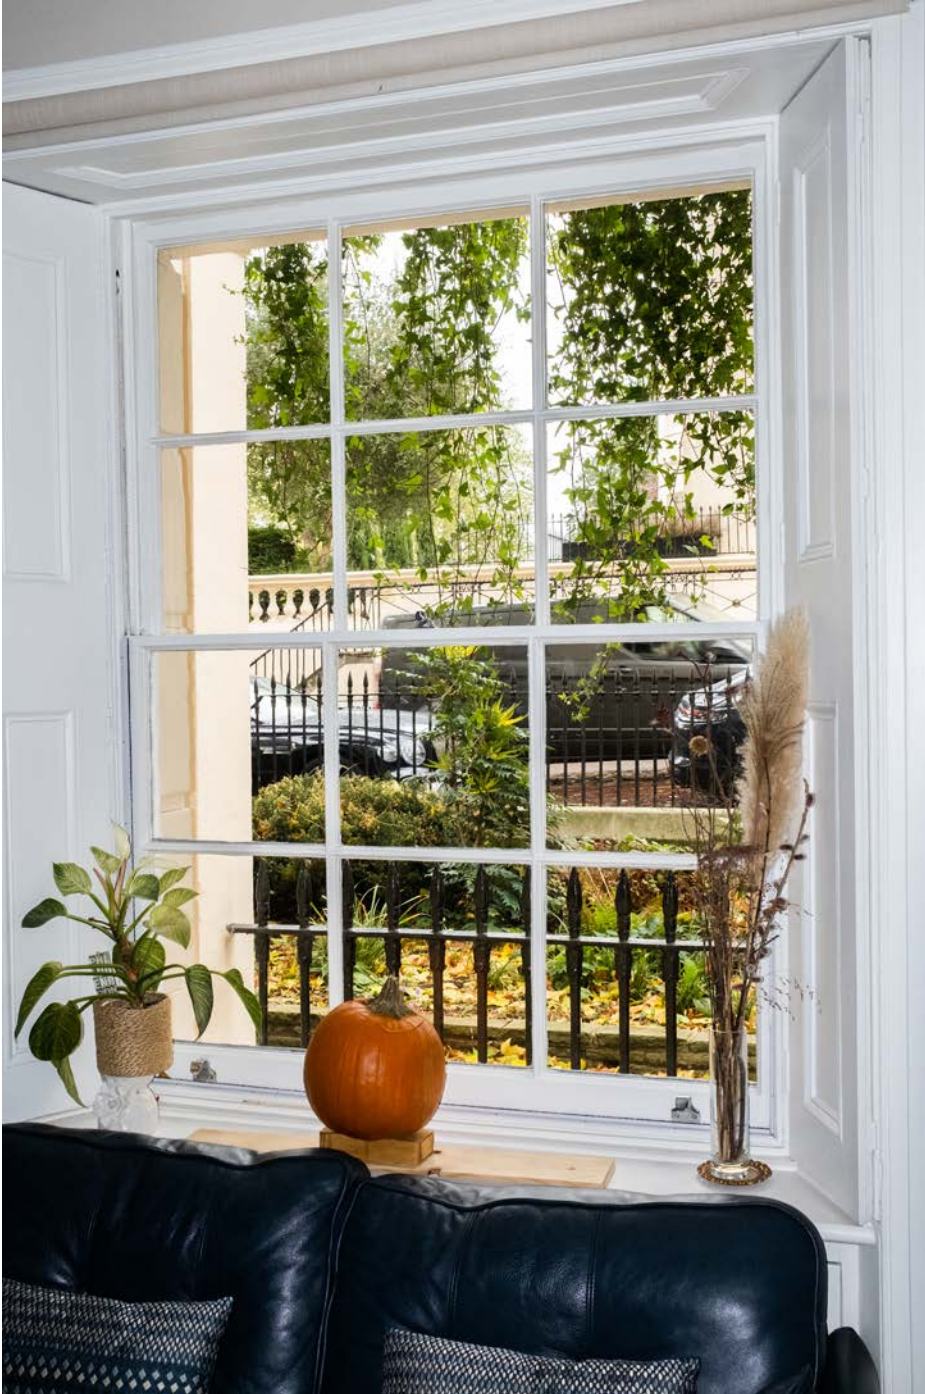
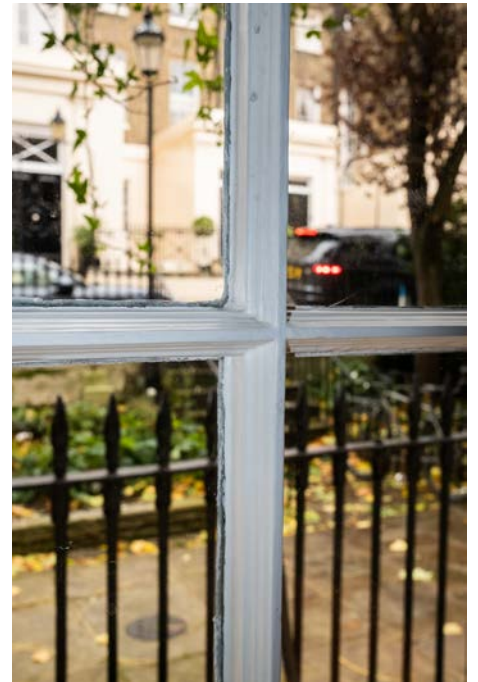
Window Ref:
WN-G.01

Location:
Ground Floor Front Sash

Condition:
Window in good condition as sheltered from weathering under balcony above, appears to be 'original fabric' with uniform reverse ovolo profiling and is to be retained.

Exemplar window, with uniform reverse ovolo profiles. All proposed windows are to be modelled on these profiles like-for-like. See detail drawing A610 for proposed profile.

Profile:
Reverse Ovolo

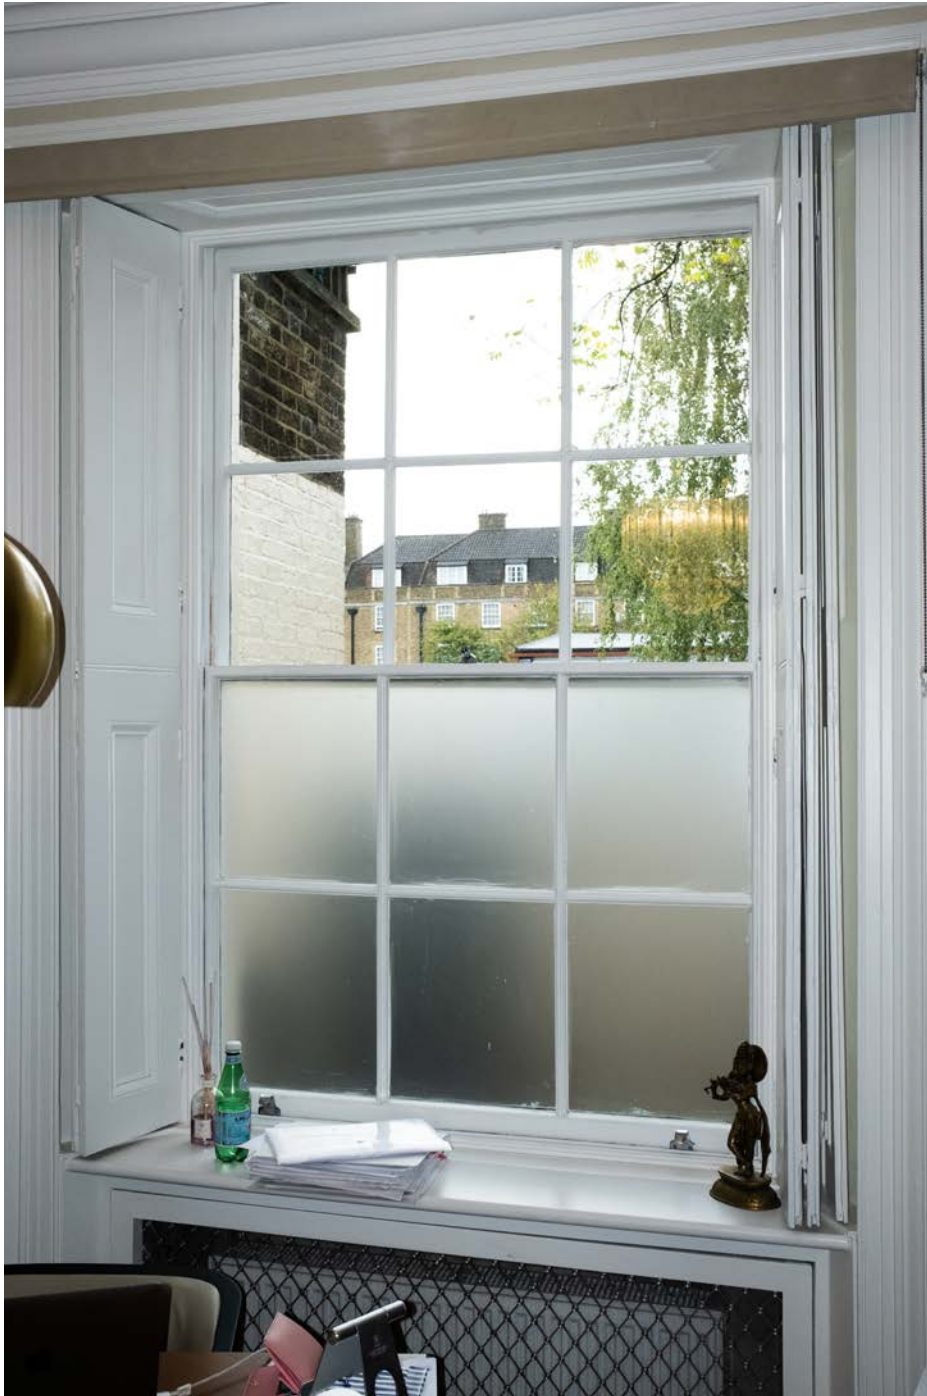
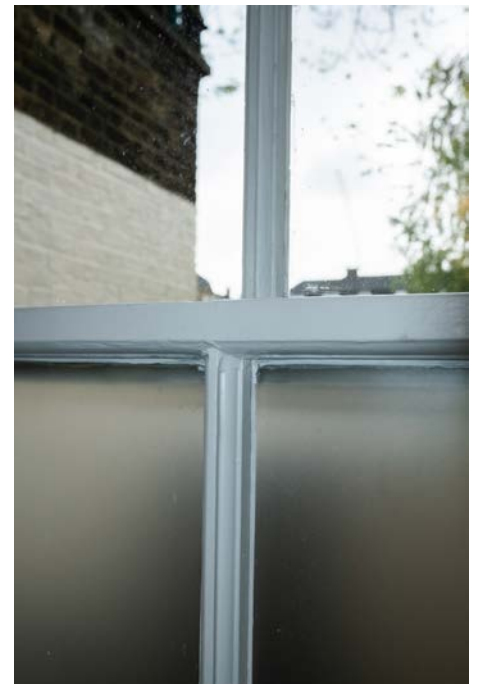
Window Ref:
WN-G.02

Location:
Ground Floor Rear Sash

Condition:
Glazing bars are different from rails. Rotten bottom sash, repaired with filler.

Profile:
Long Ovolo
Short Ovolo

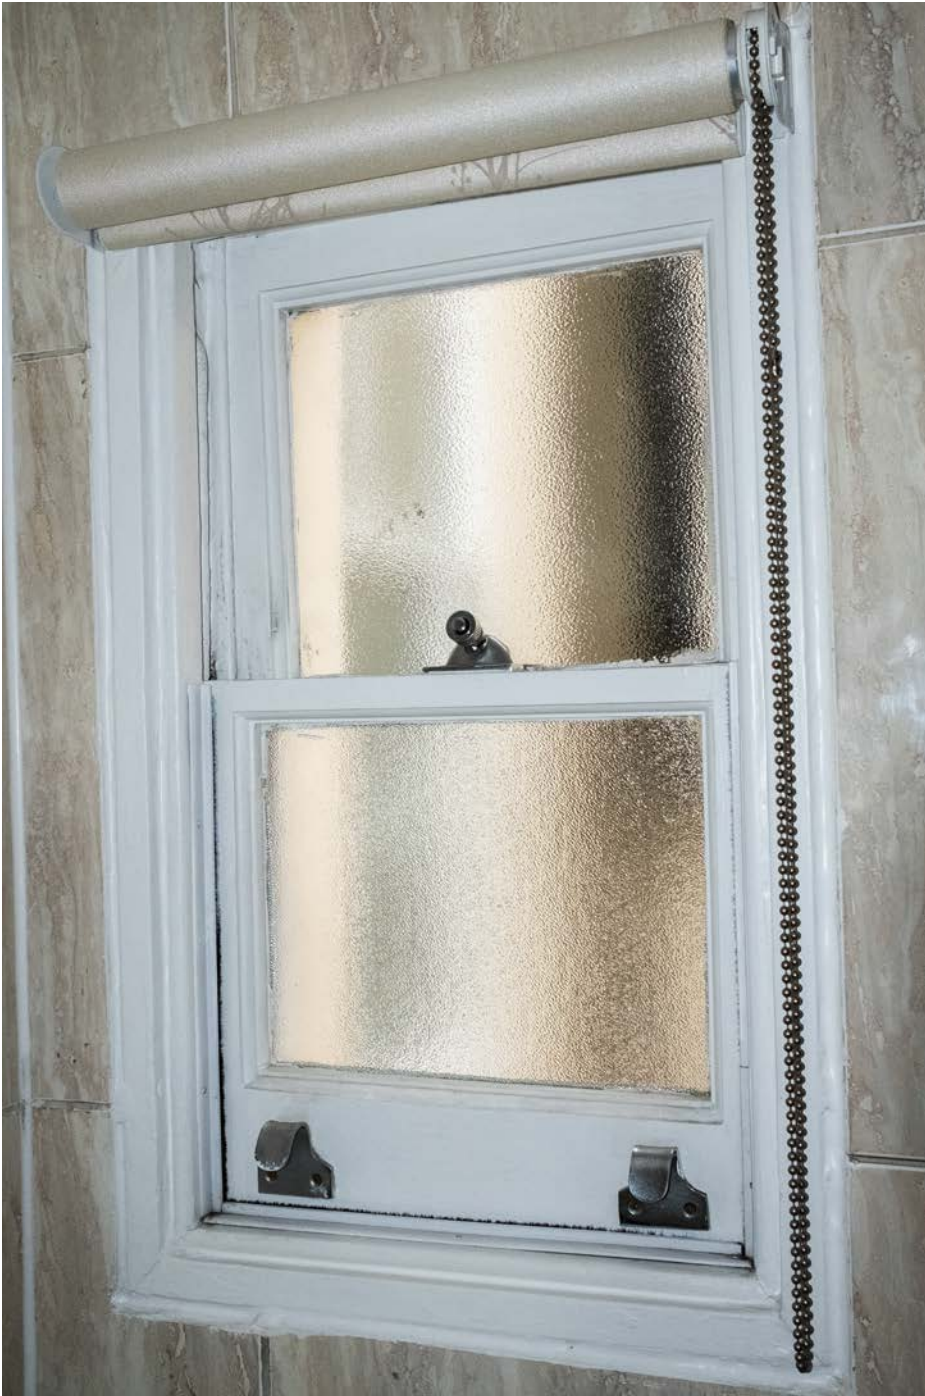
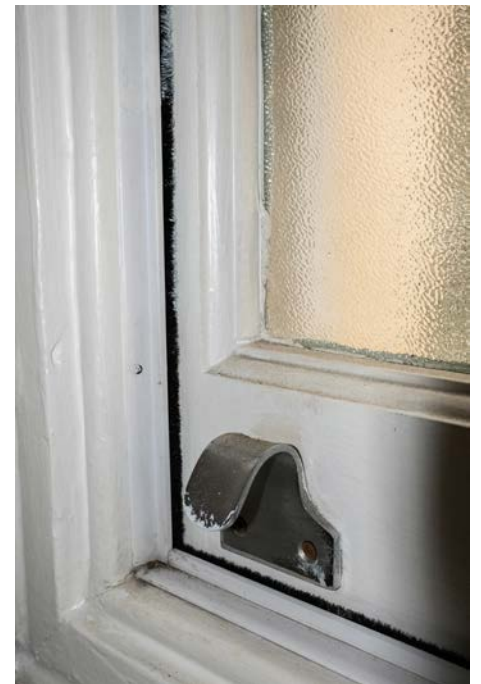
Window Ref:
WN-G.03

Location:
Ground Floor Rear Toilet Sash

Condition: Obscured glass window in fair condition

Profile: Ovolo

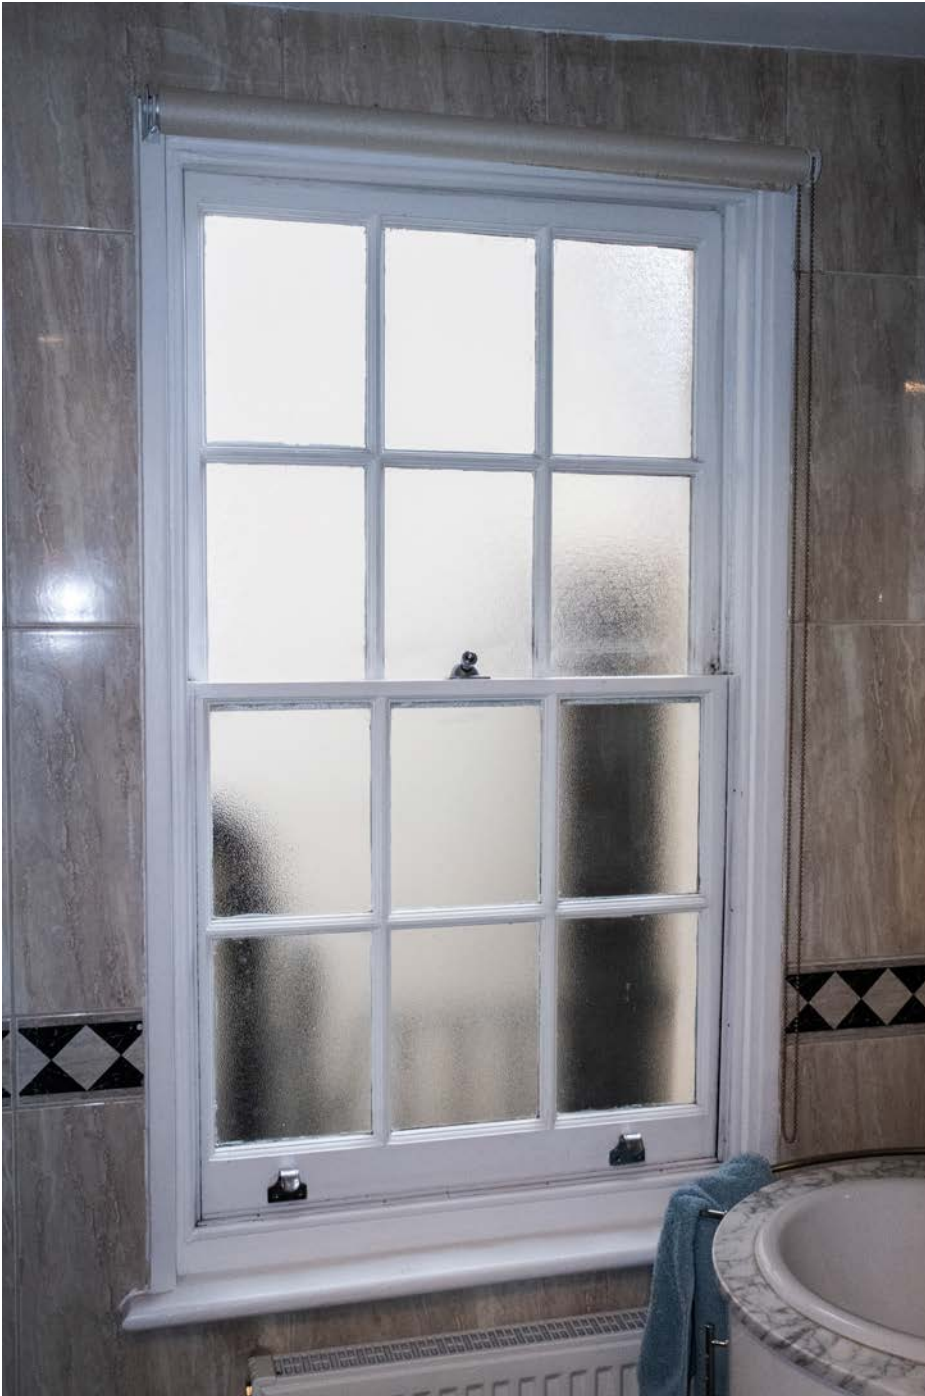
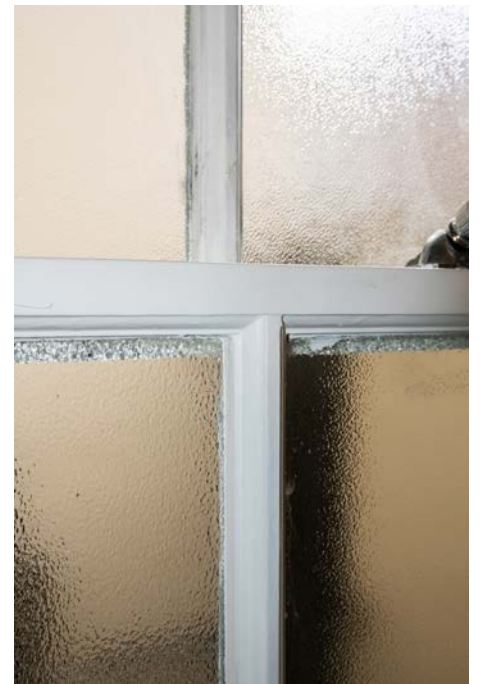
Window Ref:
WN-G.04

Location:
Ground Floor Rear Toilet Sash

Condition:
Obscured glass window in fair condition

Profile:
Ovolo

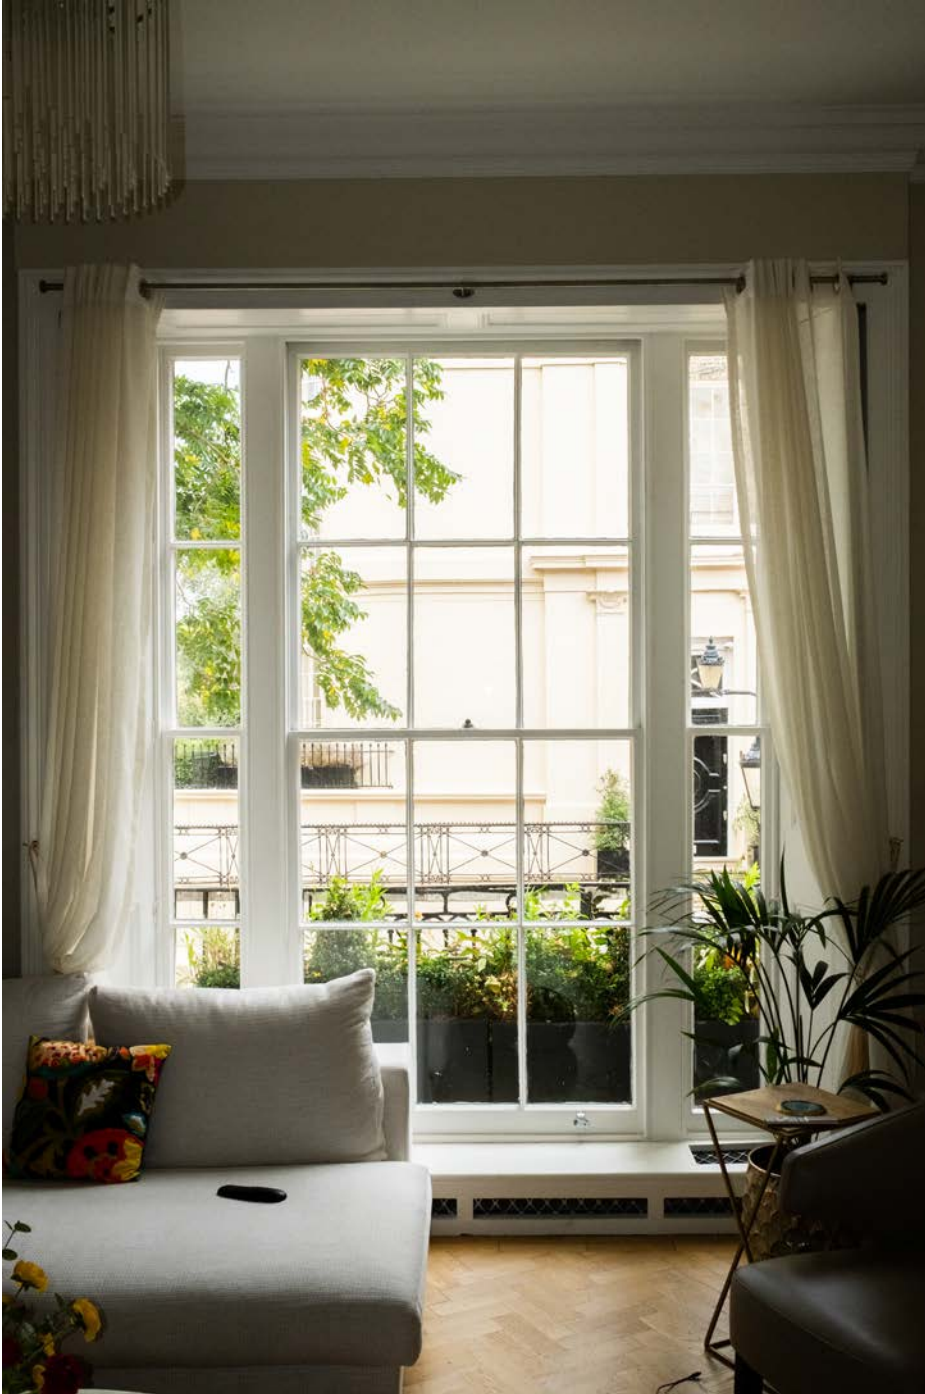
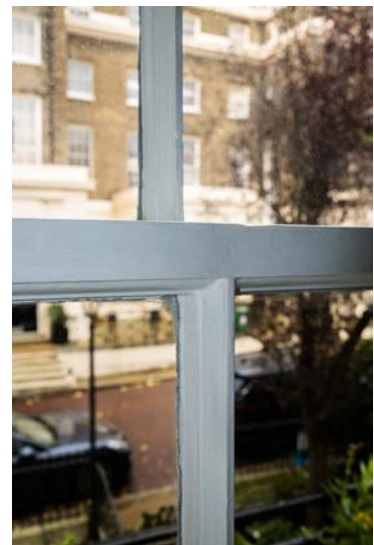
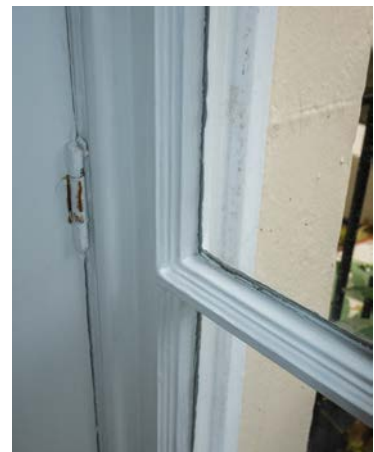
Window Ref:
WN-1.01

Location:
1st Floor Front Sash

Condition:
Centre sash on springs, side sash on weights. Springs have been poorly added and not in keeping with property.

Profile:
Centre Sash - Ovolo (top)
Side Sash - Reverse Ovolo (bottom)

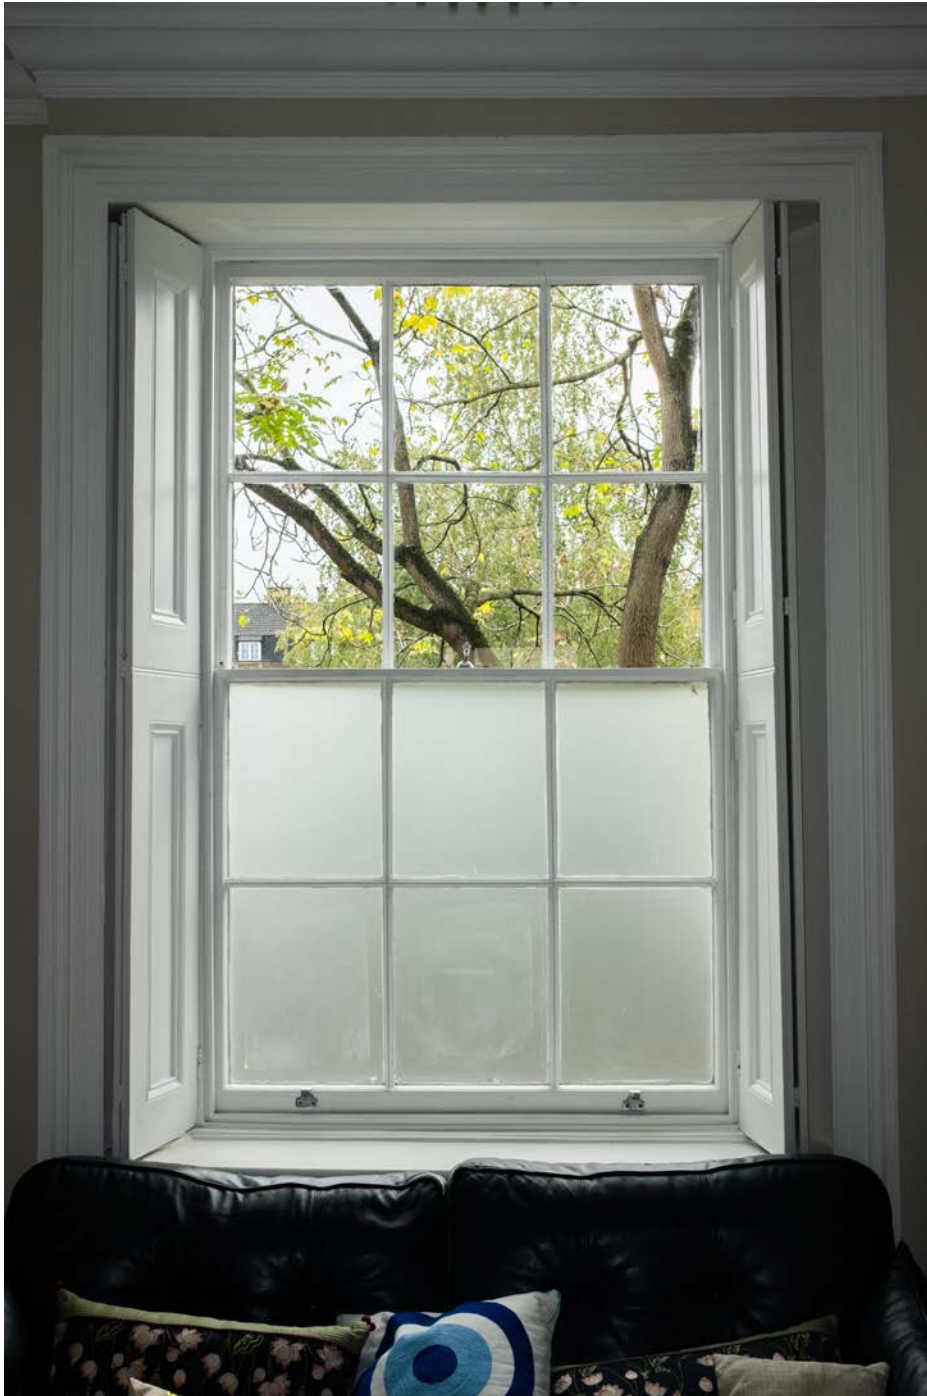
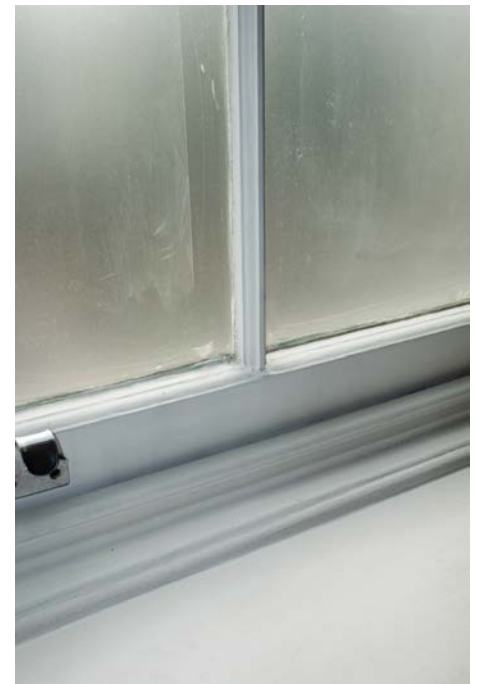
Window Ref:
WN-1.02

Location:
1st Floor Rear Sash

Condition:
Repaired with filler. Rotten bottom sash. Suspected rotten glazing bars.

Profile:
Long Ovolo
Short Ovolo

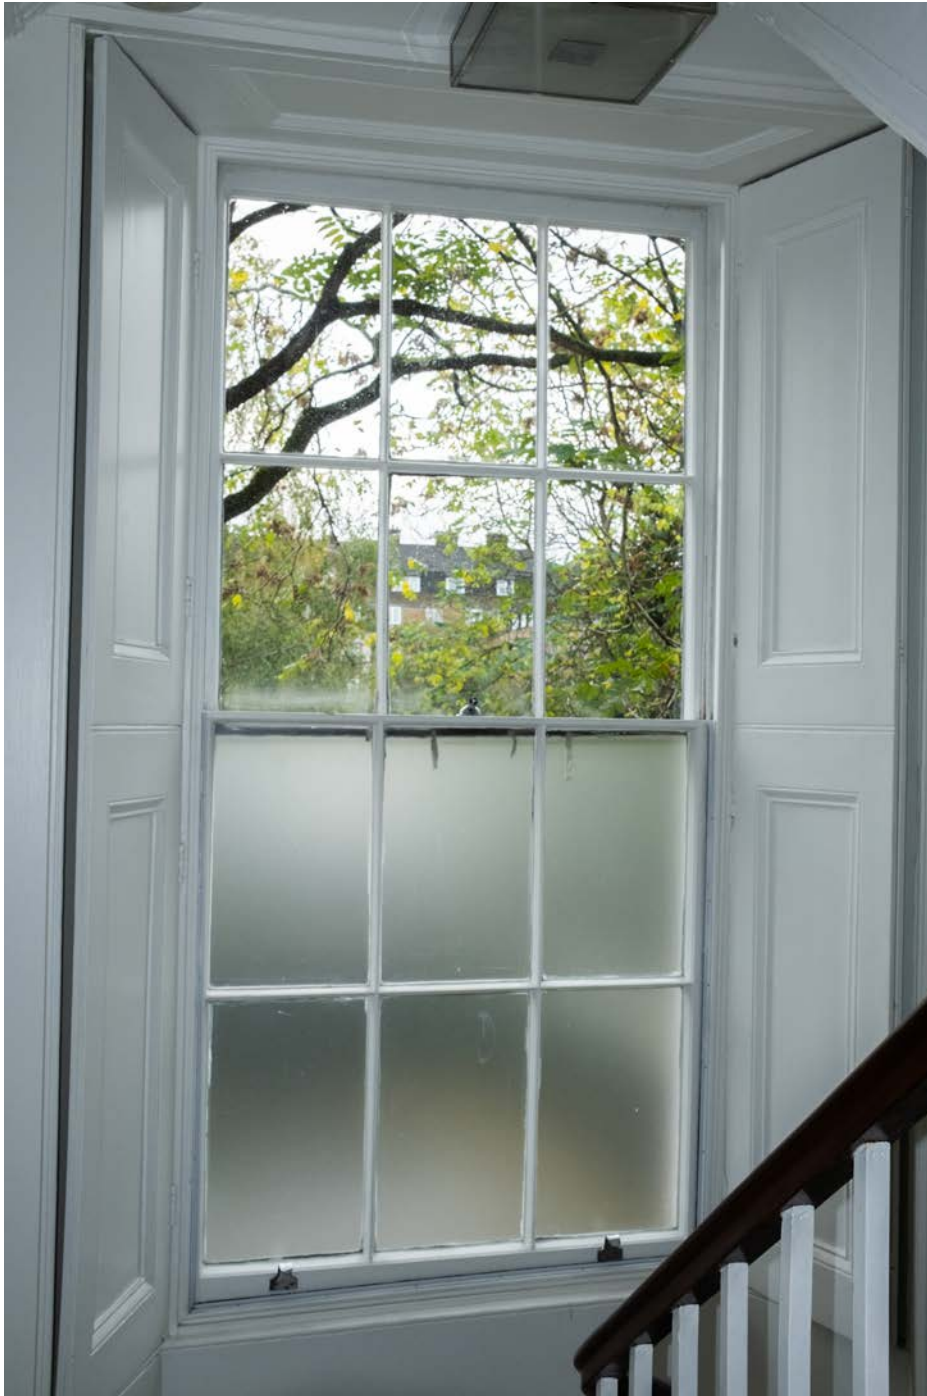
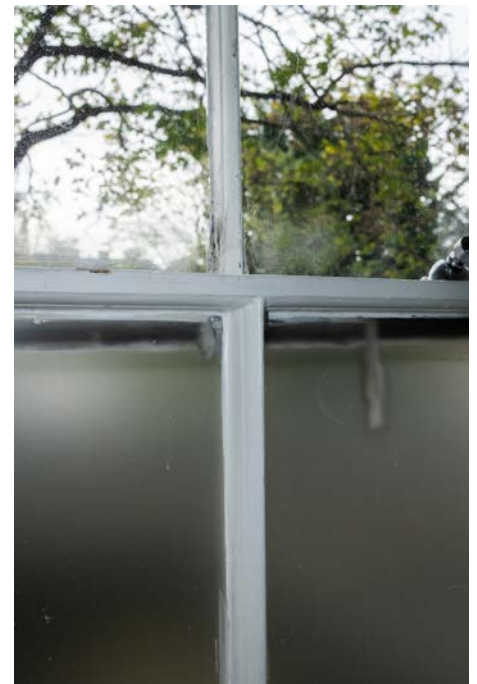
Window Ref:
WN-1.03

Location:
1st & Ground Floor Landing Sash

Condition:
Repaired with filler. Rotten bottom sash. Suspected rotten glazing bars.

Profile:
Ovolo

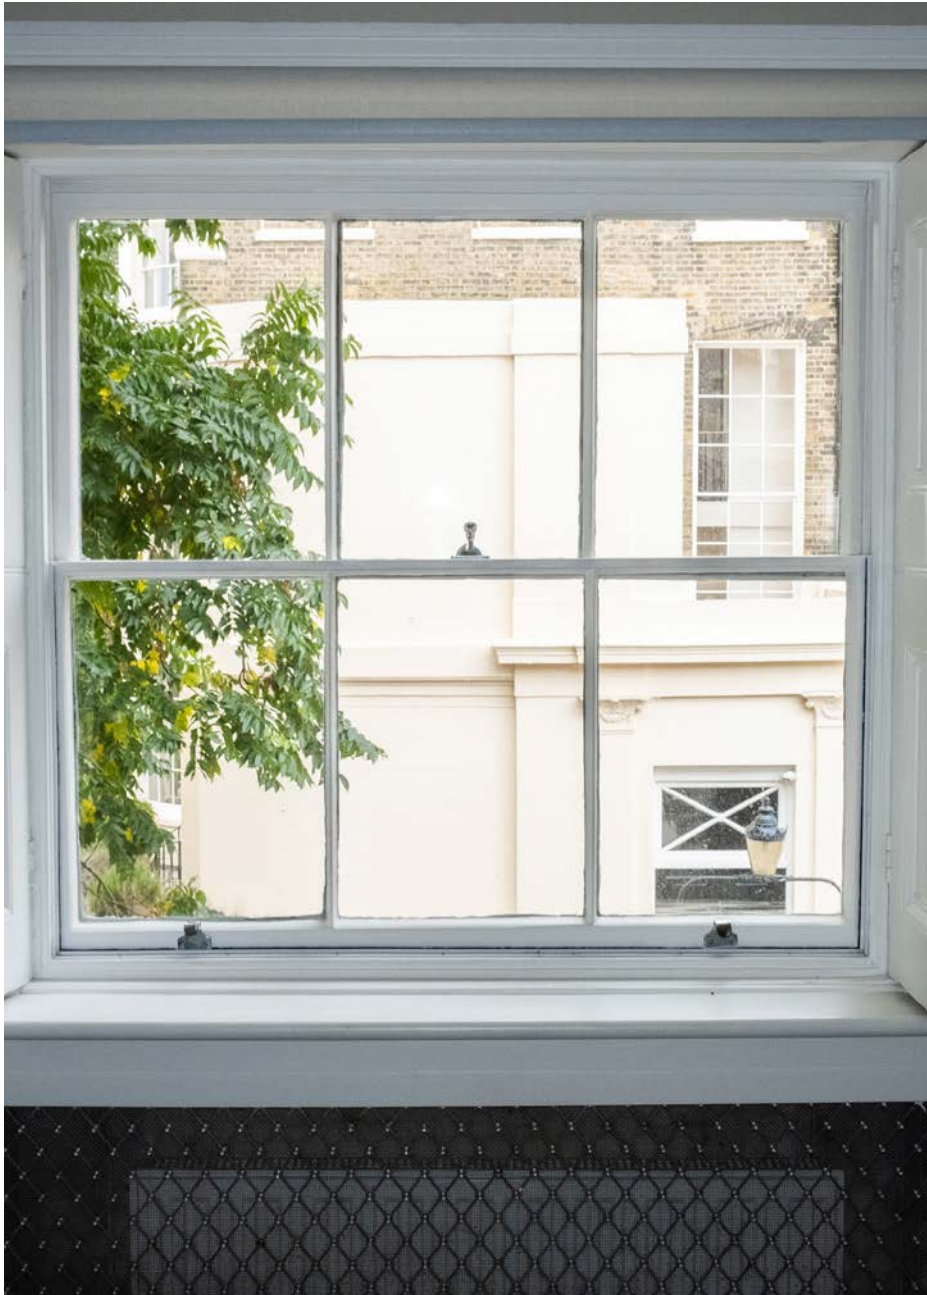
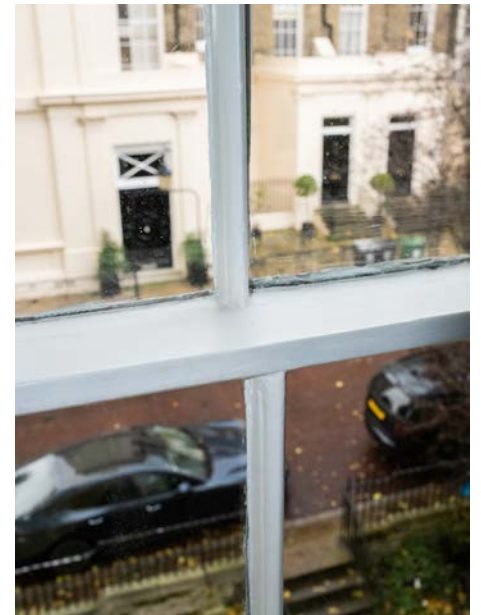
Window Ref:
WN-2.01

Location:
2nd Floor Front Sash

Condition:
Heavily repaired using filler. Bottom timber rotten,
glazing bars suspected to be rotten also.

Profile:
Ovolo

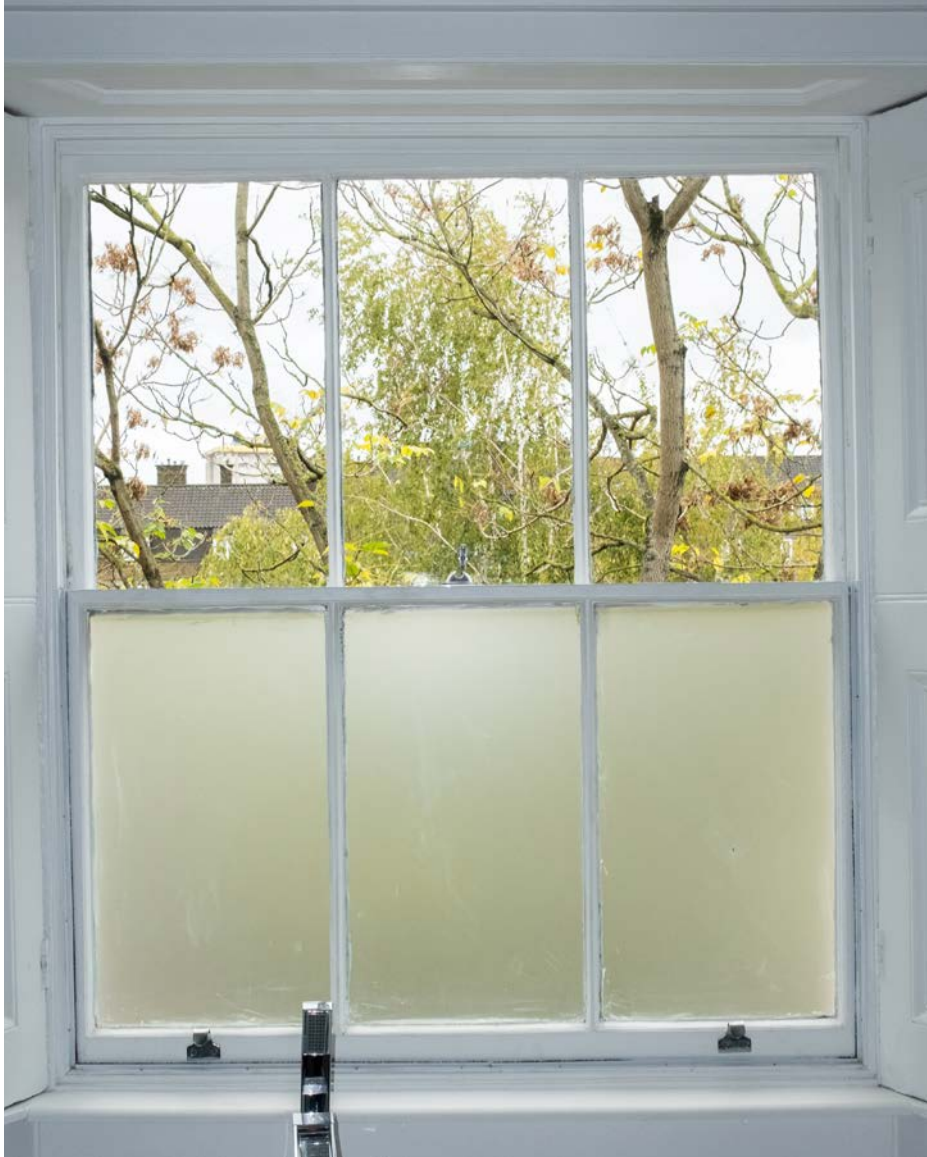
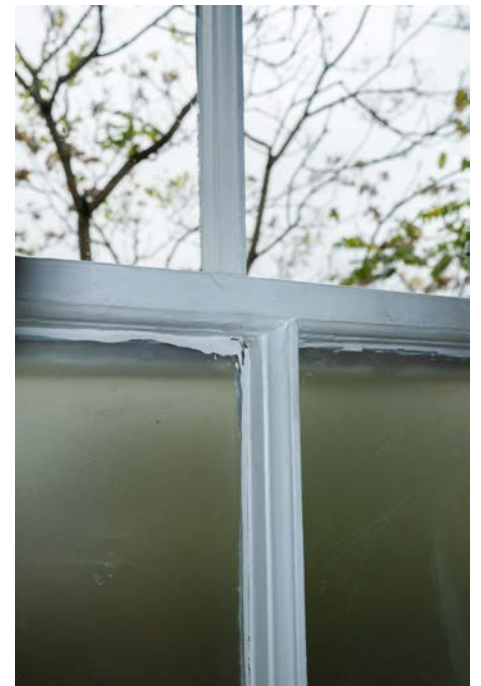
Window Ref:
WN-2.02

Location:
2nd Floor Rear Sash

Condition:
Heavily repaired using filler. Bottom timber rotten,
glazing bars suspected to be rotten also.

Profile:
Ovolo

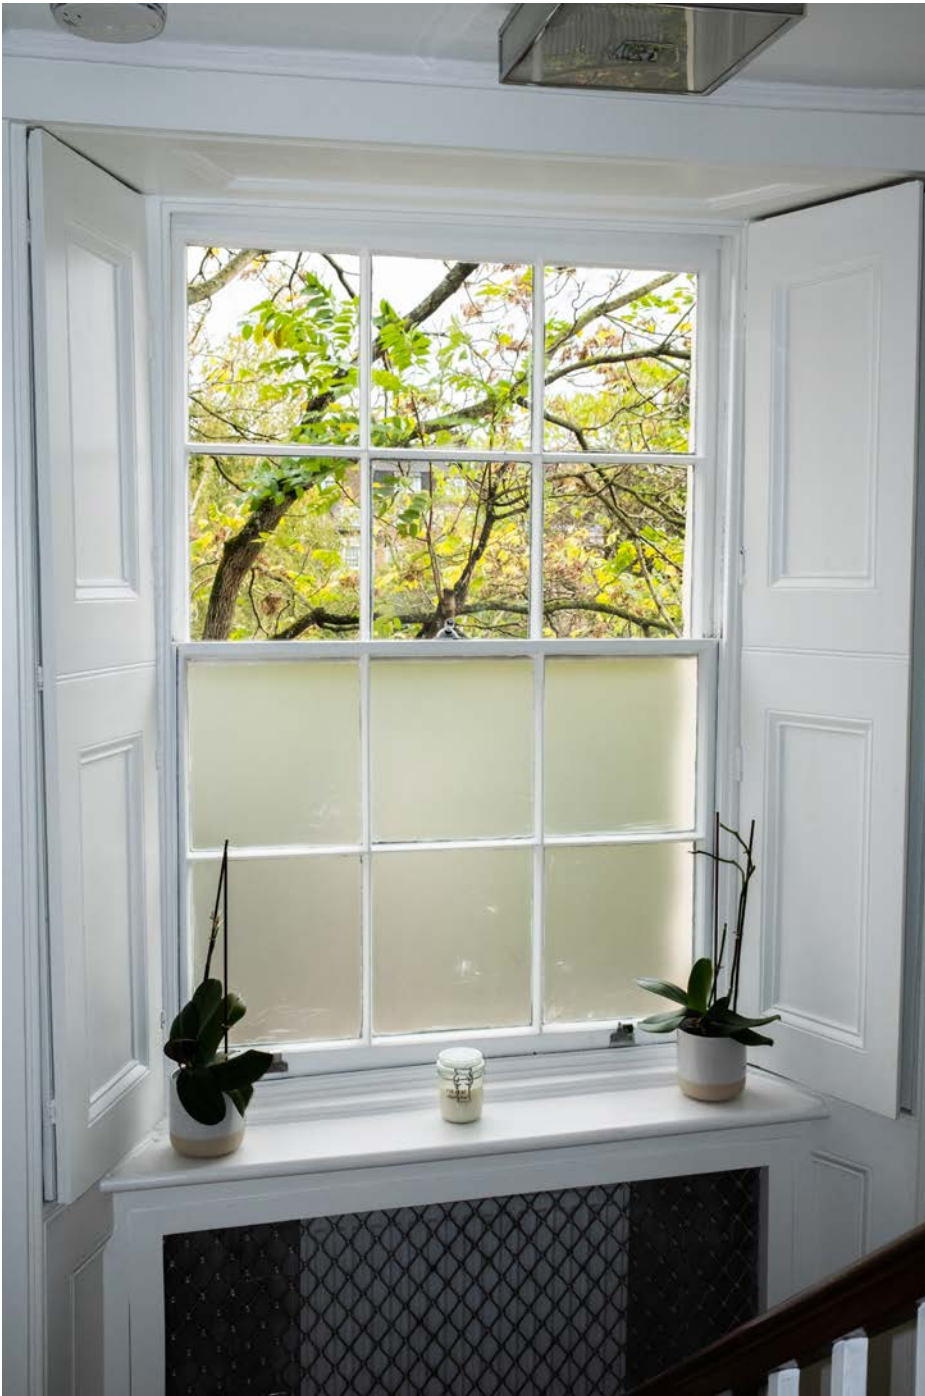
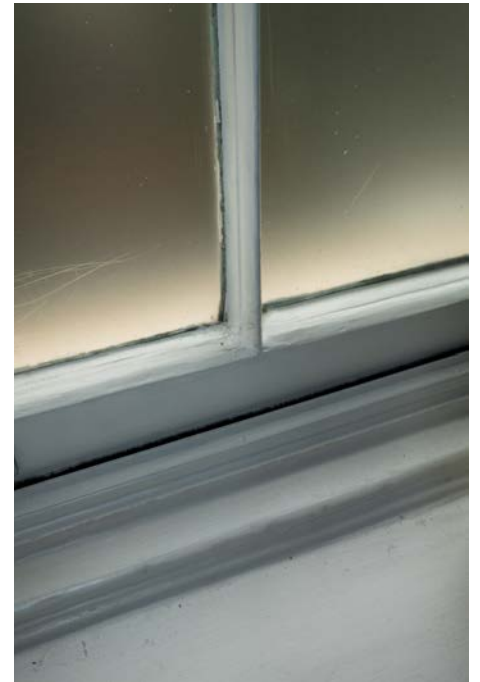
Window Ref:
WN-2.03

Location:
2nd & 1st Floor Landing Sash

Condition:
Heavily repaired using filler. Bottom timber rotten,
glazing bars suspected to be rotten also.

Profile:
Ovolo

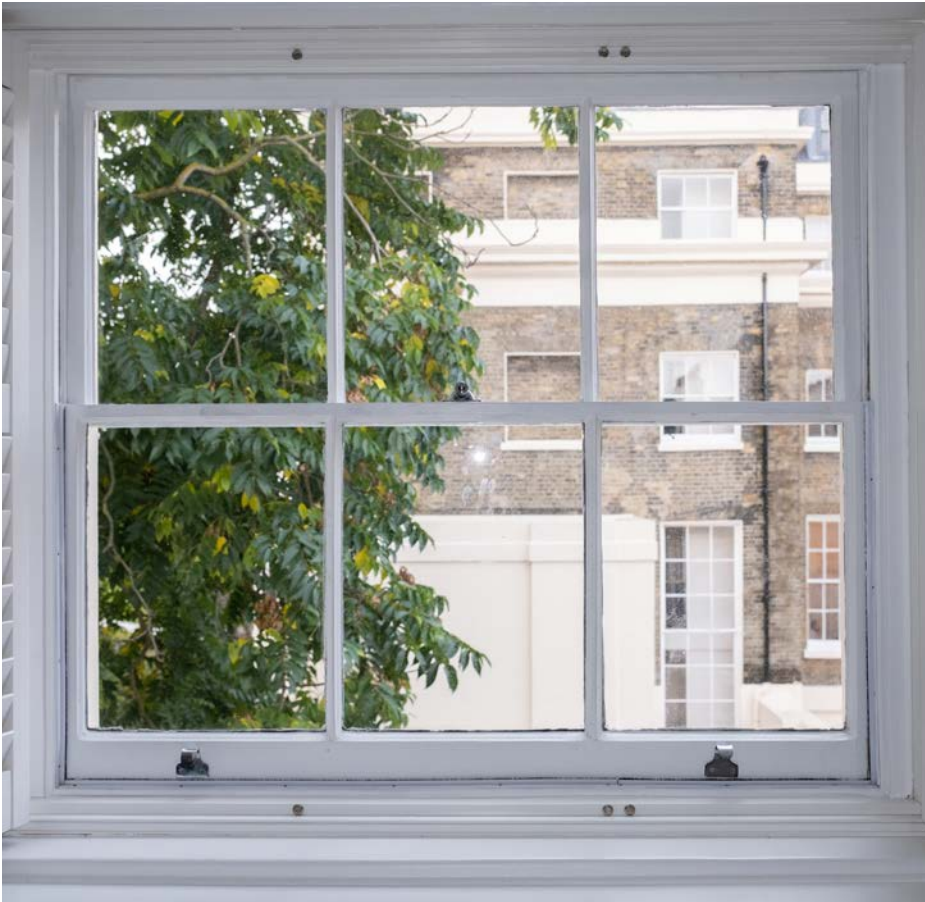
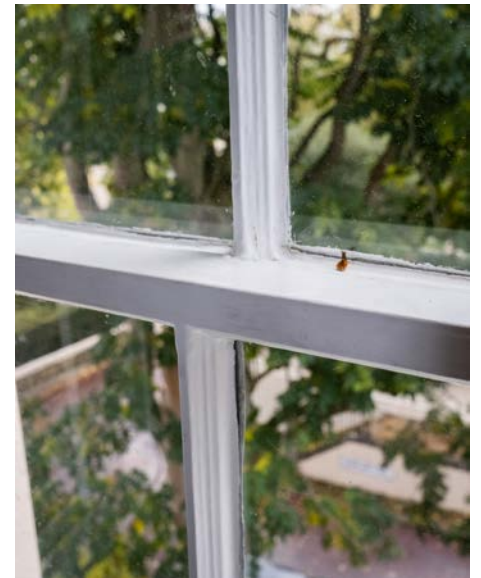
Window Ref:
WN-3.01

Location:
3rd Floor Front Sash

Condition:
Heavily repaired using filler. Bottom timber rotten,
glazing bars suspected to be rotten also.

Profile:
Reverse Ovolo
