Existing Window Report

Nov 2022

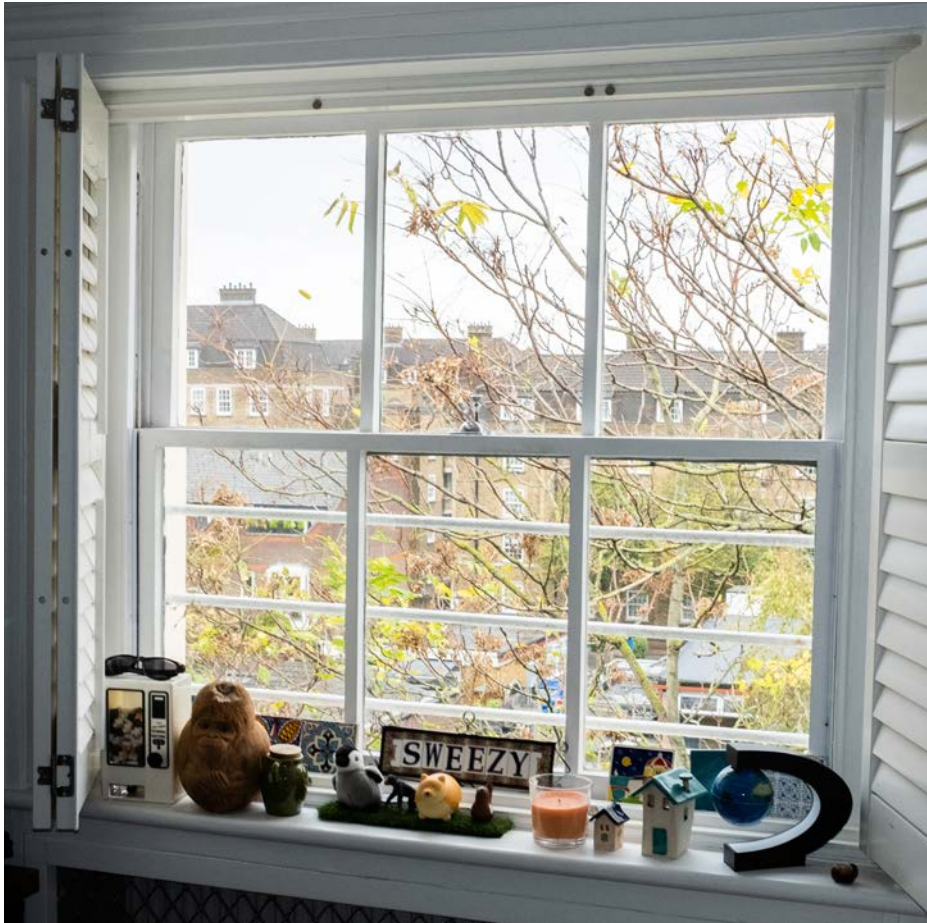
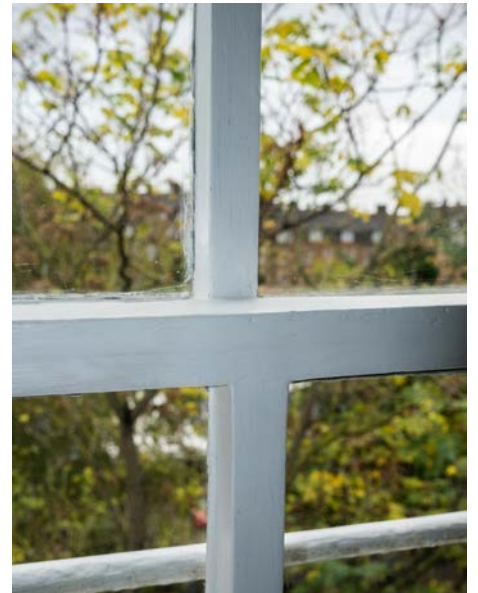
Window Ref:
WN-3.02

Location:
3rd Floor Rear Sash

Condition:
Fair condition, square moulding not in keeping with period of property.

Profile:
Square Mould

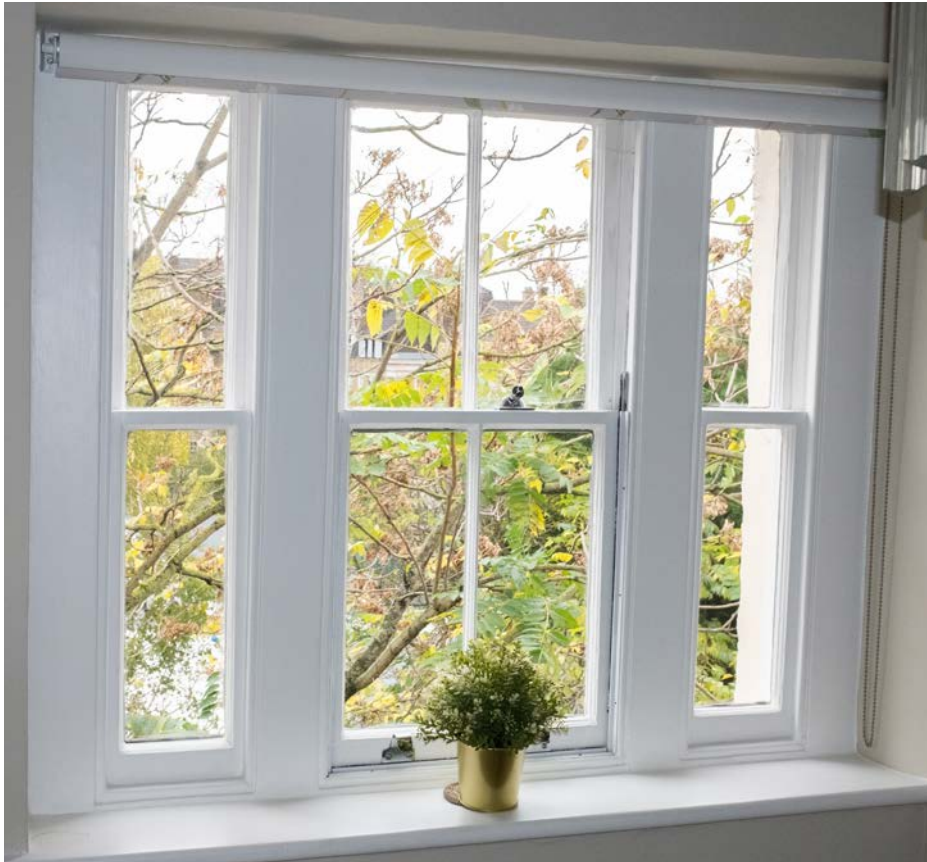
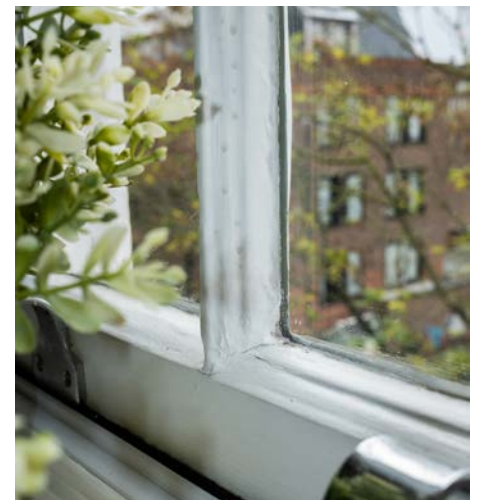
Window Ref:
WN-3.03

Location:
3rd & 2nd Floor Landing Rear Sash

Condition:
Side windows painted shut. Heavily repaired using filler. Bottom timber rotten, glazing bars suspected to be rotten also.

Profile:
Ovolo
